Service Center Engineering for a Power Plant

Circulating Water Pump Fails

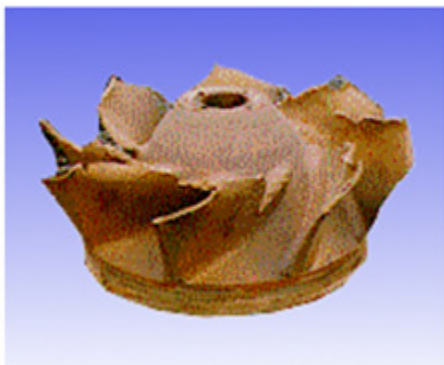
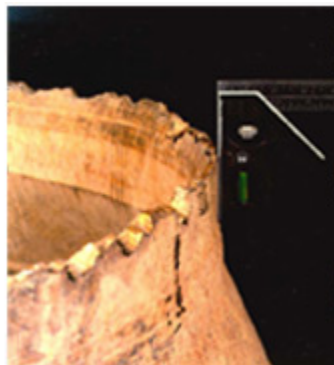
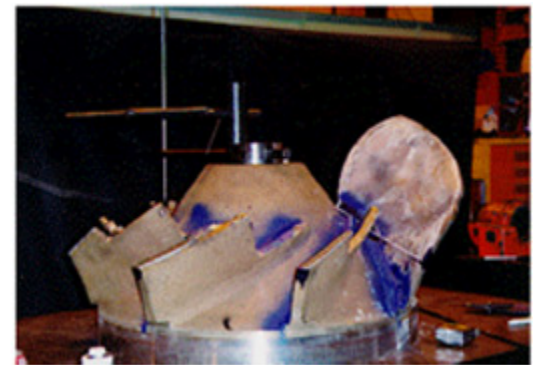
The impeller proved an even greater challenge. The existing impeller blades had been virtually destroyed when the suction bell broke into two pieces. As a result, the hydraulic profile was not available. In addition, the impeller had been cast in a special high lead content bronze, which was not available from local foundries. The use of special bronze alloys was common 40 to 50 years ago when the pump was designed and manufactured.

The service center's hydraulic design engineers analyzed the performance requirements of the original design using CFD (computational fluid design) and data that was available from the existing impeller to recreate the impeller's hydraulic profile. A CAD drawing was developed and electronically transferred to the foundry for the mold used to cast the impeller vanes.

Because the engineers' solution involved welding new blades to the existing impeller hub, it was essential to manufacture the blades from precisely the same material as the hub. A metallurgical analysis had to be performed on the original impeller so new vanes could be cast of the special bronze alloy material. The service center sent samples of the unusual bronze material out for analysis and worked with a smelter to duplicate the original material composition exactly. The ingots they produced were then transferred to a foundry where they were used to cast the newly designed blades. What remained of the old blades were carefully plasma arc removed. The new blades were then welded (using base metal welding material to ensure a high degree of strength) to the original impeller hub.
