Engineered Modifications for an Ash Handling Water Pump

Written by: George Harris, Hydro Inc.

Publisher: Pumps & Systems / May, 2009

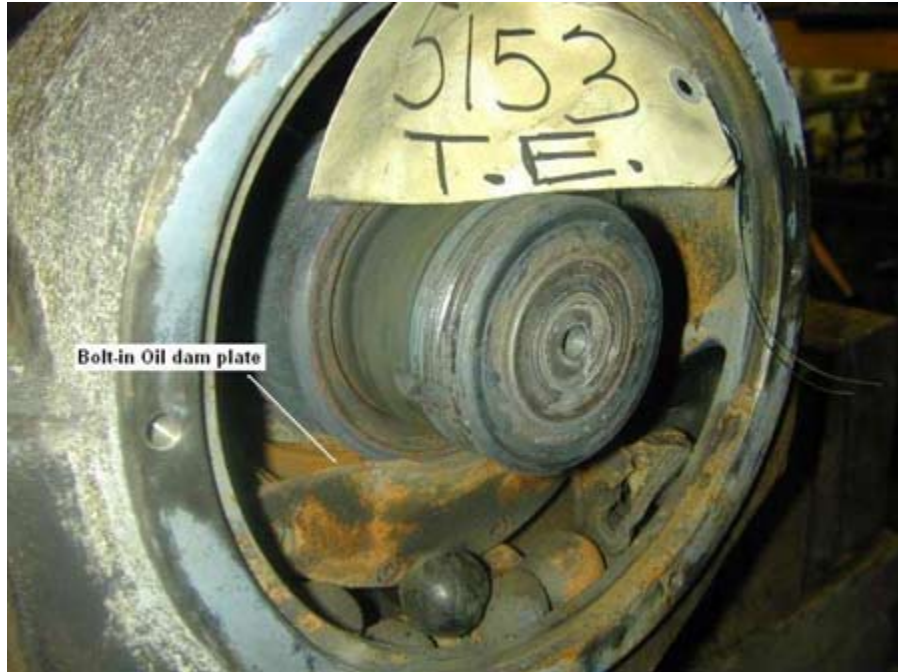
During disassembly, it was observed that there was not much evidence of any residual lubricant inside the bearing housing on the non-drive end side. There was rust build-up on the bearing debris (see Figure 2).

A 3/8-in diameter oil drain hole was added in the bearing bore at the 6:00 position, which eliminated

bolt-in bearing housing oil dams. This would allow oil to be drained away from the bearings without any contaminants settling close to the bearings.

The bearing housing oil level was changed from 2.5-in below pump centerline to 3.5-in below pump centerline. The intent was to avoid excess churning of oil in the sump by the bearings in operation. To keep the bearings well lubricated, the pump repair shop increased the oil flinger ring diameters to allow the flingers to pick up sufficient oil from the new sump level.

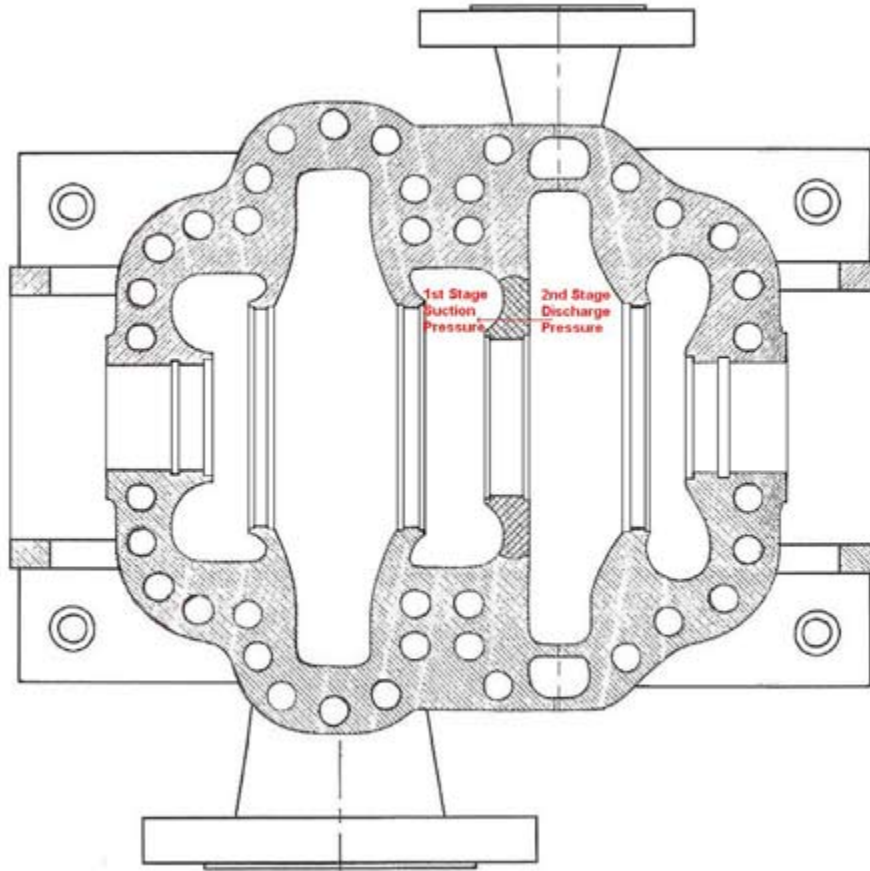
As part of the service center's dimensional inspection, the pump casing split line faces were inspected for flatness. It was observed that the casing split line faces adjacent to the second stage impeller, toward the non-drive side, had low spots. When the casing halves were assembled without any shims at the split line face, gaps measuring from 0.010-in to 0.020-in were observed between the top half and the bottom half at the split lines in these areas. Since this would also form the fit for the balance drum bushing separating the high pressure side from the suction side, this could have provided a possible leakage path (see Figure 3).

As part of the rebuild, the pump case fits were also welded and re-machined to restore OEM sizes and flatness. The pump was reassembled with new wear components and new bearings and was then shipped to the station.

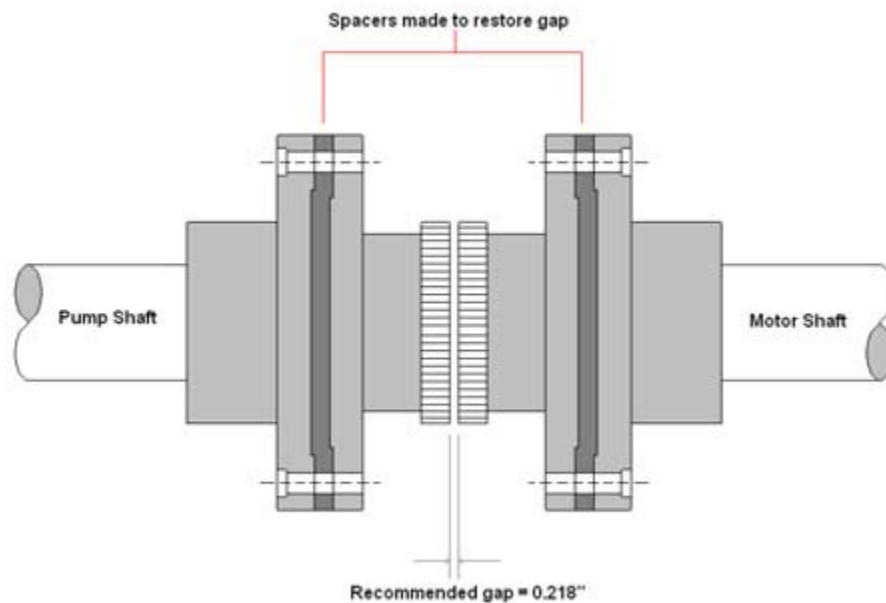
During installation, the service center personnel set the pump in position and connected its discharge and suction flanges to the plant piping before securing the pump feet. The purpose of this was to ensure that the pump was not under stress because of the piping. They then proceeded to align the motor to the pump. After confirming the direction of rotation, they performed a no-load run of the motor to locate its magnetic center. It was observed that the gap between the coupling hubs was 0.820-in (compared to an OEM recommended gap of 0.218-in). This may have been a preexisting condition. The only way to close this gap would have been to pull the motor rotor toward the pump and disturb its magnetic center.

To keep the motor running at its magnetic center, the service center manufactured two spacers (one for each coupling hub) to bridge this gap (see Figure 8) and completed the alignment using laser alignment equipment.
