How Poor Repairs on Boiler Feed Pumps Affect Performance and Reliability

George Harris, Hydro, Inc.

Analyzing the poor repairs on a boiler feed pump and how they affect the pump's performance and reliability.

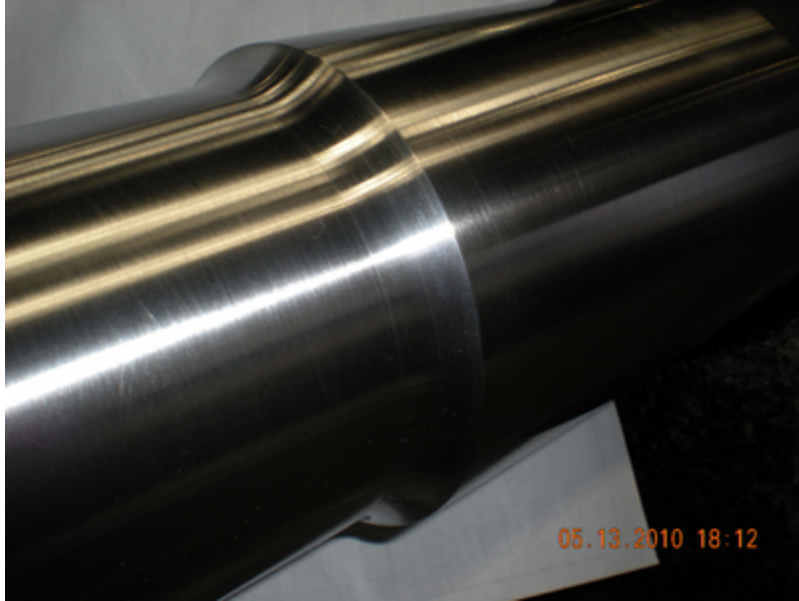
There was also lack of smooth radii at diameter transitions. Radii help reduce stress concentrations and

help prevent shaft failures.

A newly manufactured shaft with the proper radius

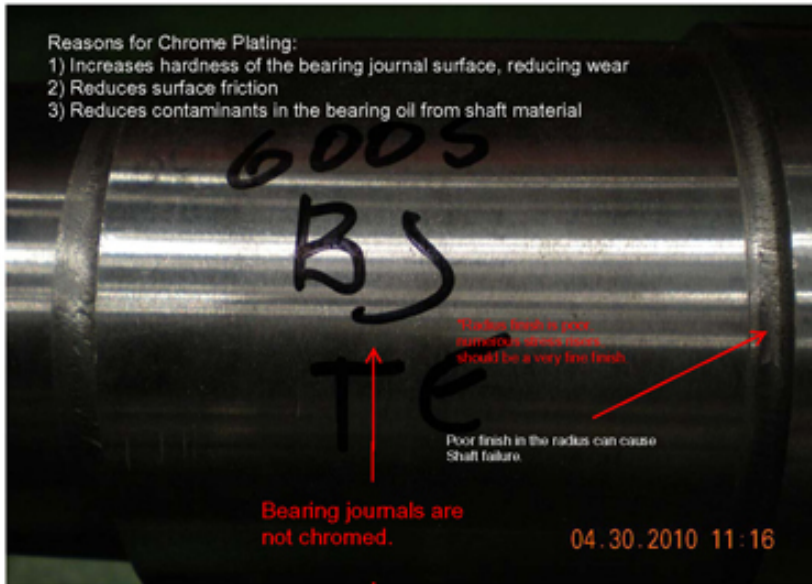
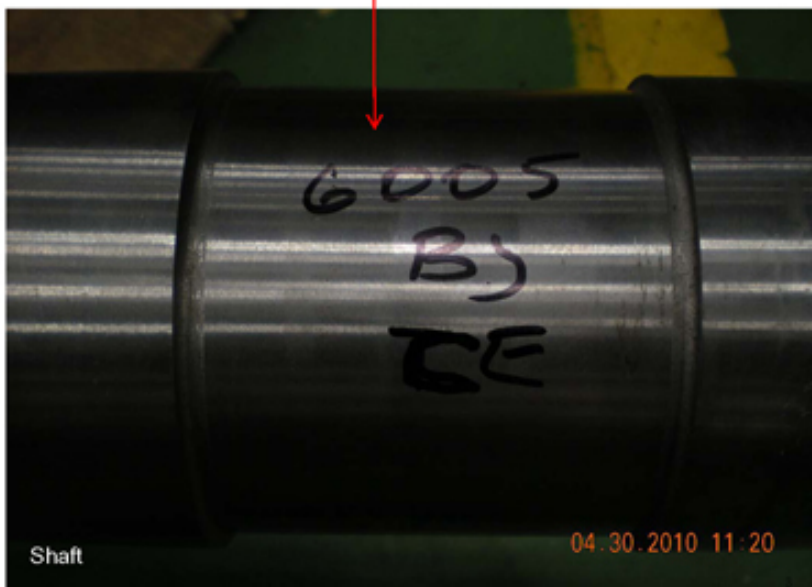
The bearing journal surfaces were not chrome-plated. Lack of chrome plating decreases the shaft and sleeve bearing life. Chrome plating reduces surface friction, reduces wear and helps to reduce contaminants in the oil from the shaft base material.

Bearing journals had not been chrome-plated in previous low quality repair.

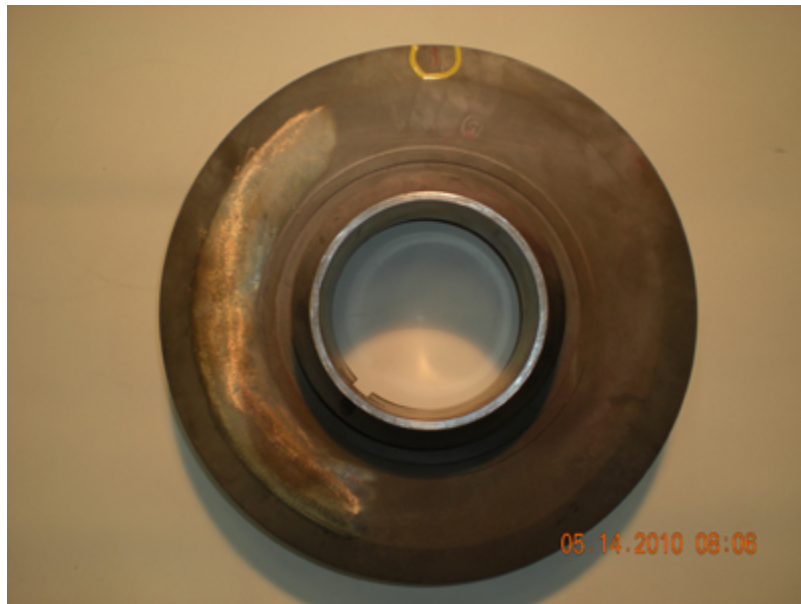
A through crack existed at the periphery of two impellers. Defects near the periphery of an impeller can lead to catastrophic failure from centrifugal forces. Moreover, suction vane edges were ground flat, which results in a loss of performance and NPSH. As much as five to seven additional feet of NPSH required by poor practices could result in cavitation and reduced operating life.

NDE inspection revealed a 1/2 in. linear indication on the back shroud of impellar #5.

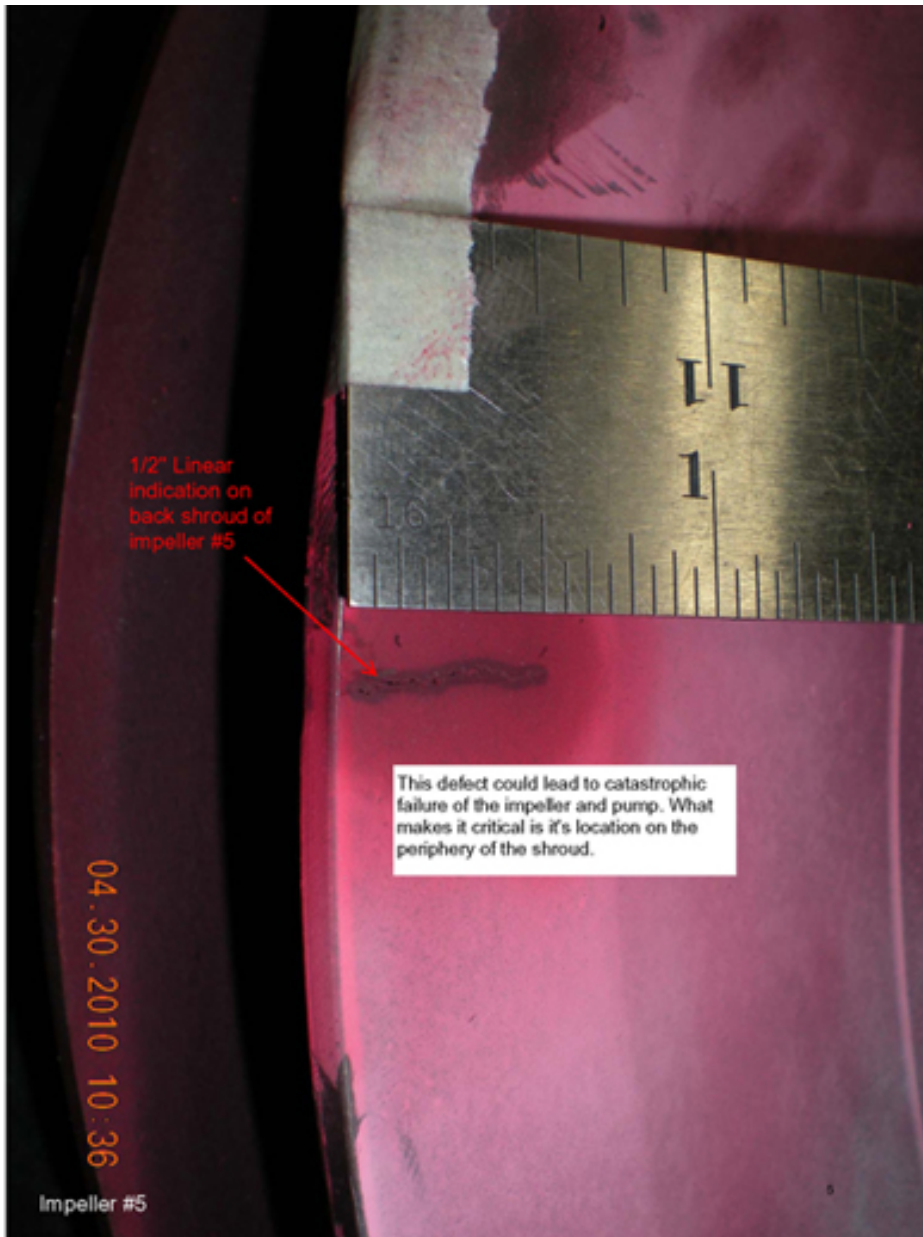
This defect could lead to catastrophic failure of the impeller and pump.

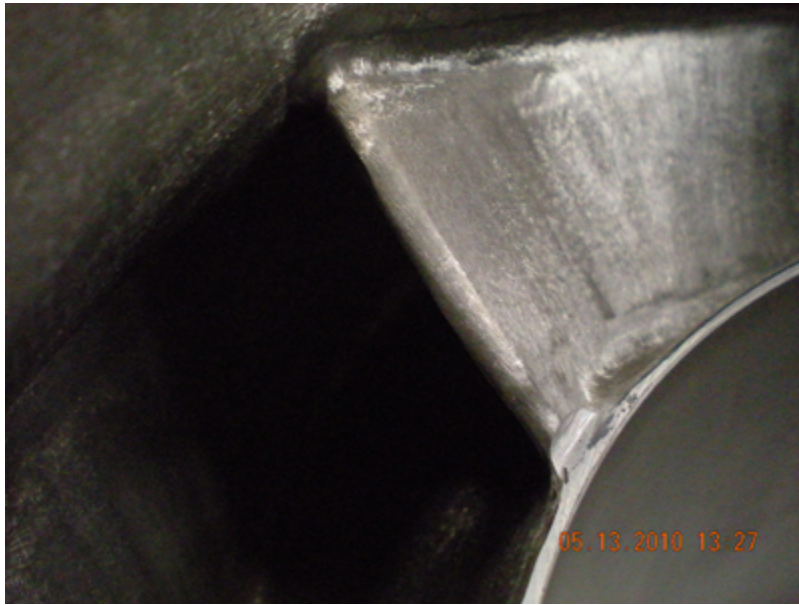
Properly dressed impeller vane.

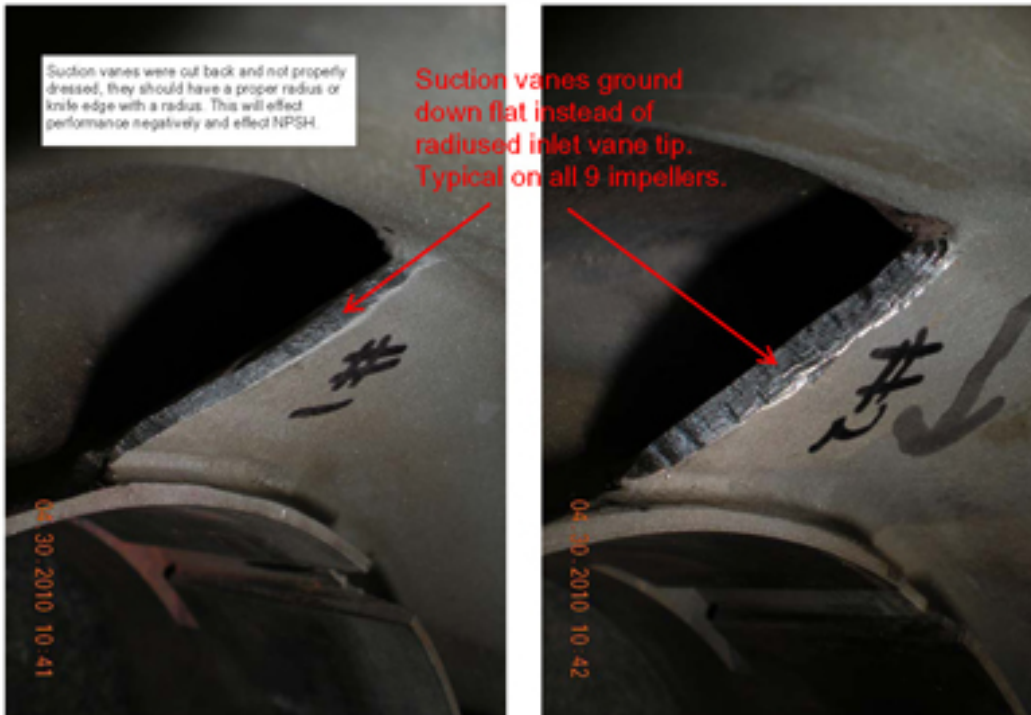
Suction vanes had been ground down and not properly dressed.

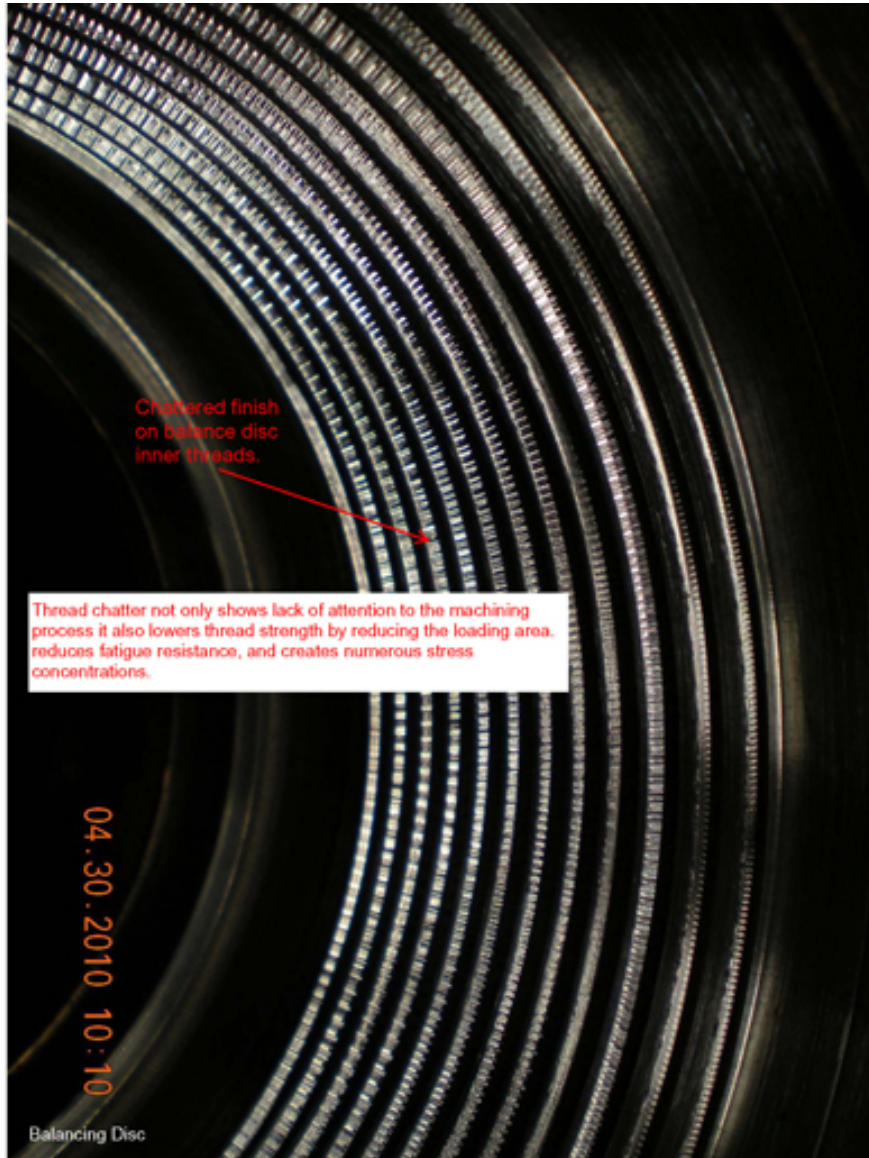
Poor machining practices left internal thread chatter. The machine tool chatter marks increase the fluid bypass flow past the balancing disc, which reduces pressure and ultimately increases the axial thrust on the thrust bearing. The thrust bearing operating temperature will increase and result in reduced life.

Thread chatter on balance disc inner threads is evidence of poor previous machining practices.

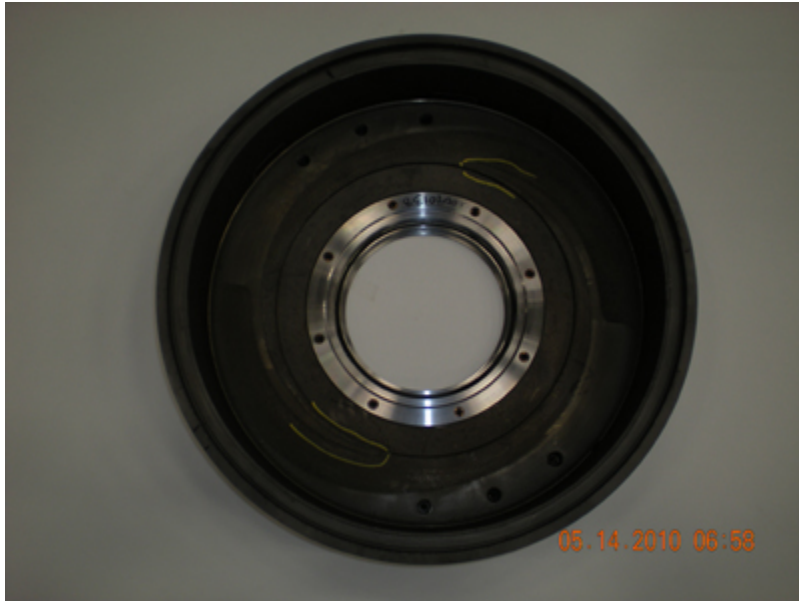
Improperly repaired stage piece shows obvious widening of the diffuser vane due to numerous skim cuts without restoration to original diffuser dimensions.

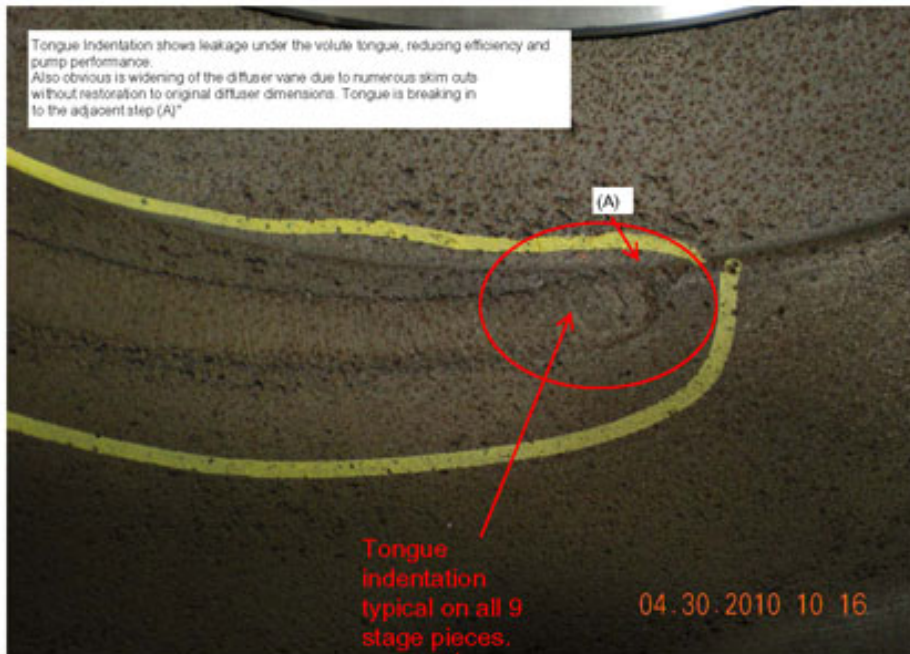
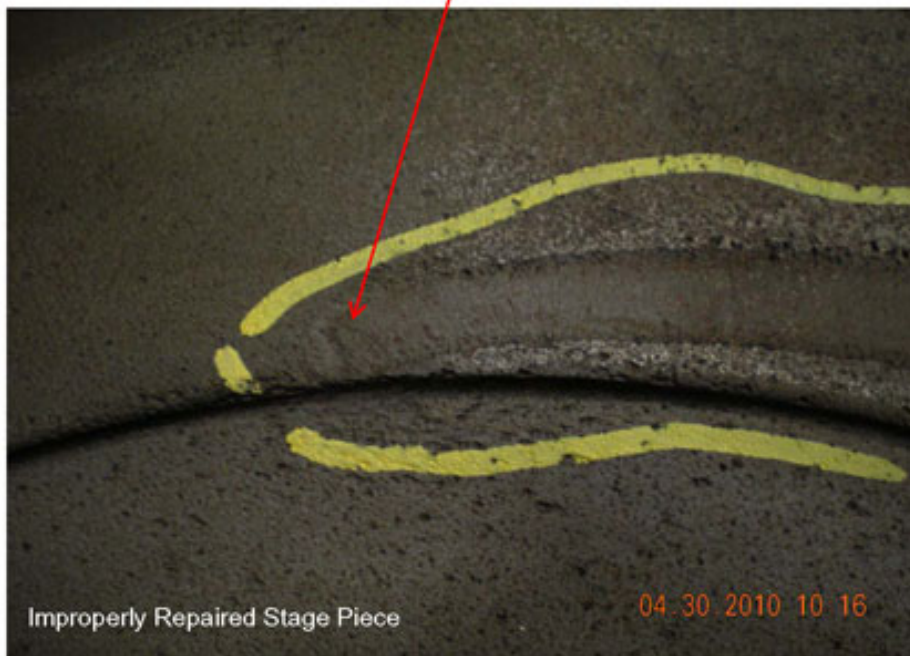
Tongue indentation reduces efficiency by creating a leakage path.

Tongue indentation on stage piece shows leakage under the volute tongue.

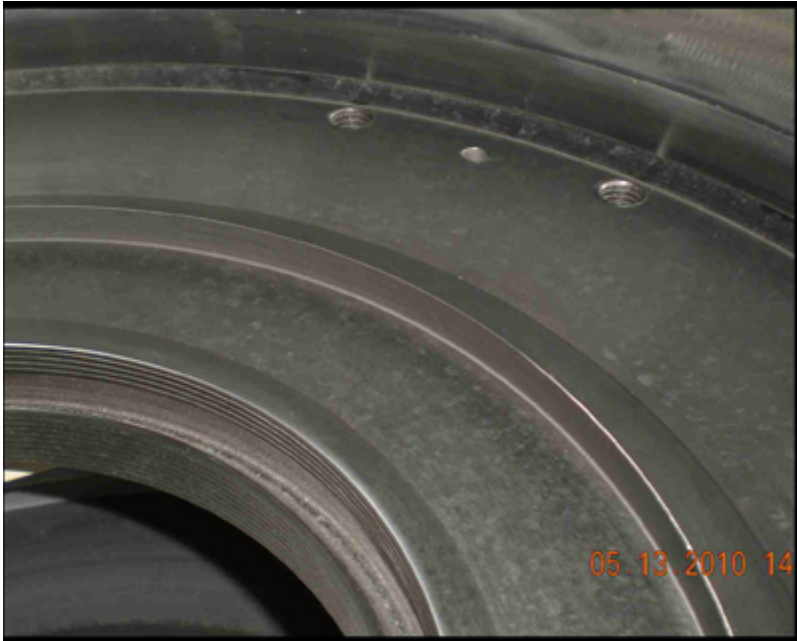
Close up of stage piece after proper repair.

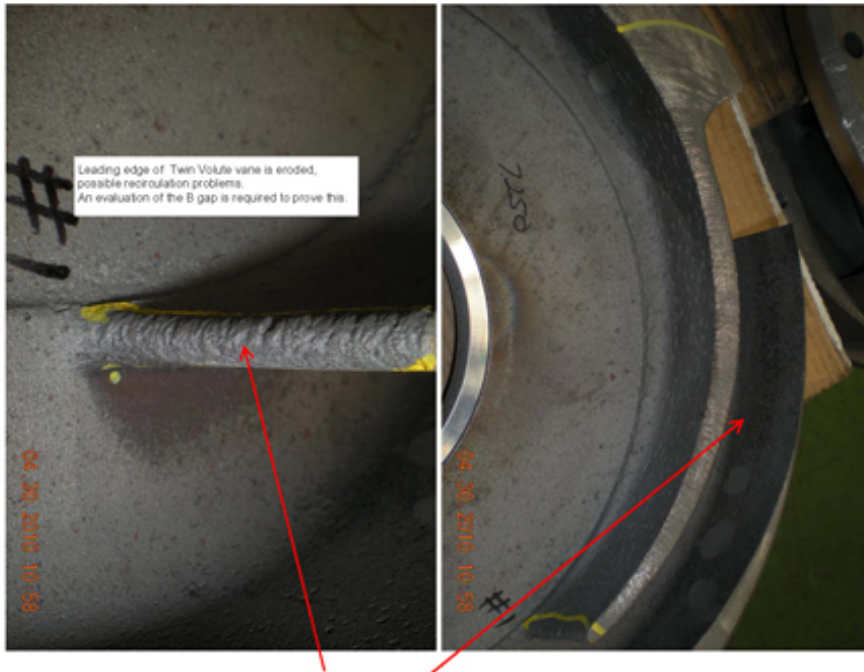
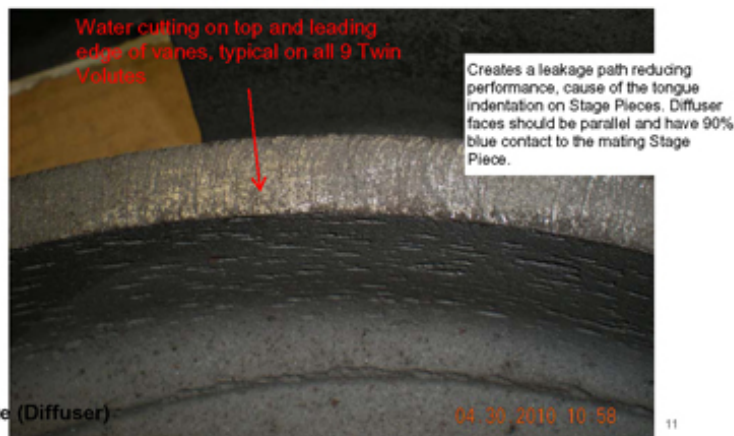
Vane erosion was found at the leading edge and was caused by possible recirculation issues or improper Gap "B" modification, resulting in reduced overall pump performance and life. The service center also found that the diffuser bolts had been welded. This is an improper method for retaining the diffuser bolts. Stainless clips should be used; the original repair shop was cutting cost by not re-cutting the groove and using clips. Furthermore, the bushing face had tack welds. The tack welds will reduce the total axial float of the rotating element.

Leading edge of all nine twin volute vanes were eroded; creating a leakage path and causing the tongue indentations on the stage pieces.

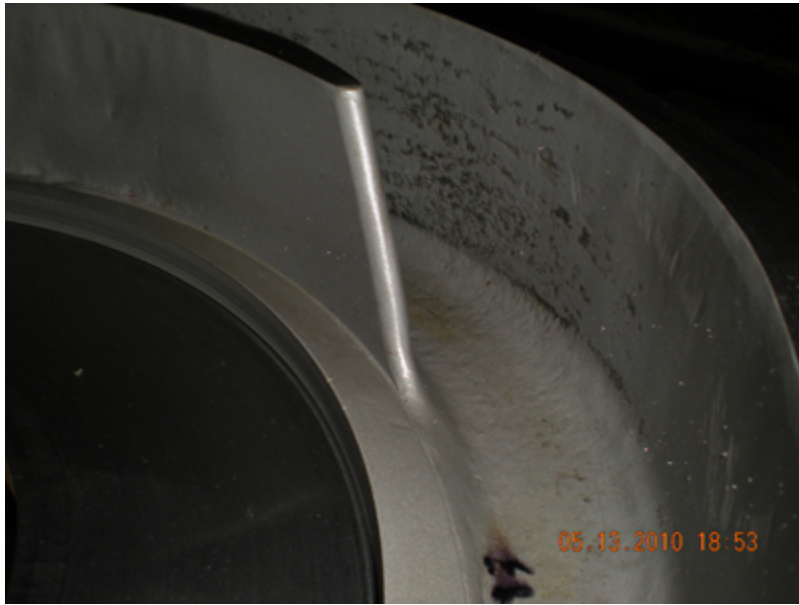
Diffuser vane properly restored
