Unearthing the Root Cause of Vibration Issues

A recently constructed fertilizer plant was experiencing significant vibration problems on their brand new UAN Solution pumps. This vibration forced the plant to take the equipment out of service.

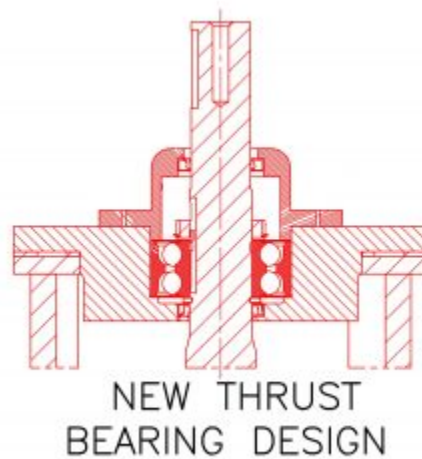
When the pump was disassembled, it was evident that there were significant problems at the motor bearing and guide bushing locations. The motor ball bearing cage had become unseated and was damaged. Inspection of the mechanical seal revealed damage to the sealing faces.

The DCI also revealed elliptical wear on the guide bushing bores that was biased to one side, indicating a misalignment problem. Galling was observed at the impeller and case rings.

- The single row angular contact motor thrust bearing was replaced by a double-row deep groove ball bearing
- The lineshaft coupling location was moved to above the guide bushing area. Shaft sleeves were manufactured and installed to run against the bushing bore
- All bushings were designed to have a spiral groove that would help flush any particulate still present in the lubricating flush out of the bushing bore
- Component tolerances were significantly tightened to ensure better centerline compatibility of stationary parts and to reduce the probability of misalignment

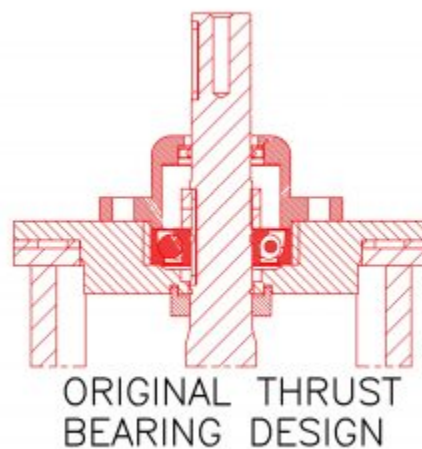
Another contributing cause to the high vibration was the contact and wear at the guide bushing and case ring bores. This wear was caused by several factors, the greatest of which was a design flaw that placed the lineshaft coupling under the guide bushing bore. Poor component tolerances, misalignment, and subpar work done by the contractors during initial installation, including sole plate runout and probable pipe strain problems, also contributed to the contact and wear.

To relocate the lineshaft couplings away from the guide bushing location, the impeller shaft length was increased from 12" to 14". The intermediate shaft length was kept the same and the head shaft was reduced by 2" to maintain the same total rotor length. Additionally, shaft sleeves were installed at the guide bushing location to protect the shaft and maintain the design clearance to the guide bushing.
