Testing Brings a Long-Term Solution

When an oil and gas vertical firewater pump suffered heavy abrasion and wear due to significant sand and particulate matter from a nearby river, [HydroTex](#) Golden Triangle, based in Beaumont, Texas, solved the problem, meeting the hydraulic requirements of the firewater system.

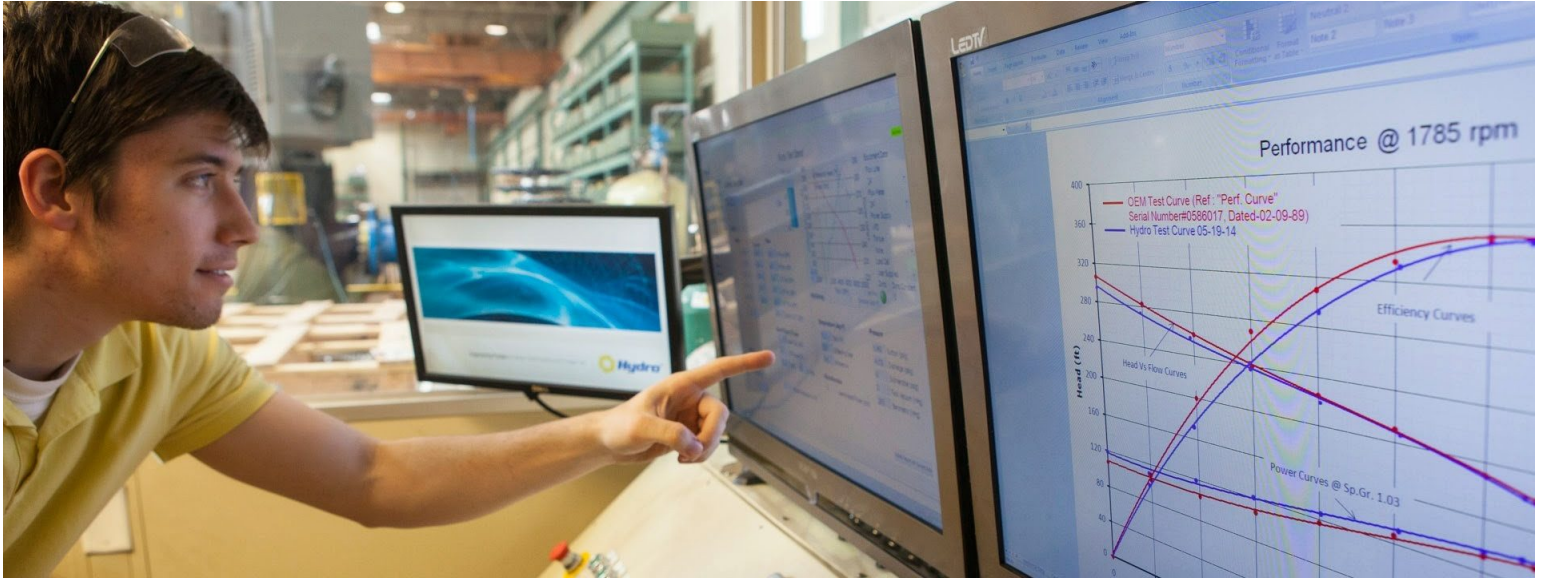
In this case, the impellers were severely worn, which meant that replacements and upgrades were needed if it was to meet the National Firewater Protection Agency (NFPA) hydraulic requirements. The critical pump was removed from service and classified as an emergency. The removal naturally resulted in downtime at the local site, so a quick turnaround was vital.

The engineering analysis had uncovered that the packing was too tight, resulting in the formation of an hourglass shape on the shaft due to severe wear. The pump had not been in service for an extended time but pumping the abrasive sand had caused the overall damage. Further repairs by Hydro, Inc. included replacing the shafts, wear rings, bushings, and reclaiming registers in a complete pump rebuild.

Hydro, Inc. further concluded that the sand damage would not be eliminated. However, the longevity of the equipment was provided by rerating the impellers to meet 110% of capacity.
