# Condition Monitoring Uncovers Misalignment Issues

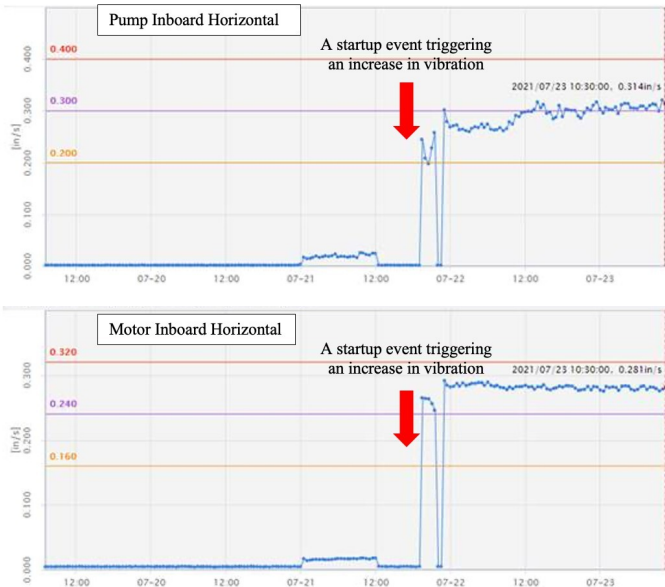
Alarm thresholds are chosen based on API standards. Hydro's monitoring software is programmed to automatically report any alarm or emergent issue to Hydro's engineering team and to the engineering team of the refinery. The graphs showcase a startup event with elevated vibration amplitude levels above the alarm 2 thresholds ( $>0.300$  ips RMS) at the pump inboard and motor inboard sensor locations in the horizontal direction.

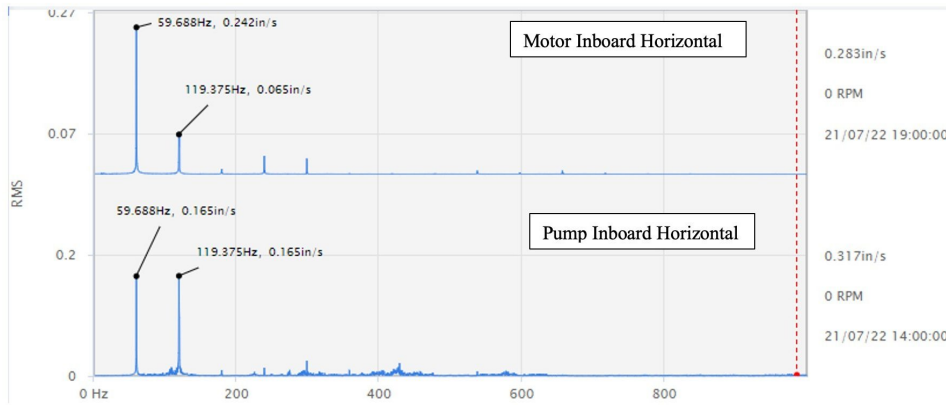
In this case, Hydro's engineering team suspected that the elevated vibration amplitude levels were a result of a misalignment condition. Misalignment occurs when the centerlines of the coupled shafts do not coincide, creating high radial forces across the coupling. In addition, misalignment is indicated by excessive amplitude levels of 1x RPM and 2x RPM response. The FFT Spectrum graphs below displays a dominant excitation frequency at 1x RPM (59.688Hz) and 2x RPM (119.37Hz) for both the pump inboard and motor inboard sensor locations.

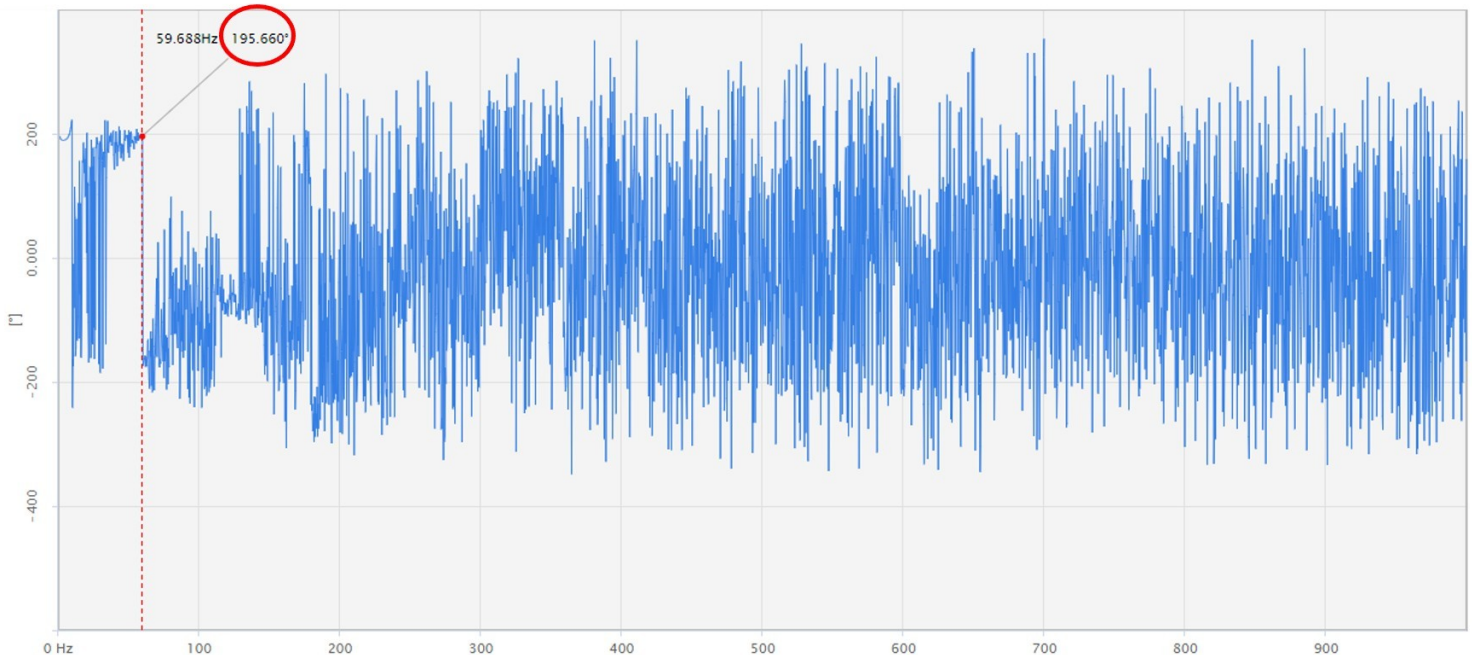
Phase analysis has been performed on the pump inboard and motor inboard sensor locations to allow Hydro's engineers to further confirm the diagnosis of misalignment. Misalignment is characterized by a phase difference of  $180^\circ \pm 30^\circ$  between the coupled components. Referencing the phase difference chart, the phase difference between the

pump inboard and motor inboard sensor locations is  $195^\circ$ , within range of the  $180^\circ \pm 30^\circ$  phase rule.

Following the analysis, Hydro's engineering team notified the customer of the apparent issue and recommended that the machine train be inspected and realigned at the earliest convenience. Hydro will reassess the vibration amplitude levels of the machine train once the alignment has been complete.
