Pitfalls in Puerto Rico: Rescued by Reverse Engineering

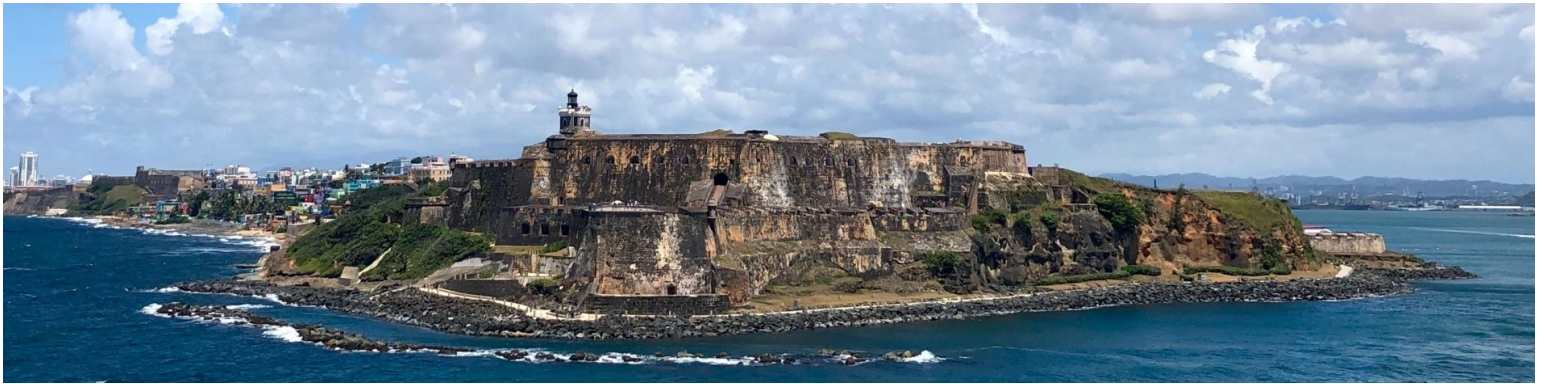
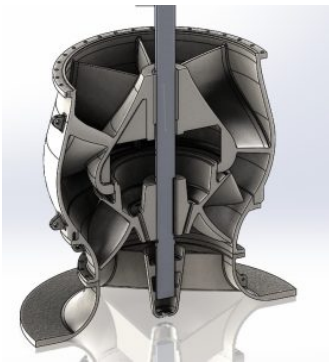
When the experts at Hydro were called on to reverse-engineer parts for a large circulating water pump in the Caribbean, they were concerned to discover an OEM-provided suction bell had failed during service. All internal ribs were lost and the bearing holder was found loose within the assembly. Not only had the suction bell failed, but the customer was facing excessive lead times for the parts needed for the refurbishment of the pump.

After a meticulous review of the suction bell design, it became clear that low manufacturing costs had been prioritized over reliability. Instead of providing the customer with a cast component, the OEM had provided a suction bell that had been fabricated, resulting in an excessively thin wall thickness.

Luckily, Hydro's heroes stepped in, to reverse-engineer the suction bell and create a model for a cast component, establishing the rib design and bearing holder location solely based on decades of pump design experience. The suction bell was strengthened by adding exterior ribs and increasing the wall thickness from 3/8" to 2"; these changes provided a sturdier component that would be less susceptible to vibration and external forces. The parts, including impeller, bowl, liner, pump shaft, and shaft coupling, were scanned on-site within 3 days, with the engineering analysis, modified casting design, and quote for manufacture being completed within 3 weeks.
