# Blower Outboard Bearing Failure Identified through Advanced Condition Monitoring

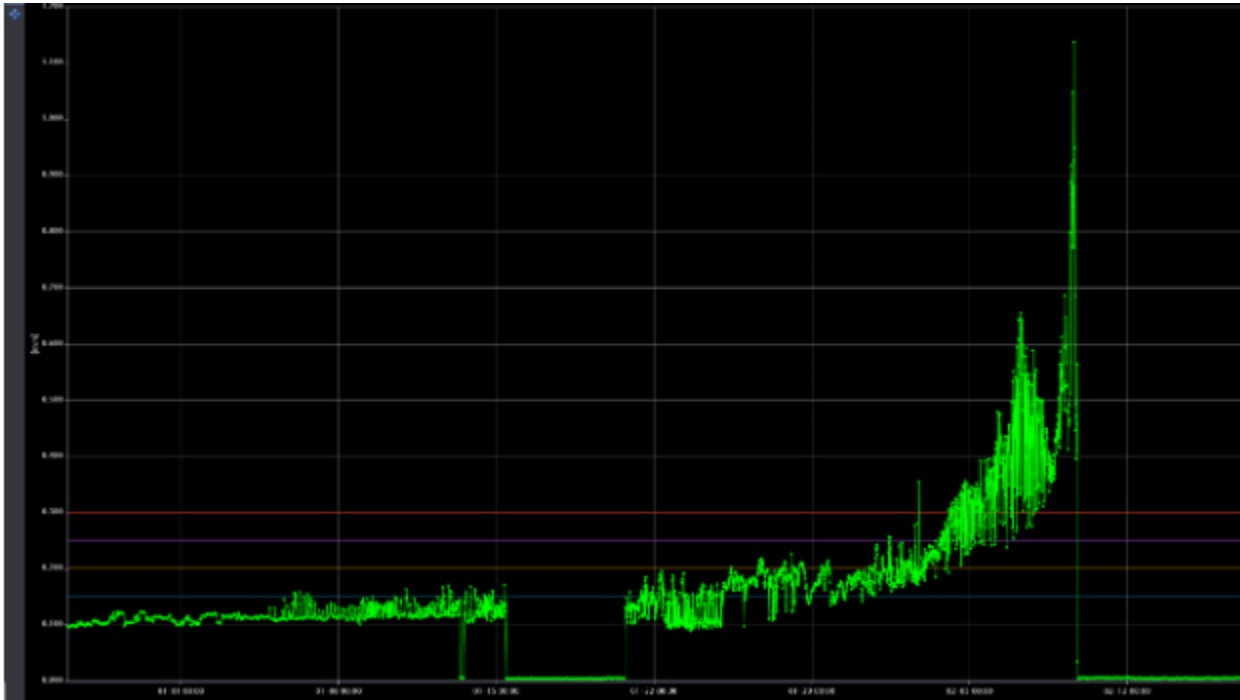
*Figure 1: Velocity Amplitude as Several Alarm Thresholds Breached*

When elevated vibration amplitudes were first detected on the problematic blower, they were in the Blower Outboard Bearing in the vertical direction (BOBV). The velocity amplitude shown below crossed the warning threshold on January 06, 2024, alerting both Hydro and the end user's site engineers that a condition was present and in blower was in the early stages of degradation. The observation was discussed during the weekly touchpoint between Hydro and the plant, where Hydro would review the health of all monitored assets and address any alarm events captured using Centaur with site stakeholders.

The vibration velocity amplitudes continued to climb, and on January 25, 2024 they crossed the Alarm #1 threshold. The Alarm #2 threshold was breached on February 01, 2024. Continual touchpoint meetings highlighted the worsening conditions and provided an analysis of the suspected failure mode(s) affecting the blower mechanical condition. The below multi-spectrum chart shows the spectra at the BOBV location at various points along the trend – mapping the signature of the degradation.

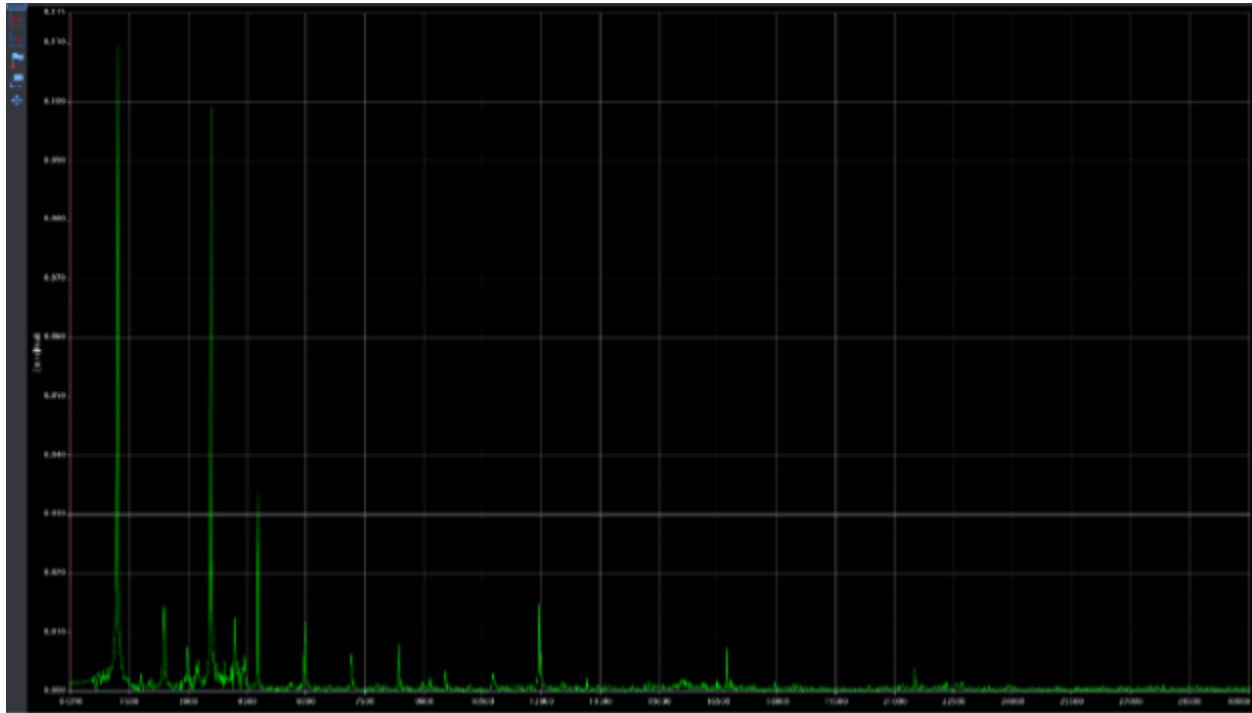
*Figure 3: Initial Conditions*

The following two spectra charts take a closer look at the condition, one chart showing the initial conditions prior to degradation and the other closer to the end of operation where bearing fault frequencies and harmonic excitation can be detected.
