Condition Monitoring Uncovers Misalignment Issues

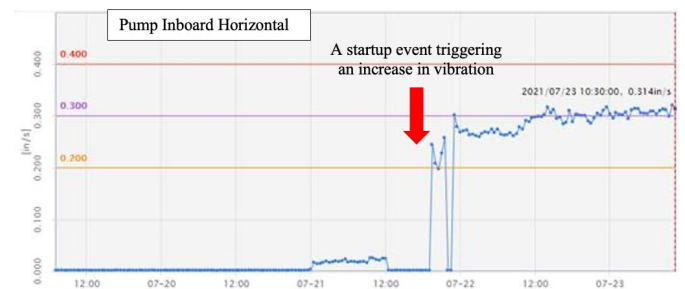
Alarm thresholds are chosen based on API standards. Hydro's monitoring software is programmed to automatically report any alarm or emergent issue to Hydro's engineering team and to the engineering team of the refinery. The graphs showcase a startup event with elevated vibration amplitude levels above the alarm 2 thresholds (>0.300 ips RMS) at the pump inboard and motor inboard sensor locations in the horizontal direction.

In this case, Hydro's engineering team suspected that the elevated vibration amplitude levels were a result of a misalignment condition. Misalignment occurs when the centerlines of the coupled shafts do not coincide, creating high radial forces across the coupling. In addition, misalignment is indicated by excessive amplitude levels of 1x RPM and 2x RPM response. The FFT Spectrum graphs below displays a dominant excitation frequency at 1x RPM (59.688Hz) and 2x RPM (119.37Hz) for both the pump inboard and motor inboard sensor locations.

Following the analysis, Hydro's engineering team notified the customer of the apparent issue and recommended that the machine train be inspected and realigned at the earliest convenience. Hydro will reassess the vibration amplitude levels of the machine train once the alignment has been complete.
