## Reliability Enhancement for Circulating Water Pump

A large Midwestern coal-fired power plant had been experiencing vibration issues and premature failures with their large Kirloskar 130 BHM circulating water pumps. The plant has two operating units, with three circulating water pumps installed in each unit. The average life of the equipment was 6 months, which is far below the industry standard for a large vertical turbine pump in this service. The pumps were sent to Hydro's HydroAire 40<sup>th</sup> Street service center for a causal analysis and remediation of any problems that were found during the investigation.

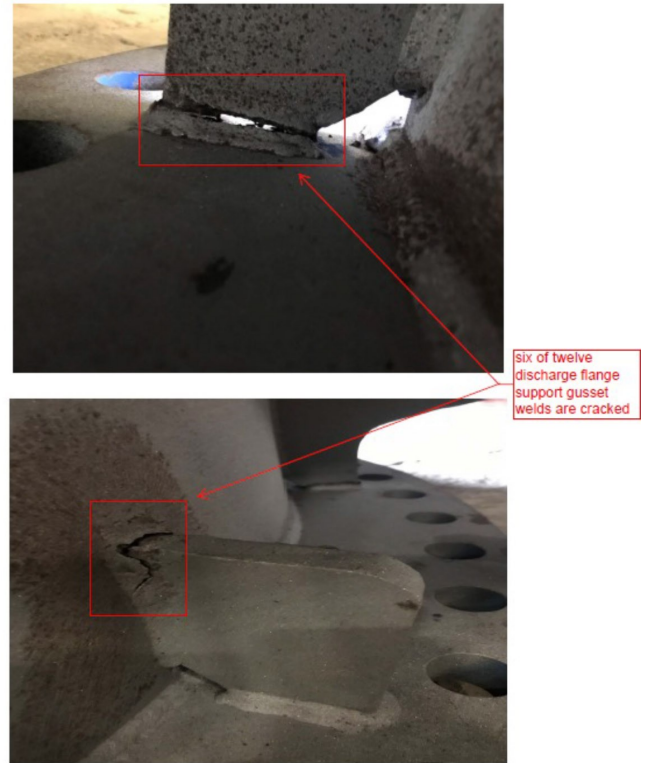
Upon disassembly, it became apparent that there were several critical issues that needed to be addressed to increase the reliability and mean-time-between-repairs for this equipment. The discharge head gussets were heavily eroded clear cracks and dislocation, which weakened the discharge head assembly and made is susceptible to high vibration.

The stuffing box was also eroded, which would make it difficult to successfully perform pump-to-motor alignment in the field upon reassembly at the site.

Modifications were designed to provide structural reinforcement to the discharge head and to eliminate the factors causing premature wear of the bearings and shaft sleeves. The eroded gussets were removed and replaced with thicker, more robust gusset to enhance the structural integrity of the components. The new gussets and lifting lugs were fabricated from carbon steel and installed using precision welding. A PT inspection was completed to ensure weld integrity. The eroded stuffing box was also repaired using weld restoration techniques.

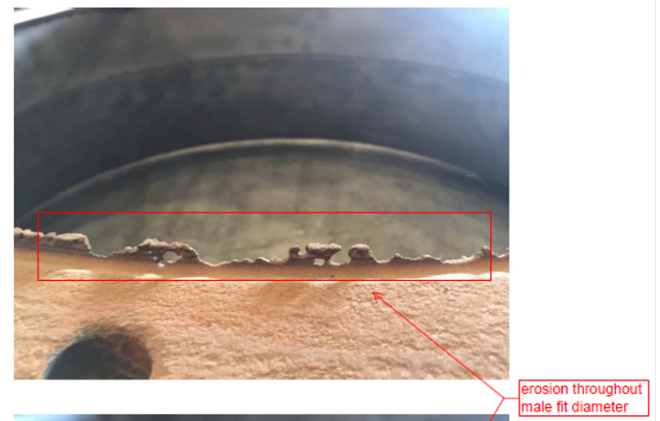
Fit-ups of the stationary assembly were excessive with average fit-ups measuring in the range of 0.010 – 0.030"; for reference, Hydro's typical acceptance criteria are 0.001 – 0.003". Critical faces and bores were also found out of acceptable tolerance, with concentricity, parallelism, and perpendicularity measuring in the range of 0.005 – 0.015", where acceptance is usually held less than 0.002". Not only did the out of tolerance fits contribute to overall misalignment, they provided a leak path that resulted in erosion of the column pipes at the fit areas.

To improve the alignment of all components within the stationary assembly, any out of tolerance fits and bores were welded up and machined to best-in-class tolerances and fits.

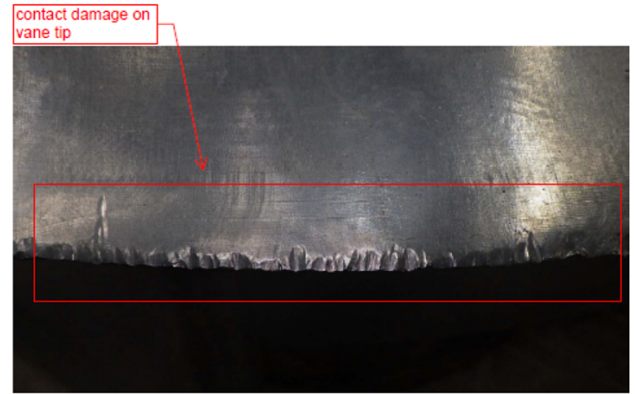
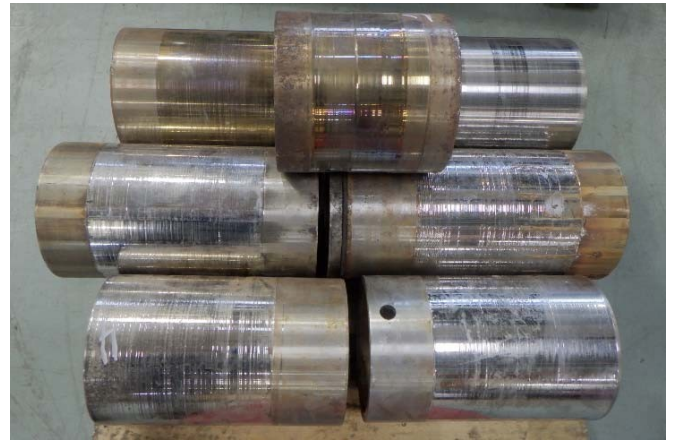
Excessive wear was also found on the impeller vanes and the impeller liner surface, indicating contact between these two components. This contact was likely caused by both the overly loose impeller fit and non-concentricity of the rotor and stator, as mentioned above. The impeller vane wear would have increased rotor imbalance, further increasing vibration. The opening of this clearance would have also reduced the pump efficiency, causing it to lose performance and require more energy to operate.

The impeller was laser scanned to create a solid model of the component that could be used to establish the correct vane profile of the component before it had been worn. This model was used to create the vane profile machining drawing that was used during impeller refurbishment. The solid model was also used post-machining to confirm that the machined component conformed to the expected dimensions during as-built inspection. The impeller bore was also corrected to provide the appropriate fit-up to the shaft.

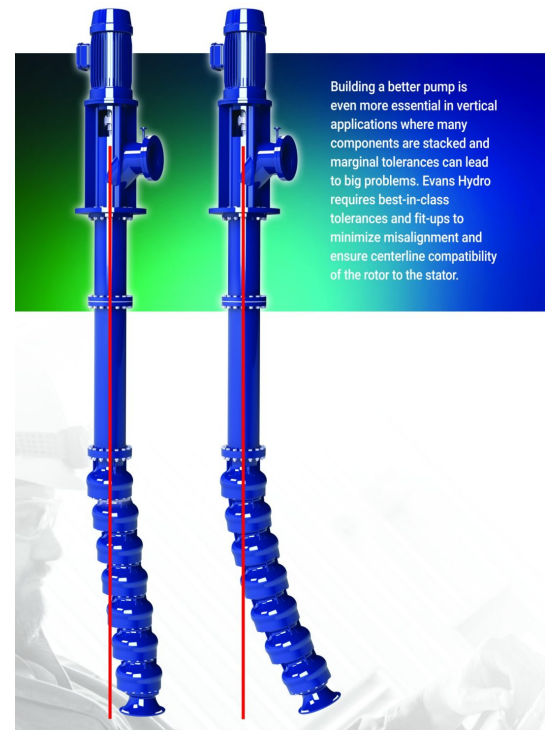
Vertical pumps are especially susceptible to misalignment since they have a large number of stacked components. Large fit-ups between each component can easily stack-up to a large offset at the bottom of the assembly that exceeds the bearing clearance. By restoring recommended fits and tolerances, non-centerline compatibility between the stationary and rotating elements would be greatly decreased.
