# Close Inspection Solves High Thrust Bearing Temperature Problem

**Careful analysis identified the issue with this multistage, oil transfer pump.**

**Written by:** Gary Dyson (Hydro, Inc.)

**Publisher:** Pumps & Systems / August 2014

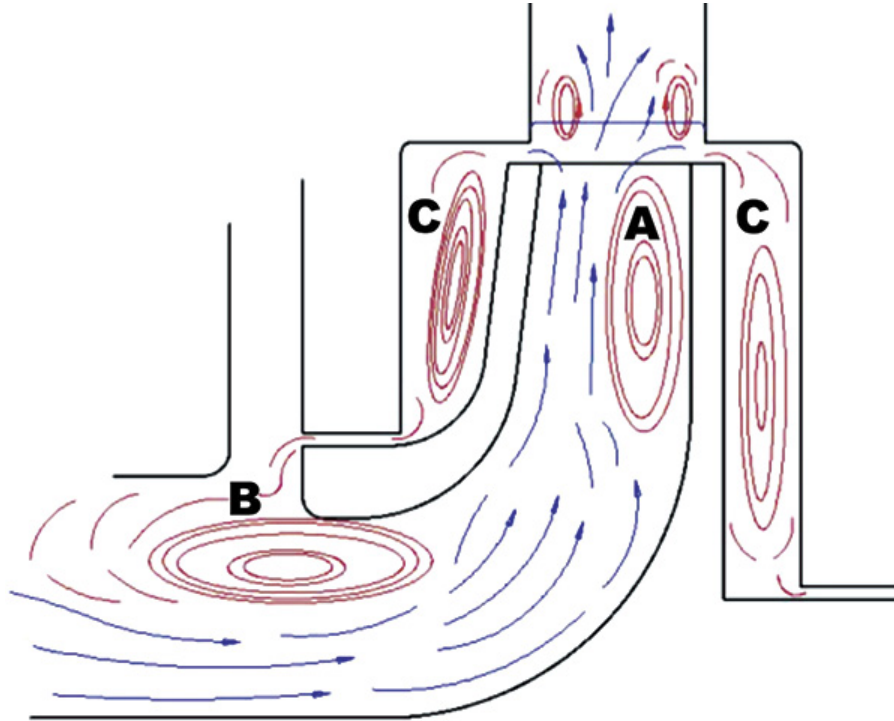
Traditionally, this flow regime interaction has been illustrated as in Figure 2 in the meridional plane. Although this image is helpful in understanding the flow physics, the true picture is far more complex.

The meridional view clearly depicts these two unstable flow interactions with the vortex that exists within the gap between the channel ring and impeller shroud (see Point C in Figure 2).

This vortex accounts for the developed thrust within this pocket. Any disruption to this vortex leads to a more unpredictable thrust regime.

The centralization effect of the rotor within this channel influences both the development and speed of this vortex. The space available for the vortex is either increased or decreased so boundary layer effects begin to dominate.

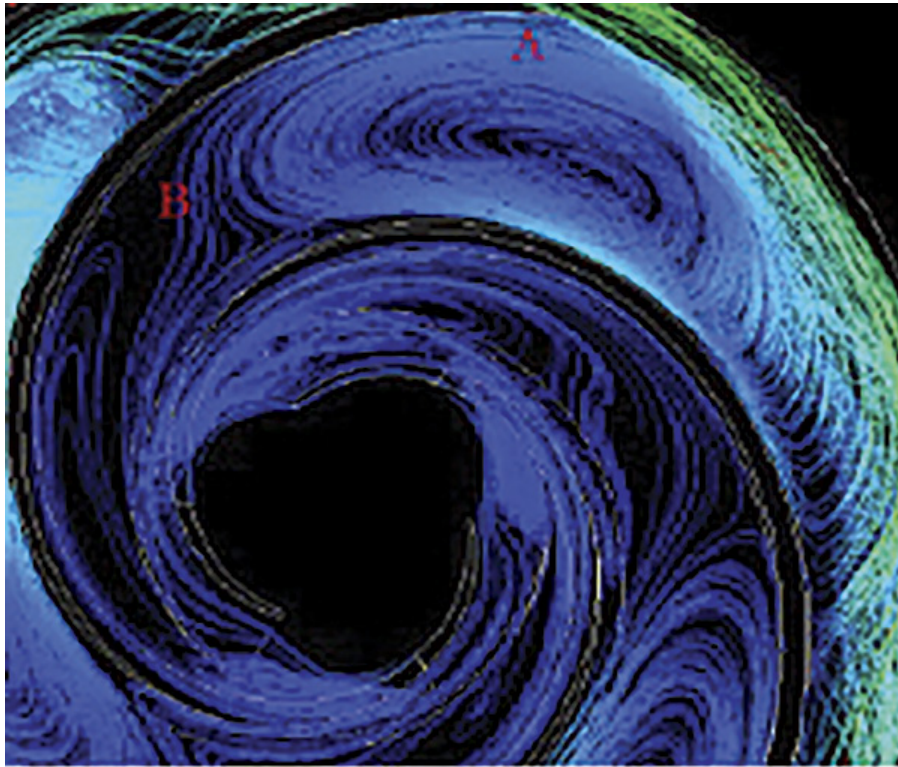
Figure 3 illustrates the complex nature of the flow that develops within the impeller when the pump operates at extreme part load. Point A illustrates the development of a discharge vortex that commences on the hub at the impeller discharge.

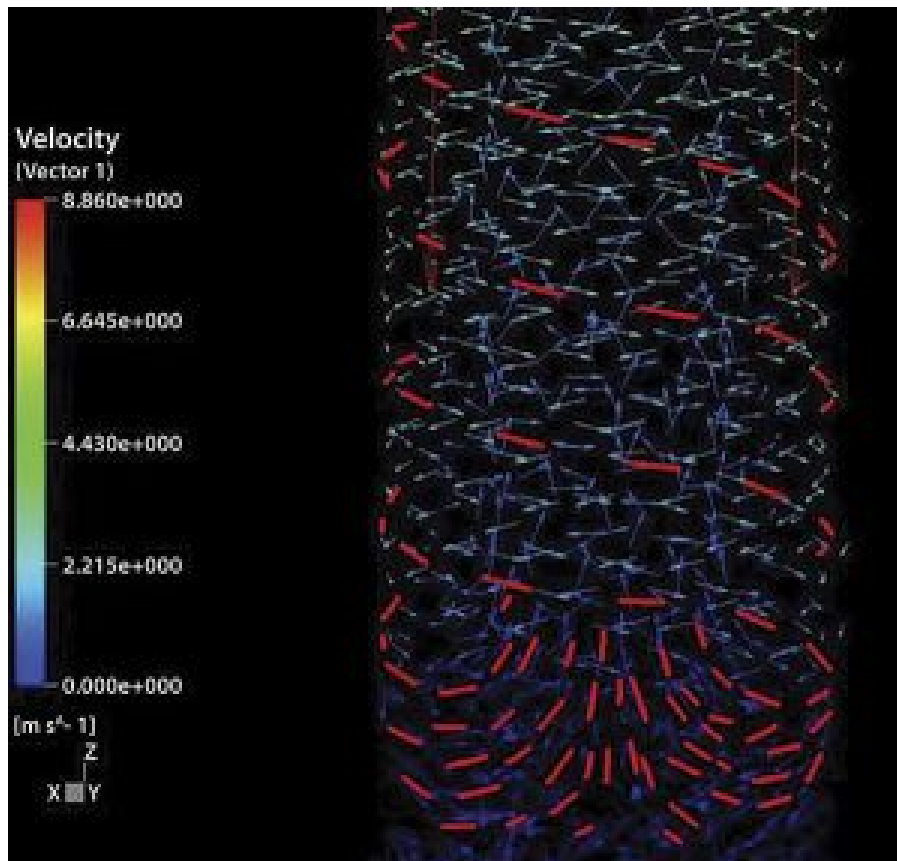
Point B illustrates the boundary of this interaction with the inlet backflow recirculation within the impeller eye. This inlet backflow recirculation is also illustrated in detail in Figure 4.

At partial capacity, the flow exits the impeller eye at the hub inlet angle and spirals down the suction channel impinging on splitters of the previous stage.
