## Engineering a Long-Term Solution

By way of example, this article will discuss a fertilizer plant in the Gulf of Mexico that had a boiler feedwater pump unit that was experiencing performance problems after a significant plant expansion project. Unfortunately, it was not the first time this particular unit had experienced a loss of capacity; the pump had been in operation only 18 months prior to the current issue.

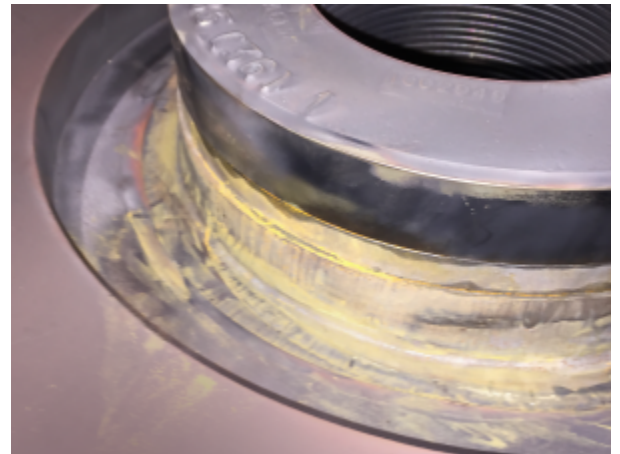
With this new information, the plant manager decided to proceed with the proposed forensic inspection plan. The service provider opted to have the pump sent to a service centre in Houston, Texas, US, for in-depth analysis and repair. The client agreed, and the entire unit, including the casing, was shipped for service (Figure 1).

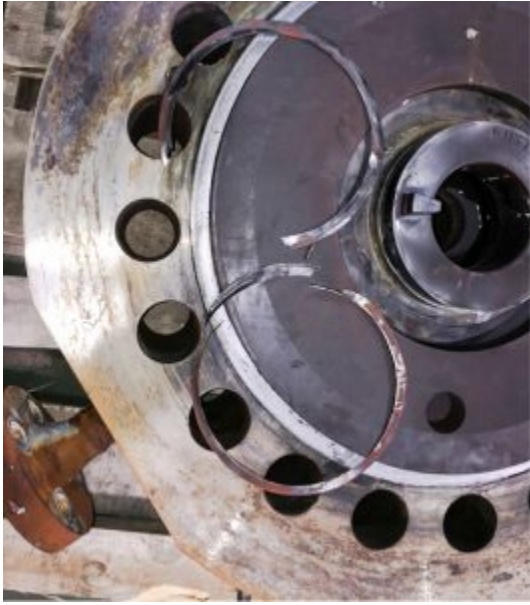
The in-depth inspection process uncovered a range of serious issues, including a damaged centring ring seat in the discharge cover (Figure 2). Most significantly, severe erosion of the suction pressure face was observed. It was determined that this erosion was due to insufficient gasket compression. The original design contained a shim compensation pack containing multiple shims (Figure 3). This shim pack was not sized correctly, leading to the failure of the internal suction head gasket.

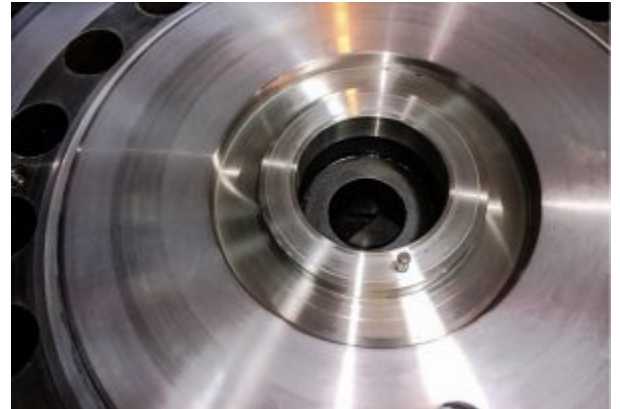
The dimensional analysis of the pump components revealed that the shim compensation pack was not thick enough to provide sufficient compression on the internal suction head gasket. The suction head gasket seals the face between the suction entry, at suction pressure, and the chamber surrounding the internal volute element, at discharge pressure. This high differential pressure makes it crucial to provide a sealing arrangement that prevents internal recirculation. Flow is driven from high pressure to low pressure areas and costly erosion damage occurs to the barrel.

The combination of the discharge head extension that protrudes into the casing, the shim compensator set, and the internal assembly determines the crush on the internal suction gasket. The insufficient thickness of the compensator shims resulted in an unloaded gasket, preventing the formation of an effective seal. The failure of this gasket allowed internal leakage from the high pressure discharge chamber back to suction.
