## Fertilizer Focus: Resolving Design Flaws in UAN Solution Pump

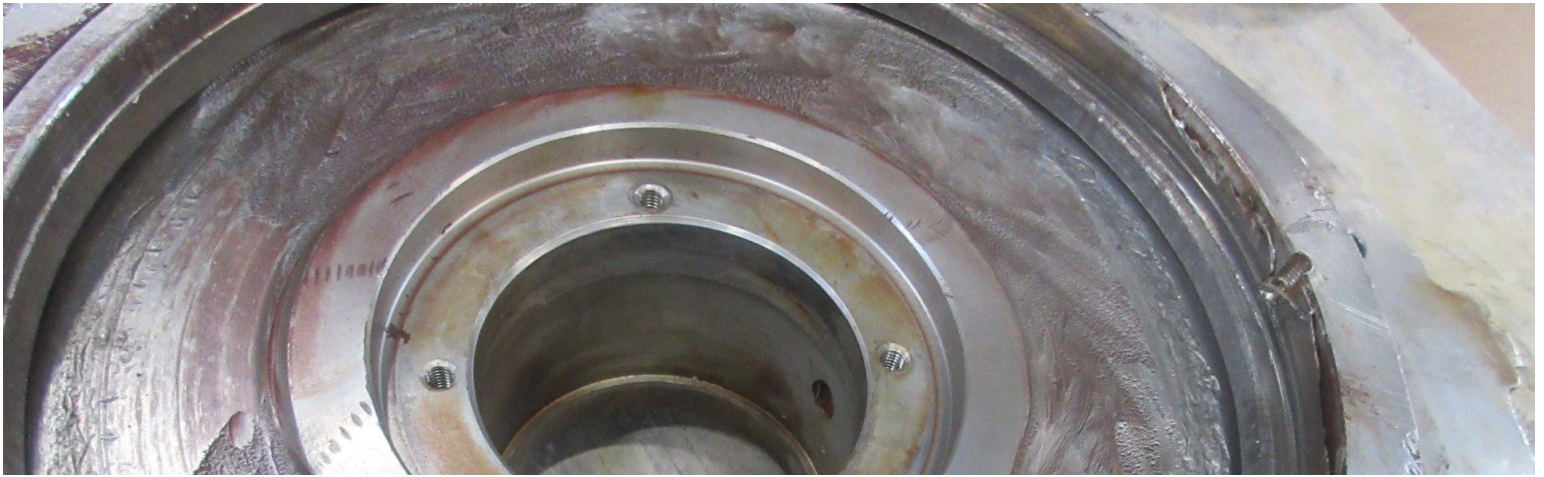
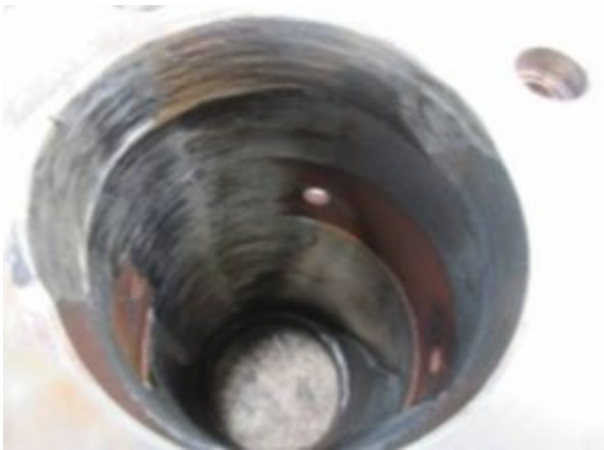
A newly commissioned US fertilizer plant was experiencing recurring vibration problems with their vertical UAN Solution pump. The VSF vertically suspended pump was removed from service and sent to Hydro for a full inspection and investigation of the vibration source. When the pump was disassembled, it was evident that there were significant problems at the motor bearing and guide bushing locations. These design flaws that were affecting reliable operation of the pump.

Inspection of the motor thrust bearing revealed that the ball bearing cage had become unseated and was damaged. During Hydro's analysis, it was determined that the motor thrust bearing was unsuitable for the service. The OEM chose a single row, angular contact bearing that could only handle thrust in one direction. During start-up, when the pump experienced an upthrust, the bearing became unseated. The unseated bearing was unable to function properly, even when the pump reached its normal operating thrust. This unrestrained upward motion of the shaft also caused damage to the mechanical seal faces.

Another problem detected during the DCI was elliptical wear of the bearing bores. In this pump, the lineshaft couplings were located under the guide bushings, which is very atypical. Lineshaft couplings are areas where the greatest runout often occurs, resulting in a greater probability of contact and wear in this area. This problematic design was coupled with excessive tolerances on the columns, spiders, sole plate, and motor flange that affected centerline compatibility of the components.

The pump was upgraded to a new design that included a relocation of the lineshaft couplings, a new thrust bearing that could handle load in both directions, and an improvement of all component tolerances to minimize the possibility of component misalignment. Almost 70% of the pump was redesigned; this work was completed on an emergency schedule of only 2-3 weeks. Since reinstallation, the pump has operated successfully with reduced vibration.
