## Full Refurbishment for Island Refinery

Decoking pump

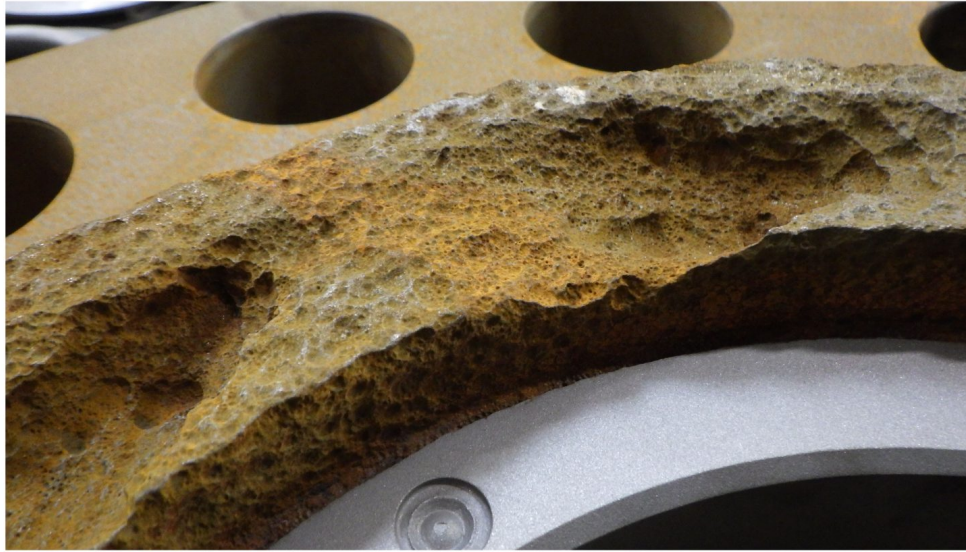
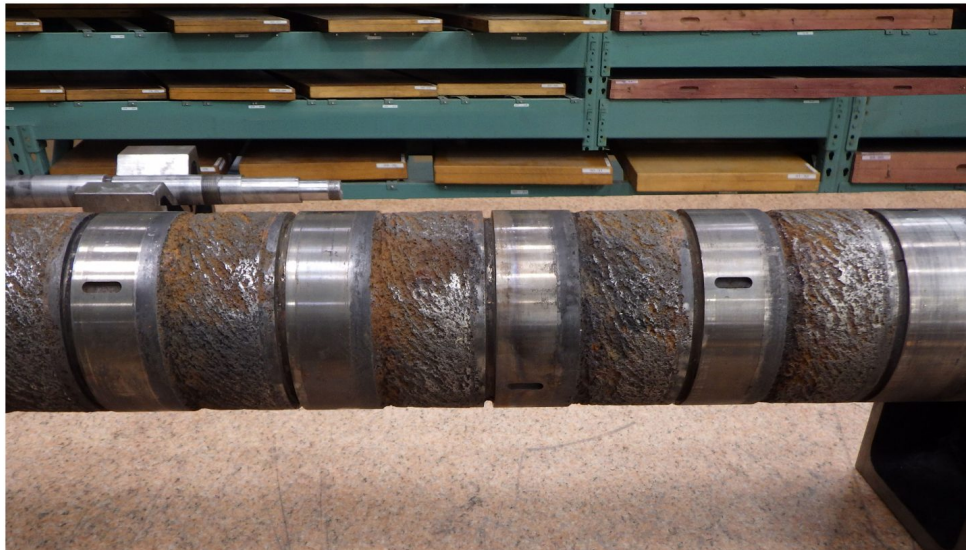
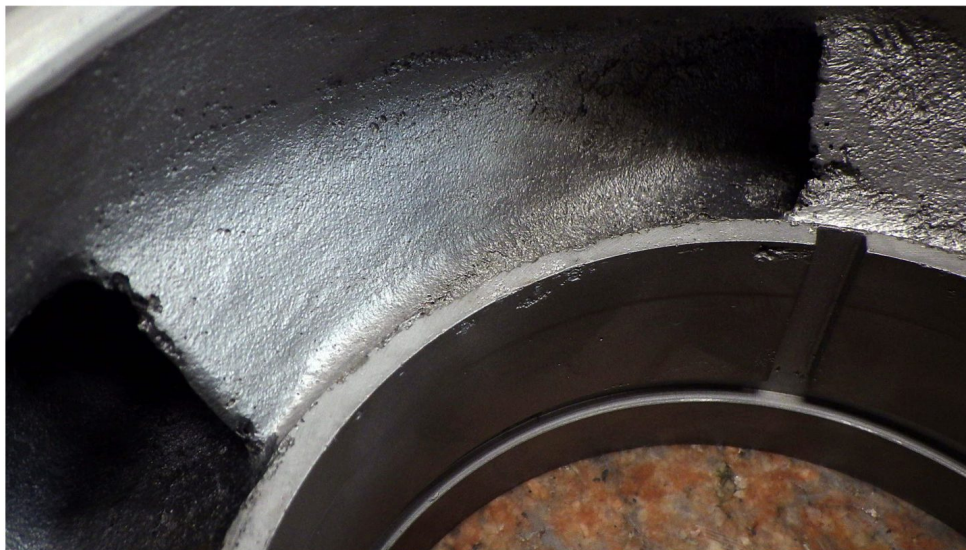
The process of reopening the plant had uncovered more than 500 pumps that needed considerable refurbishment and repair. The most important of these was a critical jet pump used for hydraulic decoking. It was badly damaged and sent to the original equipment manufacturer (OEM) for inspection. The OEM recommended that the refinery replace most of the pump parts, as well as a costly repair that would require 35 weeks to rebuild.

Instead, the refinery sent the pump to global aftermarket pump service provider, Hydro, Inc. in Chicago, where it was refurbished for just over half the cost of the OEM proposal. The time involved was also significantly improved to just eight weeks by using a non-destructive evaluation and rebuild process at a 46,000 ft<sup>2</sup> facility where Hydro develops and implements engineering modifications for improving the performance of critical pumps and then verifies that performance in their Hydraulic Institute certified test lab.

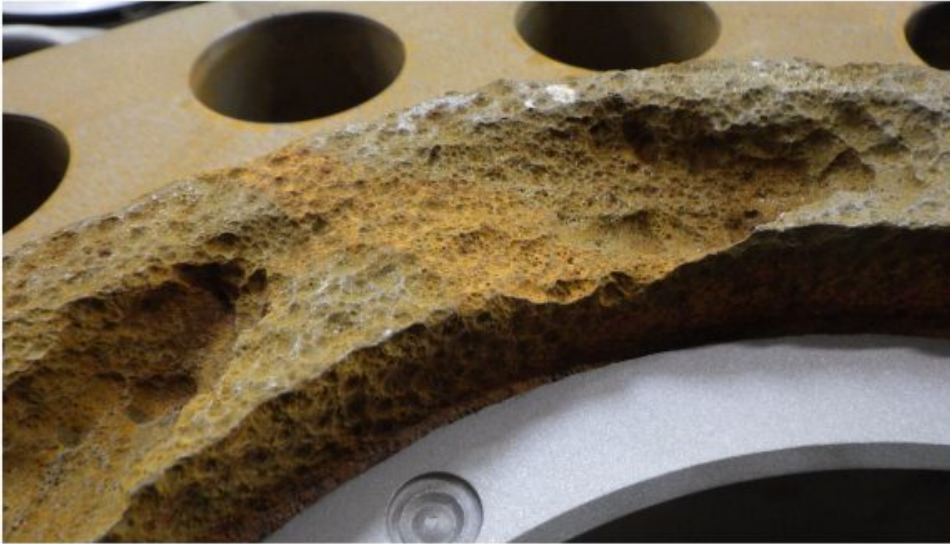
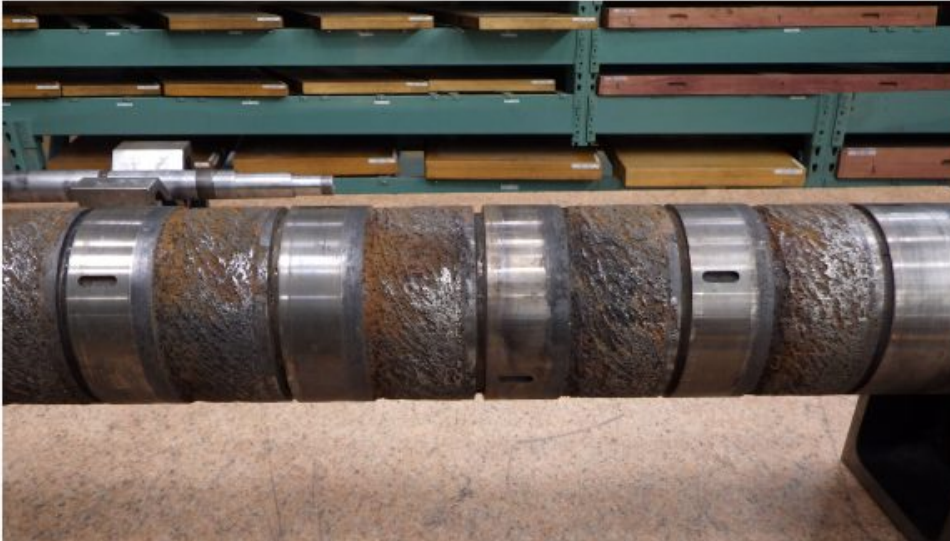
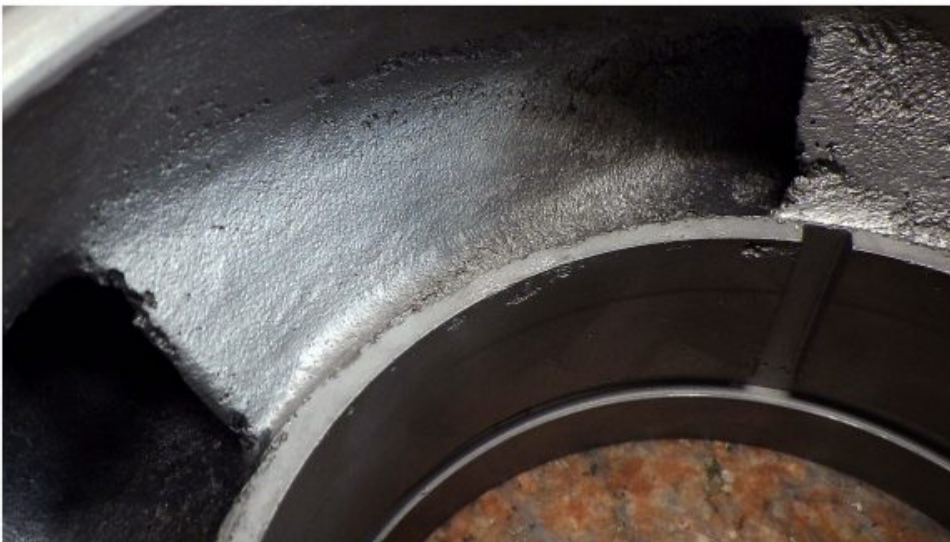
For the decoker pump, coke fines and water mixed together to create a highly acidic layer on the element. The element itself was also very old and had already suffered significant wear and tear, including:

- The shafts which had major corrosion;
- The impellers had corrosion and cavitation damage;
- The pump cover/casing also had erosion damage;
- The bearing housings needed cleaning;
- The bearing housing discharge head needed modification;

If they had placed the pump into installation, it would have failed immediately upon start-up (Figure 1).

- The shafts were replaced by going forward with a 410 forging instead of a rolled shaft so that the denser structure would avoid sagging;
- Using Direct Laser Deposition (DLD) laser cladding, the impellers were reversed engineered and then welded in order to fix the damage;
- The bearing houses needed to be cleaned and checked for parallel, concentricity and perpendicularity. The bearing housings' discharge also had to be modified from the discharge

head by cutting the carbon steel off the back and inserting some 309 stainless steel to prevent corrosion;

- The barrel itself needed to be set up and machined to remove the corrosion from the high-velocity areas. A weld overlay 309L was also used through laser DLD;
- The areas around the ring have been modified so the pump can now run hard-on-hard through the rings;
- The covers of the pump were also reverse-engineered. The diffusers in the return channels were in very bad shape. Those areas were welded to improve their condition, but should the need arise, the files are available to create an emergency part for installation/repair.
