# How Root-Cause Analysis Solved a Vertical Turbine Pump Failure

**A comprehensive approach to reverse engineering helped to establish the differences between the stainless steel and original bronze impellers.**

**Written by:** Hydro, Inc.

**Publisher:** Pumps & Systems / March 2016

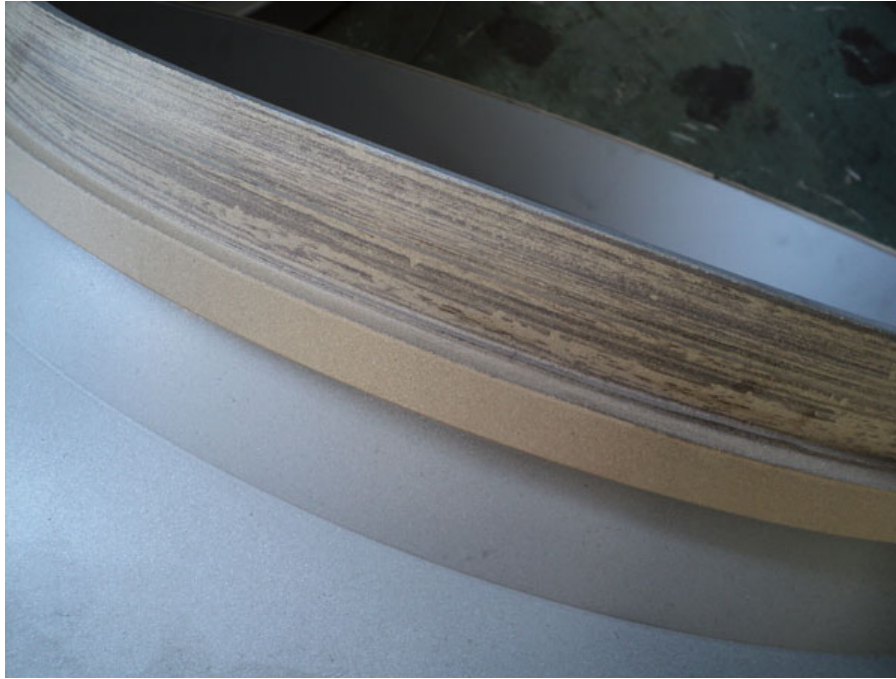
The equipment in question consisted of three-stage vertical turbine pumps running either in standalone or in [parallel](#) operation as required. The failure manifested itself through high vibration and caused severe scoring of the pump shaft and wear ring landings, leading to fatigue failure of the weld on the discharge head flange (see Images 1 and 2). The commissioned pump was refurbished and rebuilt by another company's service center with spare impellers supplied by an original equipment manufacturer. No changes to the geometry had reportedly been made, although the impeller material had been upgraded from bronze to stainless steel.

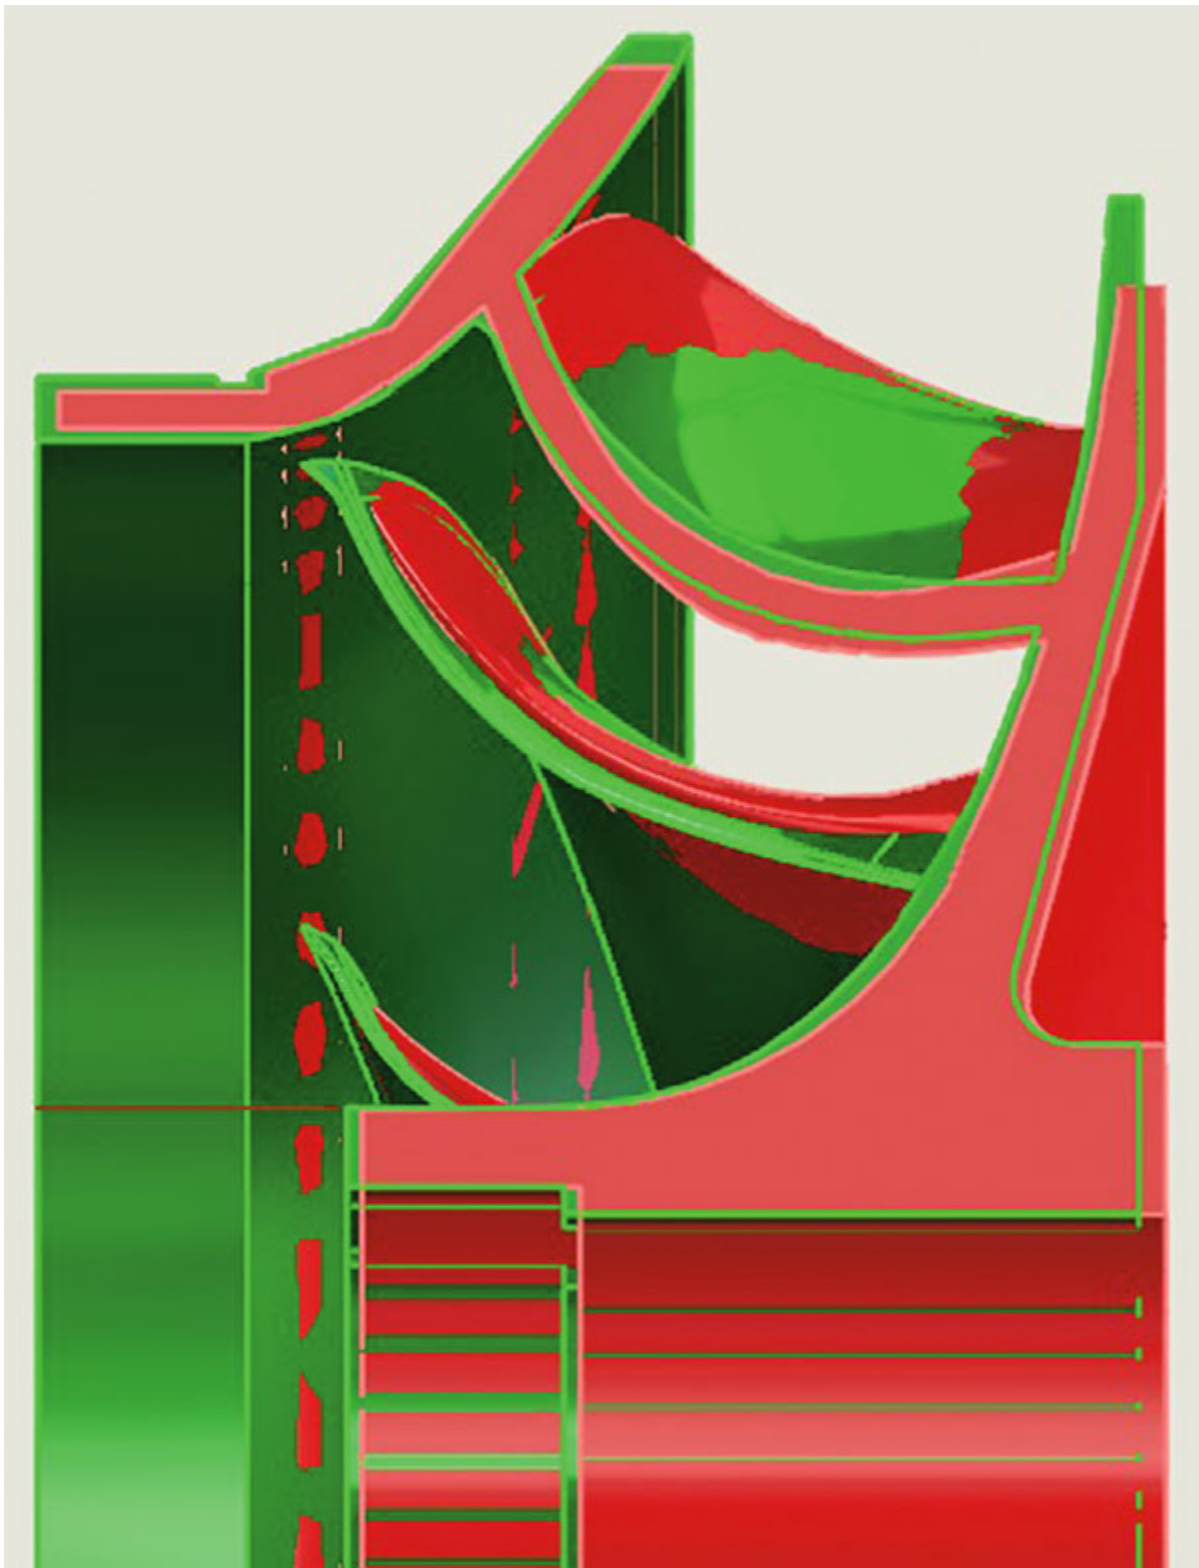
Using a comprehensive approach to impeller reverse engineering, experts established the differences between the stainless steel and the original bronze impellers. Significant differences in the vane shape and at the vane exit and inlet (at the impeller eye) raised concerns about the impeller geometry (see Figures 2 and 3).

The discharge vanes at the impeller outlet were considerably different, causing the discrepancy in head and curve shape.

The inlet angles and geometry of the impeller inlets also showed significant deviations from the original design—meaning consequences for the machine's net positive suction head required ([NPSHR](#)).

Based on the geometry differences at the impeller inlet, it was noted that the required minimum submergence level for the pump with the stainless steel impellers might be relatively higher than the required minimum for the bronze impellers.
