Hydro, Inc.'s Centaur IIoT Solution Detects Cracked Coupling at Municipal Wastewater Treatment Plant

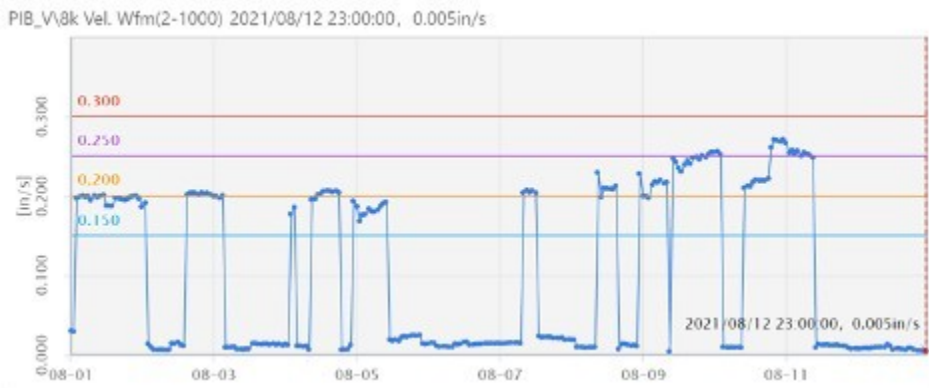
Using Hydraulic Institute standards, specifically ANSI/HI 9.6.4 for BB (between-bearing) and OH (overhung) pumps, Hydro assisted the end user in establishing alarm thresholds for each machine. Centaur's web-based software platform was then configured to send automated email alerts to the Centaur team and the end-user when a targeted alarm threshold is crossed. In early August, the Alarm 2 threshold (>0.250 ips RMS) was crossed at the pump inboard bearing location in the vertical direction. The trend plot below shows the upward trend in vibration amplitude levels and the Alarm 2 level (shown in purple).

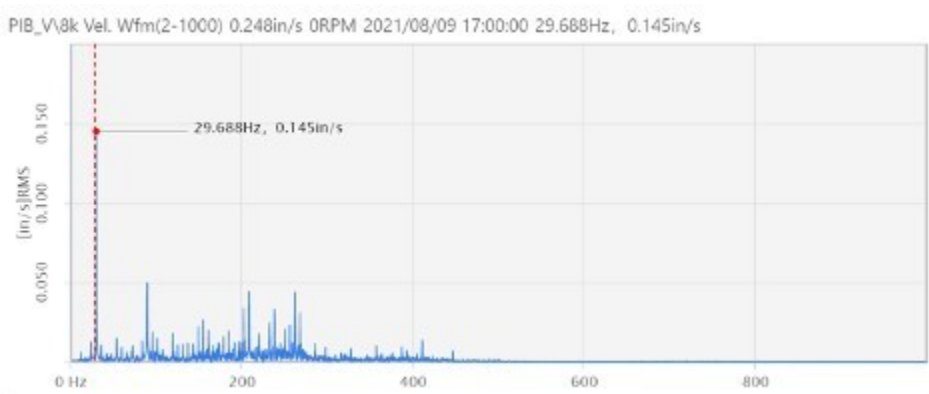
The monitored data identified a dominant excitation frequency at 1x run speed (29.688Hz) with harmonics. The team at Hydro's Monitoring & Diagnostic Center suspected that misalignment may be the root cause of the elevated vibration amplitude readings.

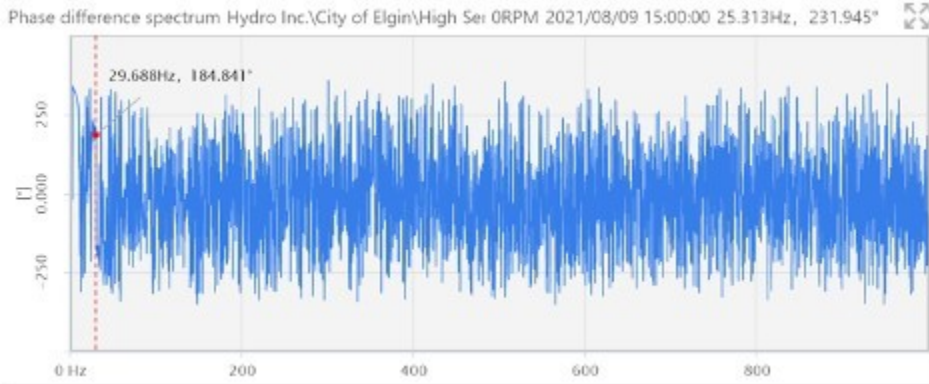
The phase difference, shown in the chart below, revealed a 184.841° phase difference between the pump inboard sensor and the motor inboard sensor. This phase angle is indicative of a potential misalignment condition between the coupled components.

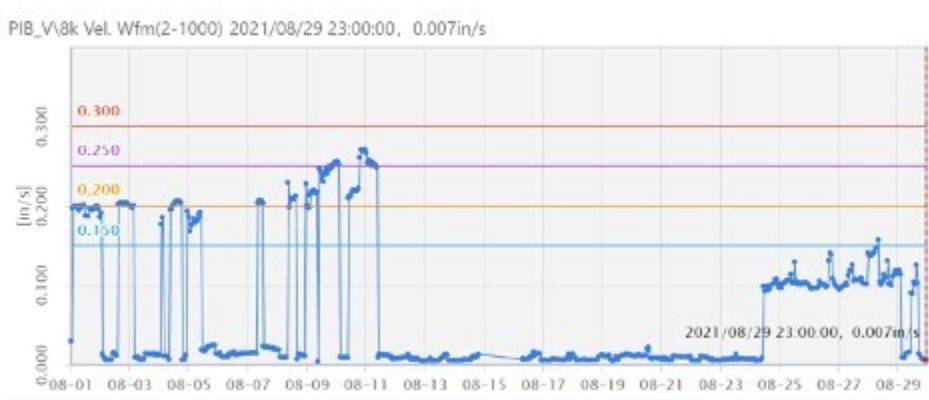
To confirm our suspicions, Hydro reached out to on-site personnel and asked for additional information that could help validate the misalignment theory. While gathering information, the site scheduled maintenance on the pump and found that the inboard coupling was cracked. Upon replacing the coupling, the vibration amplitude levels dropped below the warning threshold (<0.150 ips RMS), as shown in the trend plot below.
