# Increasing MTBR Under Emergency Conditions

By Faisal Salman, HydroAire.

NuclearPlantJournal.com Nuclear Plant Journal, May/June 2019

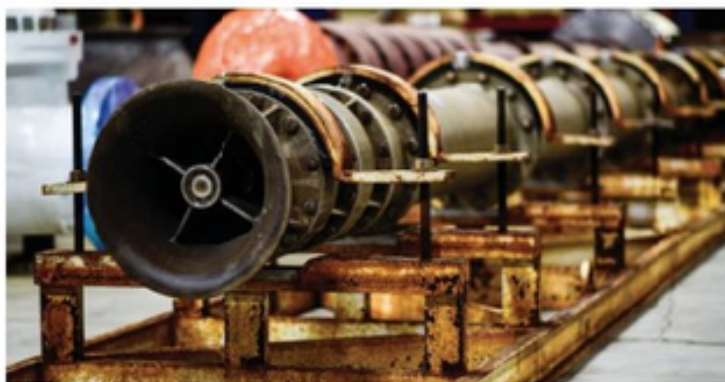
By executing an engineering analysis, the service organization had isolated several critical issues which had contributed to the pump's poor performance. It was noted that long-term damage to internal components, column pipes, and weld joints had been caused by less than optimal water chemistry. If left unattended, the consequences of this damage would lead to a higher risk of catastrophic failure.

Routine wear had contributed to severe corrosion and erosion seen throughout the pump and its components. The edges of the impeller suction vanes were worn to a sharp, thin edge. The columns also experienced damage and were displaying thinned walls. Leakage from the pump's flange joints was also noted which can decrease pressure and flow, negatively affecting the throughput.
