Quality Inspection Uncovers Impending Short-Term Failure

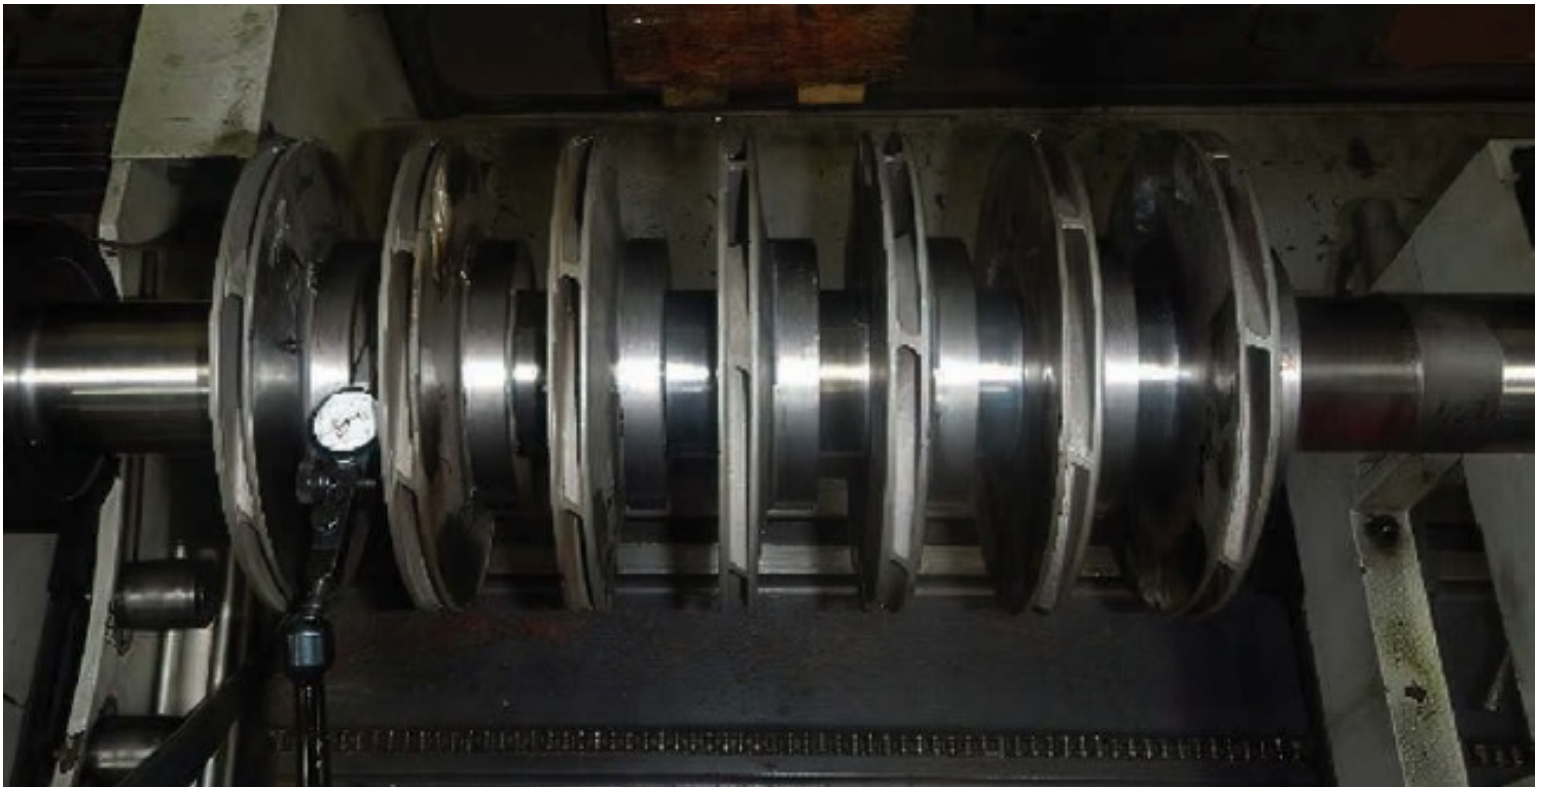
1. A tension test can verify 100% perpendicularity and parallelism of components.
