# Quality Inspection Uncovers Impending Short-Term Failure

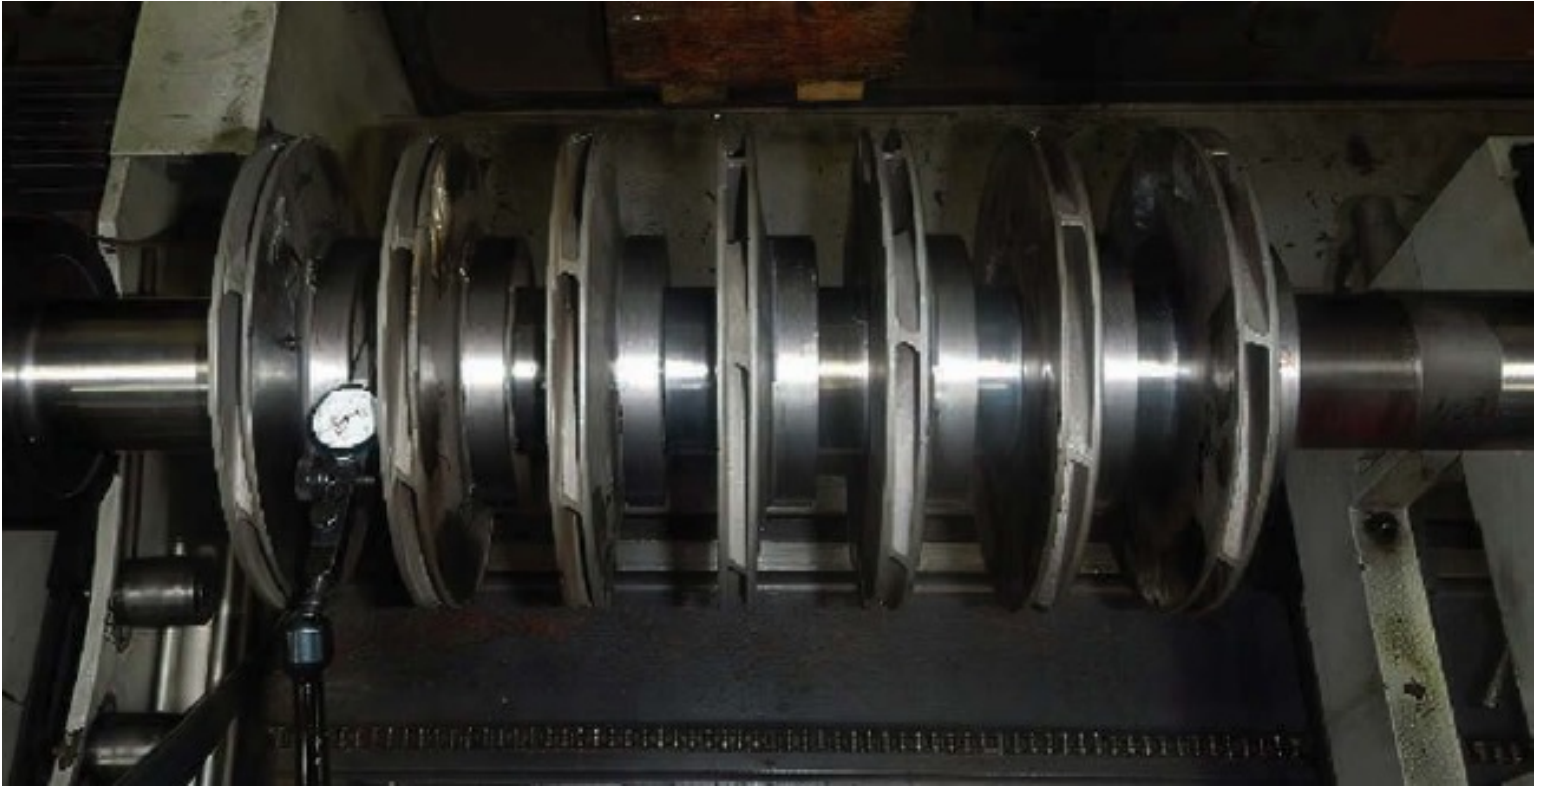
1. A tension test can verify 100% perpendicularity and parallelism of components.
