Technologies and Practices to Solve Chronic Problems

A nuclear power plant case study...

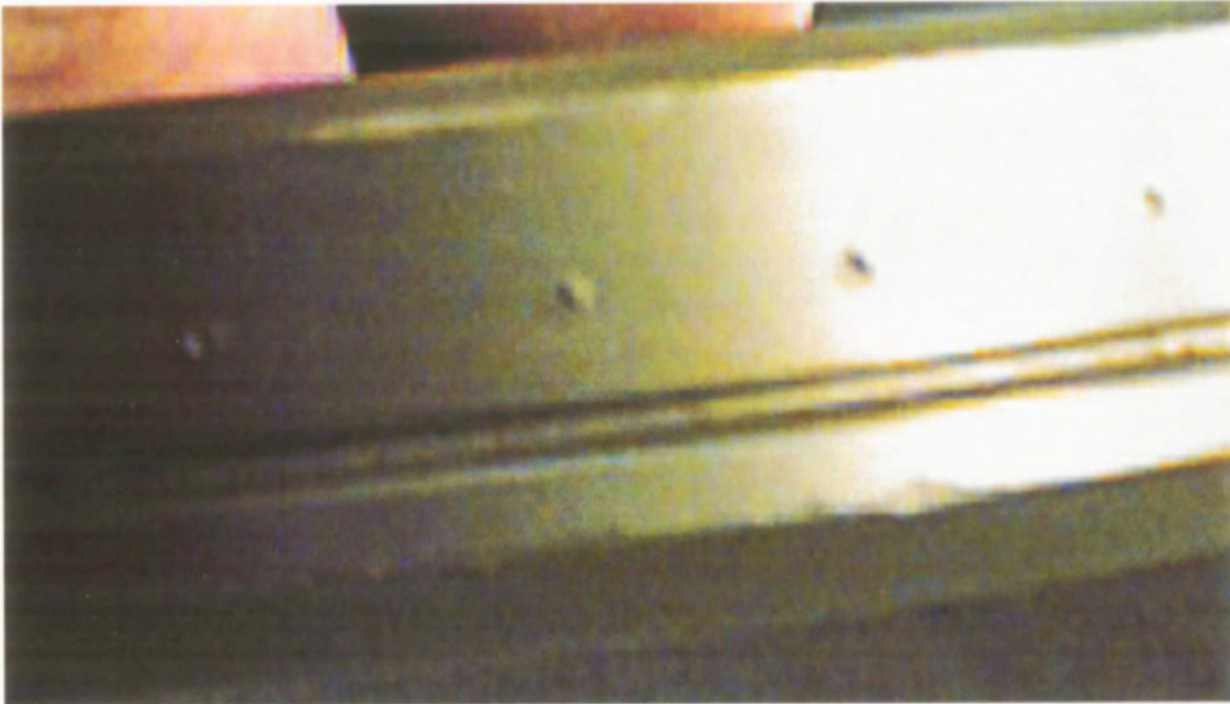
Figure 1. Return-channel bushing with punching to make fit

A detailed design review, disassembly and inspection found numerous issues that could be the source of the problems. These included inadequate/improper impeller-to-diffuser hydraulic parameters and overlaps, poor rotor centralization and wear-ring material compatibility issues. A return-channel bushing with loose fit had been center-punched 19 times to make it fit securely in its return channel (see Figure 1). While in service, the bushing became loose and released into the eye of the next stage impeller.

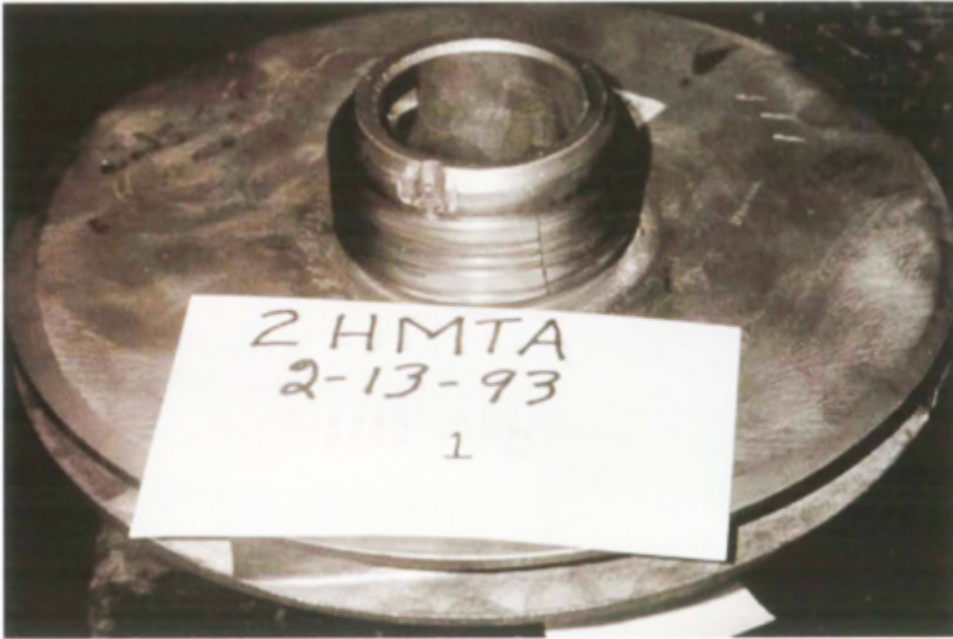
Figure 2. Broken impeller wear ring due to improper hardness (i.e. too high for tension)

Although the root cause of the problems was primarily related to improper hydraulic design for low-flow operation, other contributing factors appeared to include inadequate assembly and installation procedures and poor quality control during manufacturing. These rotor and hydraulic instabilities and manufacturing and assembly deficiencies were judged to contribute in part or solely to the excessive thrust and vibration experienced during low-flow operations.

- Upgrading impeller wear rings and return-channel bushings from 416 to 420F stainless steel;
- Changing impeller wear-ring hardness criteria to less than 300 HB (see Figure 2 showing an impeller wear ring that broke because hardness criteria had been modified and was too high for the tension);
- Changing return-channel bushing hardness criteria to greater than 400 HB;
- Balancing rotors to a maximum of 1W/N;
- Setting minimum impeller hardness at 16 HRC, and maximum at 22 HRC.

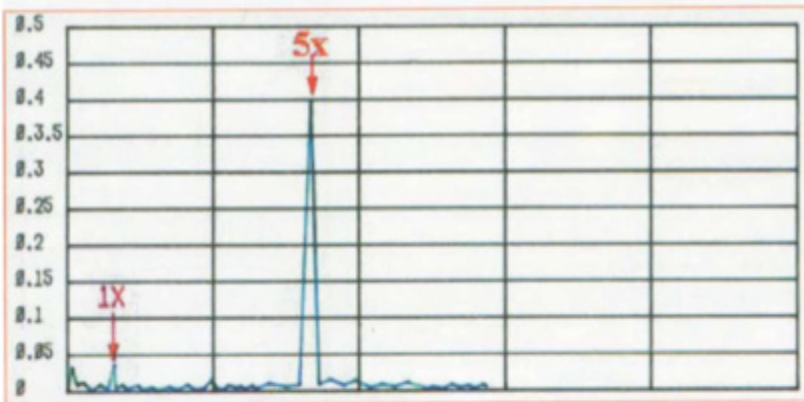
Figure 3. Vibration chart before modification

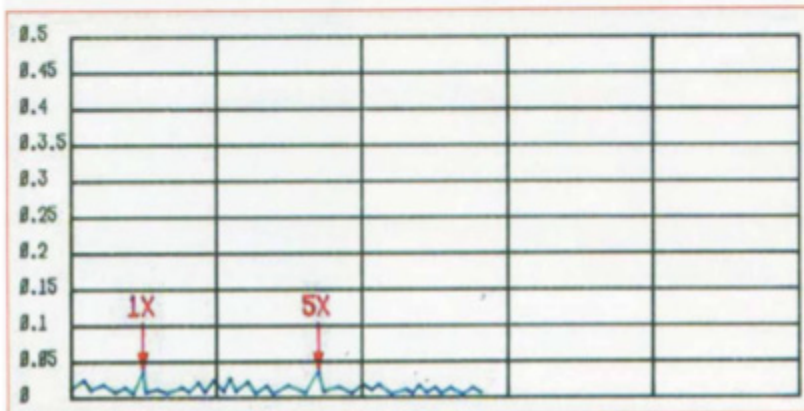
Figure 4. Vibration chart on modified element

As shown by before-and-after vibration readings in Figures 3 and 4, optimization of the A-Gap, B-Gap and impeller-to-diffuser overlap, combined with rotor centralization, material upgrades and precision balancing, finally resolved the performance issues that were being experienced by the utility. In fact, these modified AFW pumps have been performing efficiently and effectively for 12 years. This type of reliable performance, in turn, has allowed the utility to focus on other important issues in its operations.
