Technologies and Practices to Solve Chronic Problems

A nuclear power plant case study...

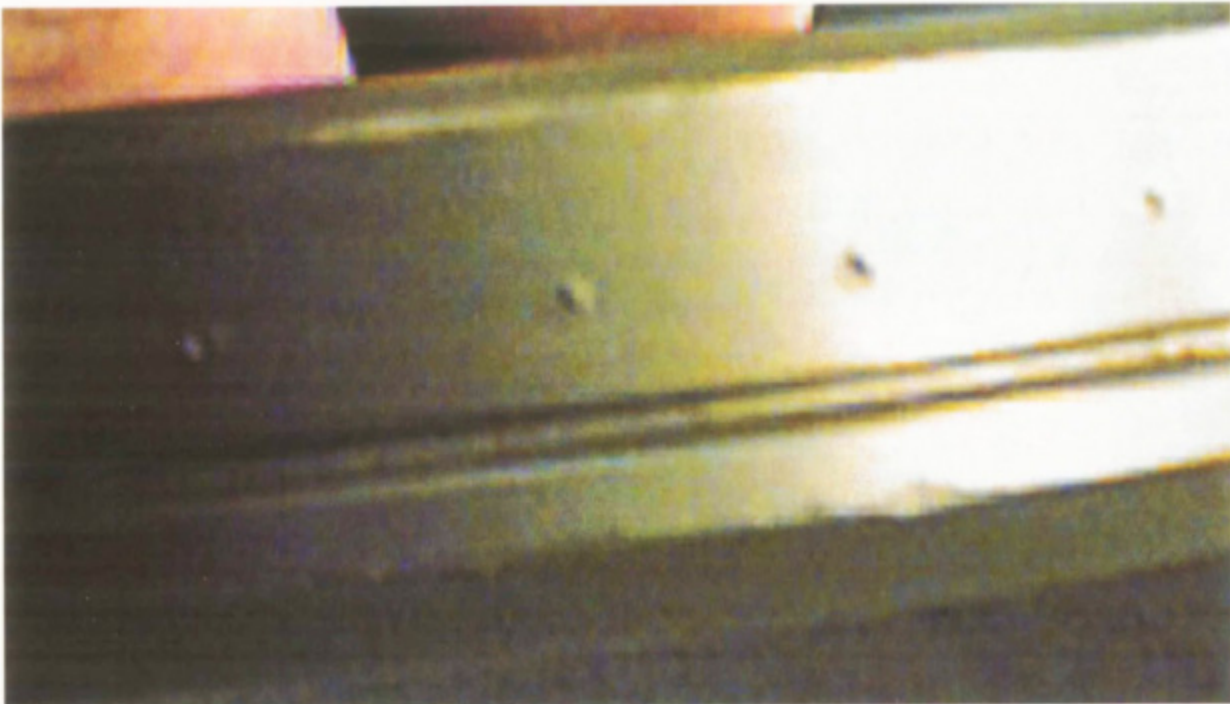
Figure 1. Return-channel bushing with punching to make fit

A detailed design review, disassembly and inspection found numerous issues that could be the source of the problems. These included inadequate/improper impeller-to-diffuser hydraulic parameters and overlaps, poor rotor centralization and wear-ring material compatibility issues. A return-channel bushing with loose fit had been centered-punched 19 times to make it fit securely in its return channel (see Figure 1). While in service, the bushing became loose and released into the eye of the next stage impeller.

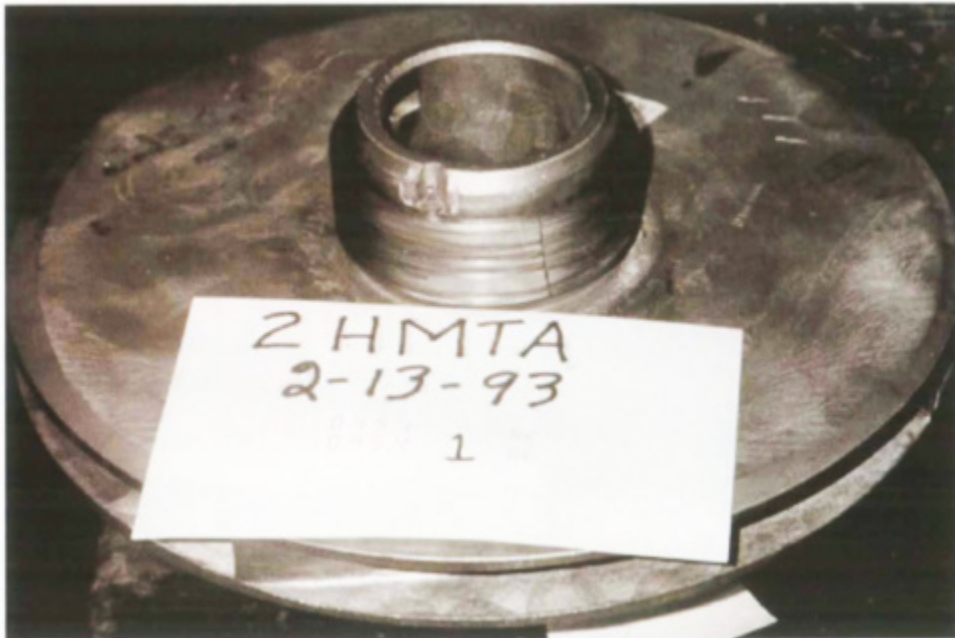
Figure 2. Broken impeller wear ring due to improper hardness (i.e. too high for tension)

- Upgrading impeller wear rings and return-channel bushings from 416 to 420F stainless steel;
- Changing impeller wear-ring hardness criteria to less than 300 HB (see Figure 2 showing an impeller wear ring that broke because hardness criteria had been modified and was too high for the tension);
- Changing return-channel bushing hardness criteria to greater than 400 HB;
- Balancing rotors to a maximum of 1W/N;
- Setting minimum impeller hardness at 16 HRC, and maximum at 22 HRC.

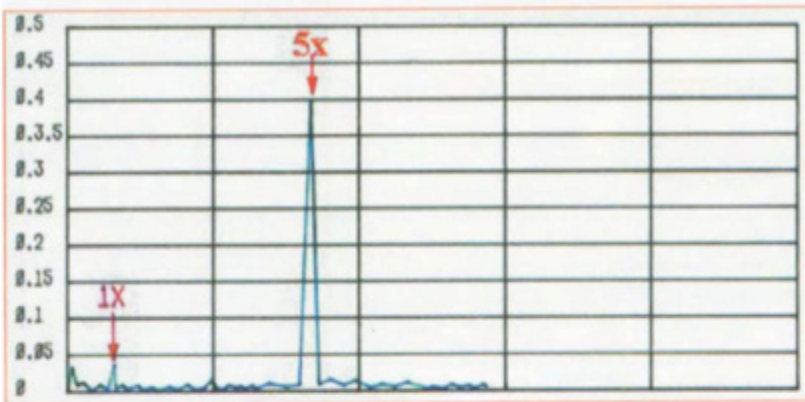
Figure 3. Vibration chart before modification

As shown by before-and-after vibration readings in Figures 3 and 4, optimization of the A-Gap, B-Gap and impeller-to-diffuser overlap, combined with rotor centralization, material upgrades and precision balancing, finally resolved the performance issues that were being experienced by the utility. In fact, these modified AFW pumps have been performing efficiently and effectively for 12 years. This type of reliable performance, in turn, has allowed the utility to focus on other important issues in its operations.

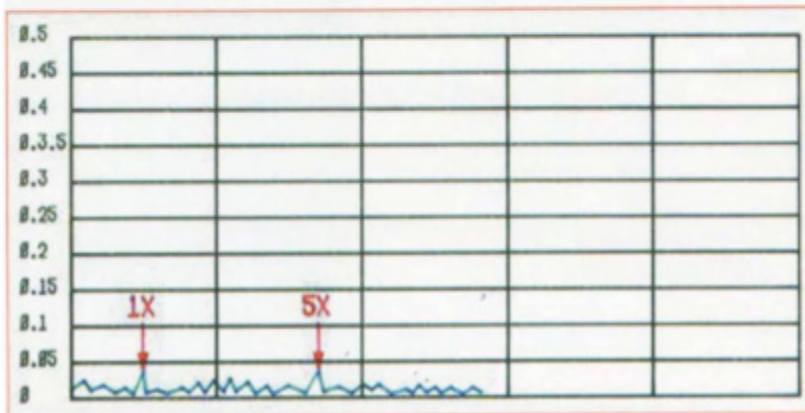
Figure 4. Vibration chart on modified element
