Service Center Engineering for a Power Plant

Circulating Water Pump Fails

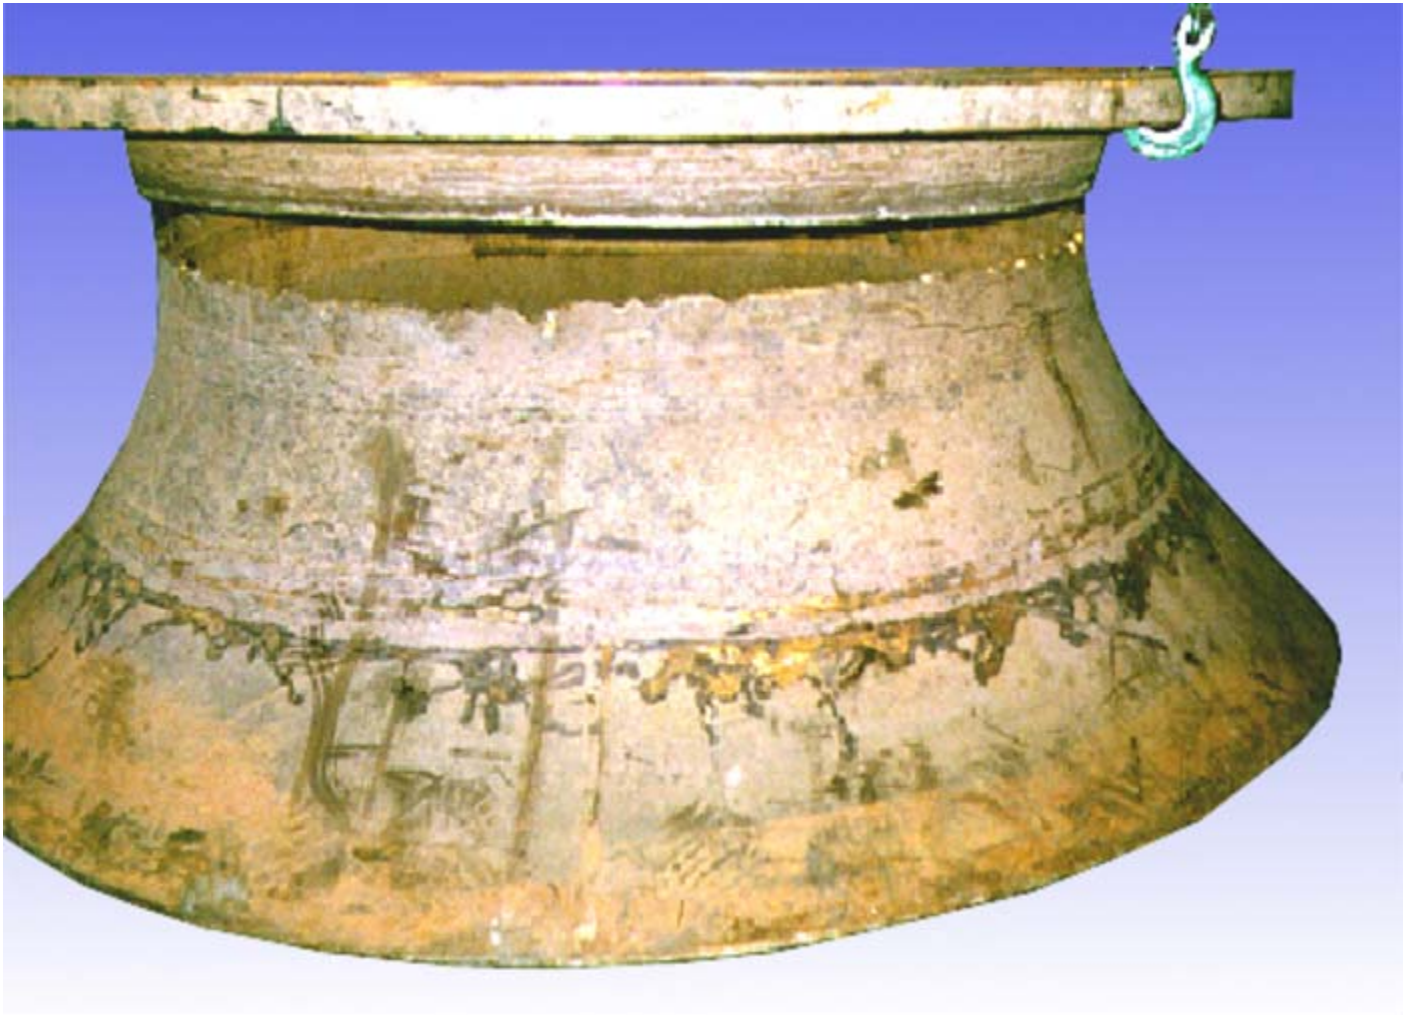
Inspection of the pump revealed that the existing suction bell was not in accord with the pump's original design. The severely damaged bell had a straight wall (probably a section of standard column pipe was used in the previous repair), which did not meet the contoured wall of the original design. The straight-wall did not have the proper contour to match the impeller profile. The reduction of the gap between the impeller and the wall of the suction bell affected the pump's flow and served as the basis for poor overall performance. Moreover, the wall thickness of the existing bell was only 0.080-in. In some areas, the wall had been further weakened by improper machining, which reduced the thickness of the wall to only 0.020-in.

The service center engineers believed that the improper contour and reduced wall thickness had significantly weakened the component's strength. It was likely that higher than normal vibration had affected the weakened component, causing the fabricated bell to break apart into two sections while in operation. This failure severely damaged the impeller, almost completely destroying the impeller blades.

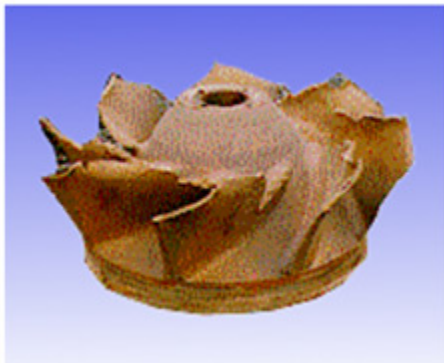
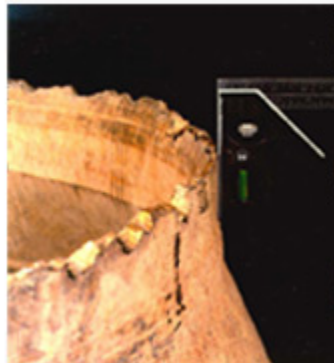
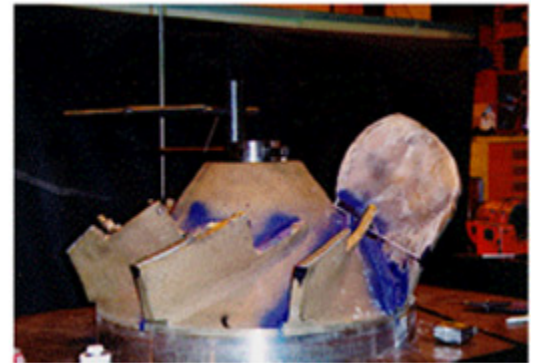
The impeller proved an even greater challenge. The existing impeller blades had been virtually destroyed when the suction bell broke into two pieces. As a result, the hydraulic profile was not available. In addition, the impeller had been cast in a special high lead content bronze, which was not available from local foundries. The use of special bronze alloys was common 40 to 50 years ago when the pump was designed and manufactured.

The service center's hydraulic design engineers analyzed the performance requirements of the original design using CFD (computational fluid design) and data that was available from the existing impeller to recreate the impeller's hydraulic profile. A CAD drawing was developed and electronically transferred to the foundry for the mold used to cast the impeller vanes.

Because the engineers' solution involved welding new blades to the existing impeller hub, it was essential to manufacture the blades from precisely the same material as the hub. A metallurgical analysis had to be performed on the original impeller so new vanes could be cast of the special bronze alloy material. The service center sent samples of the unusual bronze material out for analysis and worked with a smelter to duplicate the original material composition exactly. The ingots they produced were then transferred to a foundry where they were used to cast the newly designed blades. What remained of the old blades were carefully plasma arc removed. The new blades were then welded (using base metal welding material to ensure a high degree of strength) to the original impeller hub.
