Service Center Engineering for a Power Plant

Circulating Water Pump Fails

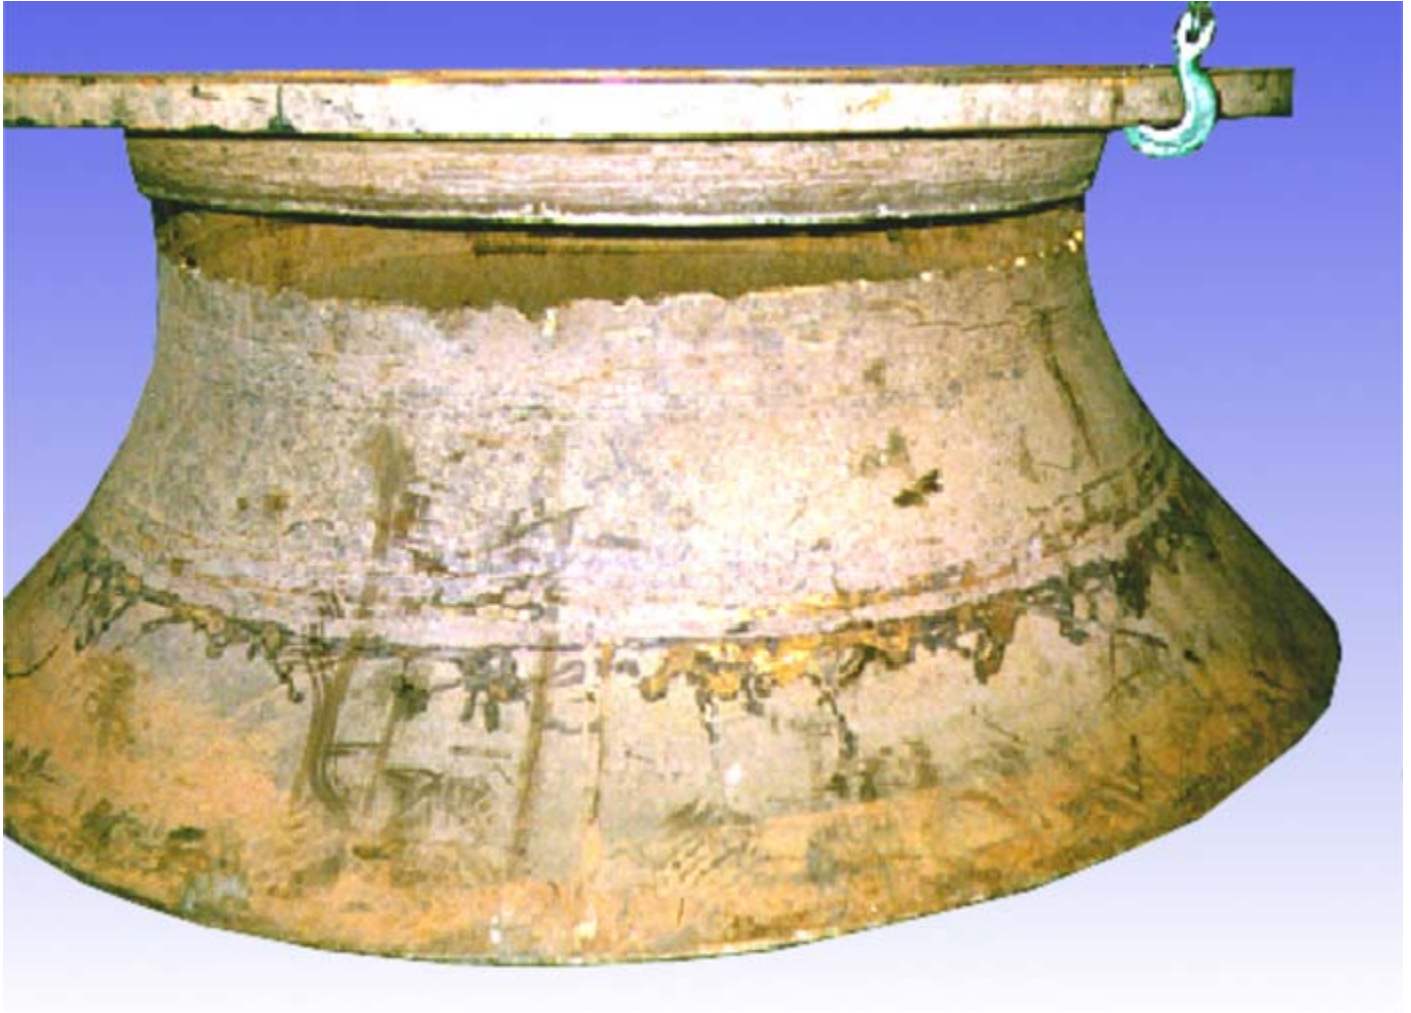
Inspection of the pump revealed that the existing suction bell was not in accord with the pump's original design. The severely damaged bell had a straight wall (probably a section of standard column pipe was used in the previous repair), which did not meet the contoured wall of the original design. The straight-wall did not have the proper contour to match the impeller profile. The reduction of the gap between the impeller and the wall of the suction bell affected the pump's flow and served as the basis for poor overall performance. Moreover, the wall thickness of the existing bell was only 0.080-in. In some areas, the wall had been further weakened by improper machining, which reduced the thickness of the wall to only 0.020-in.

The service center engineers believed that the improper contour and reduced wall thickness had significantly weakened the component's strength. It was likely that higher than normal vibration had affected the weakened component, causing the fabricated bell to break apart into two sections while in operation. This failure severely damaged the impeller, almost completely destroying the impeller blades.
