# Service Center Engineering for a Power Plant

## **Circulating Water Pump Fails**

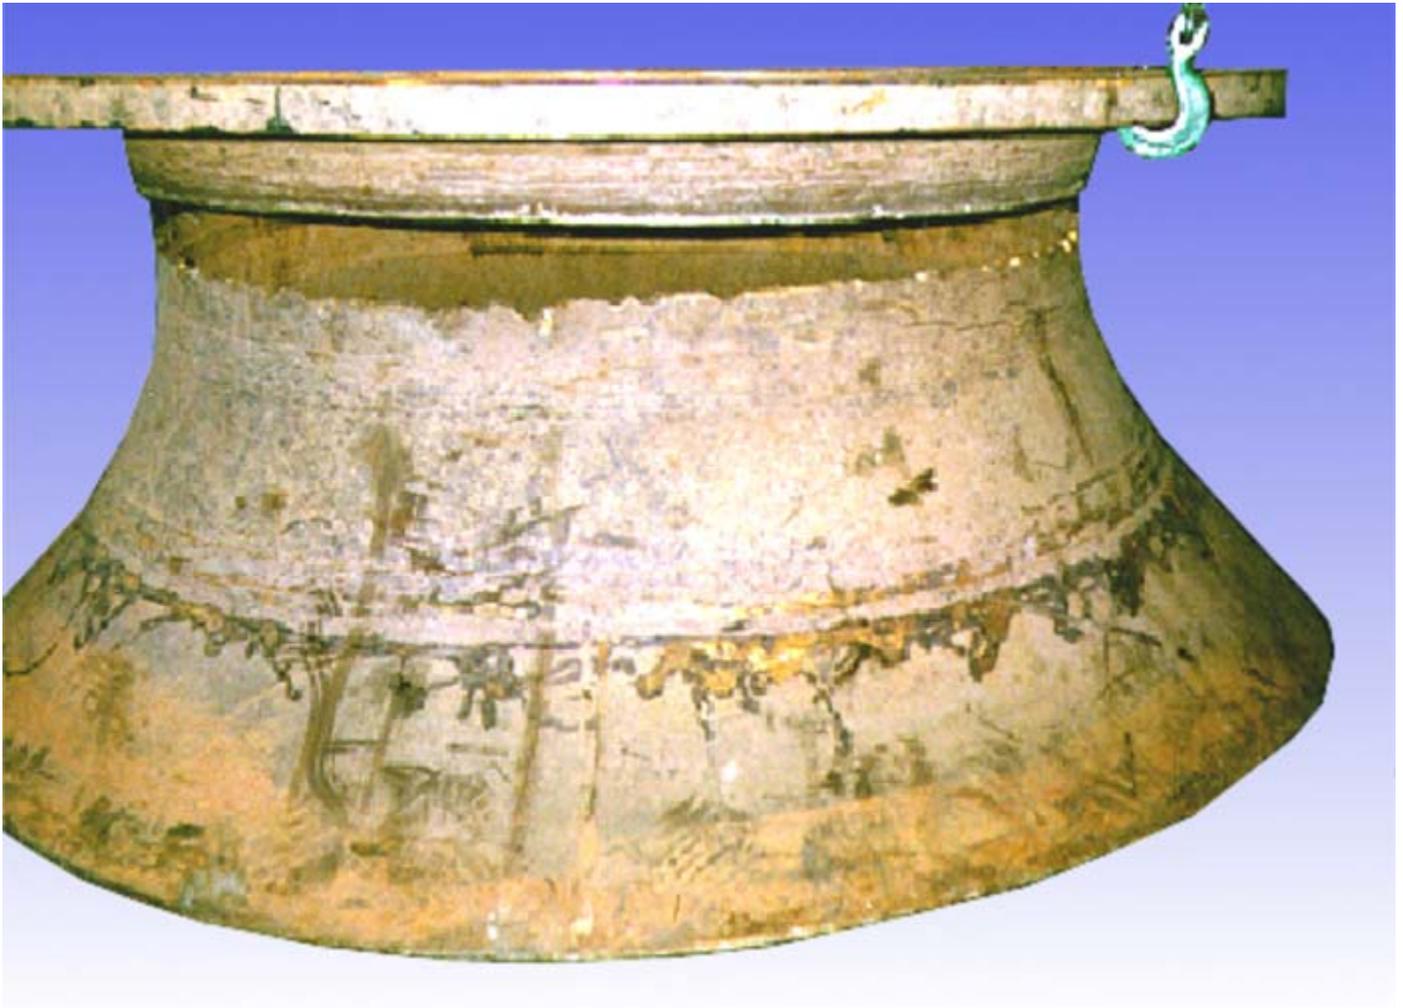
Inspection of the pump revealed that the existing suction bell was not in accord with the pump's original design. The severely damaged bell had a straight wall (probably a section of standard column pipe was used in the previous repair), which did not meet the contoured wall of the original design. The straight-wall did not have the proper contour to match the impeller profile. The reduction of the gap between the impeller and the wall of the suction bell affected the pump's flow and served as the basis for poor overall performance. Moreover, the wall thickness of the existing bell was only 0.080-in. In some areas, the wall had been further weakened by improper machining, which reduced the thickness of the wall to only 0.020-in.

The service center engineers believed that the improper contour and reduced wall thickness had significantly weakened the component's strength. It was likely that higher than normal vibration had affected the weakened component, causing the fabricated bell to break apart into two sections while in operation. This failure severely damaged the impeller, almost completely destroying the impeller blades.

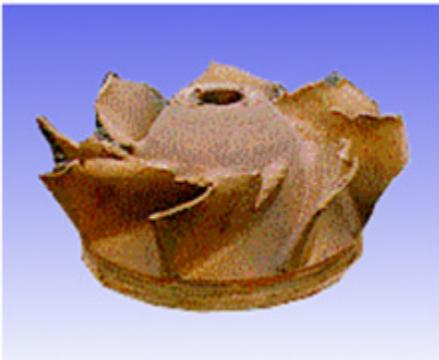
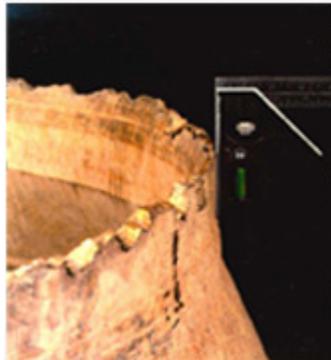
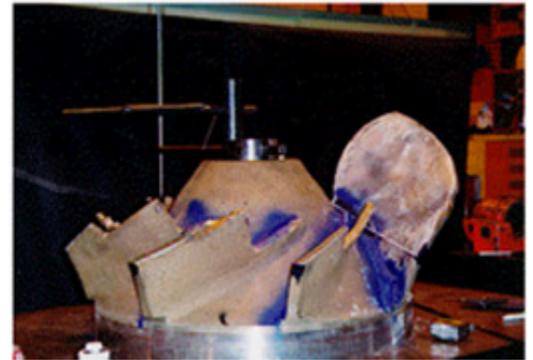
The impeller proved an even greater challenge. The existing impeller blades had been virtually destroyed when the suction bell broke into two pieces. As a result, the hydraulic profile was not available. In addition, the impeller had been cast in a special high lead content bronze, which was not available from local foundries. The use of special bronze alloys was common 40 to 50 years ago when the pump was designed and manufactured.

The service center's hydraulic design engineers analyzed the performance requirements of the original design using CFD (computational fluid design) and data that was available from the existing impeller to recreate the impeller's hydraulic profile. A CAD drawing was developed and electronically transferred to the foundry for the mold used to cast the impeller vanes.

Because the engineers' solution involved welding new blades to the existing impeller hub, it was essential to manufacture the blades from precisely the same material as the hub. A metallurgical analysis had to be performed on the original impeller so new vanes could be cast of the special bronze alloy material. The service center sent samples of the unusual bronze material out for analysis and worked with a smelter to duplicate the original material composition exactly. The ingots they produced were then transferred to a foundry where they were used to cast the newly designed blades. What remained of the old blades were carefully plasma arc removed. The new blades were then welded (using base metal welding material to ensure a high degree of strength) to the original impeller hub.
