# Engineered Modifications for an Ash Handling Water Pump

**Written by:** George Harris, Hydro Inc.

**Publisher:** Pumps & Systems / May, 2009

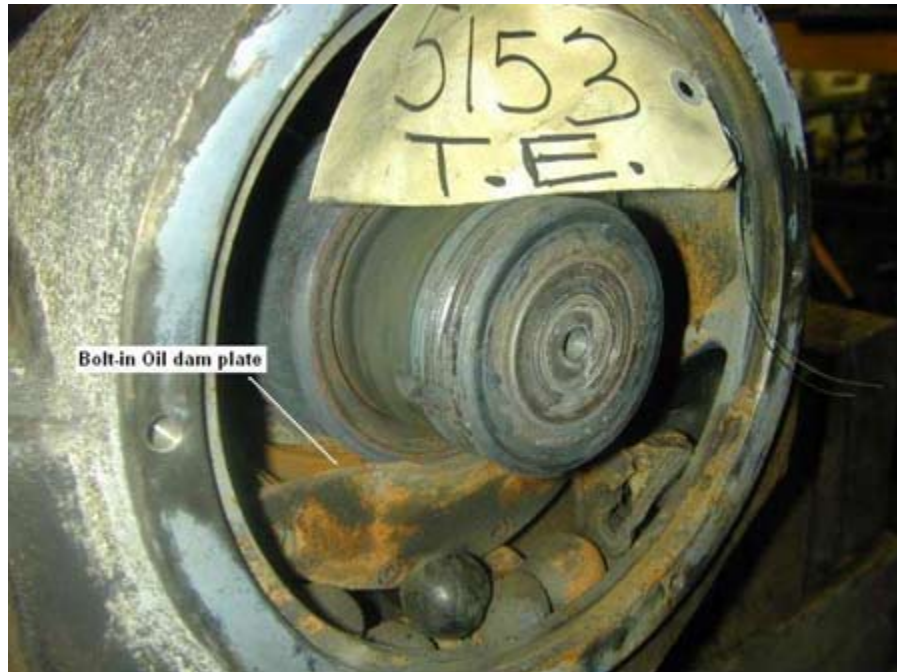
During disassembly, it was observed that there was not much evidence of any residual lubricant inside the bearing housing on the non-drive end side. There was rust build-up on the bearing debris (see Figure 2).

A 3/8-in diameter oil drain hole was added in the bearing bore at the 6:00 position, which eliminated

bolt-in bearing housing oil dams. This would allow oil to be drained away from the bearings without any contaminants settling close to the bearings.

The bearing housing oil level was changed from 2.5-in below pump centerline to 3.5-in below pump centerline. The intent was to avoid excess churning of oil in the sump by the bearings in operation. To keep the bearings well lubricated, the pump repair shop increased the oil flinger ring diameters to allow the flingers to pick up sufficient oil from the new sump level.

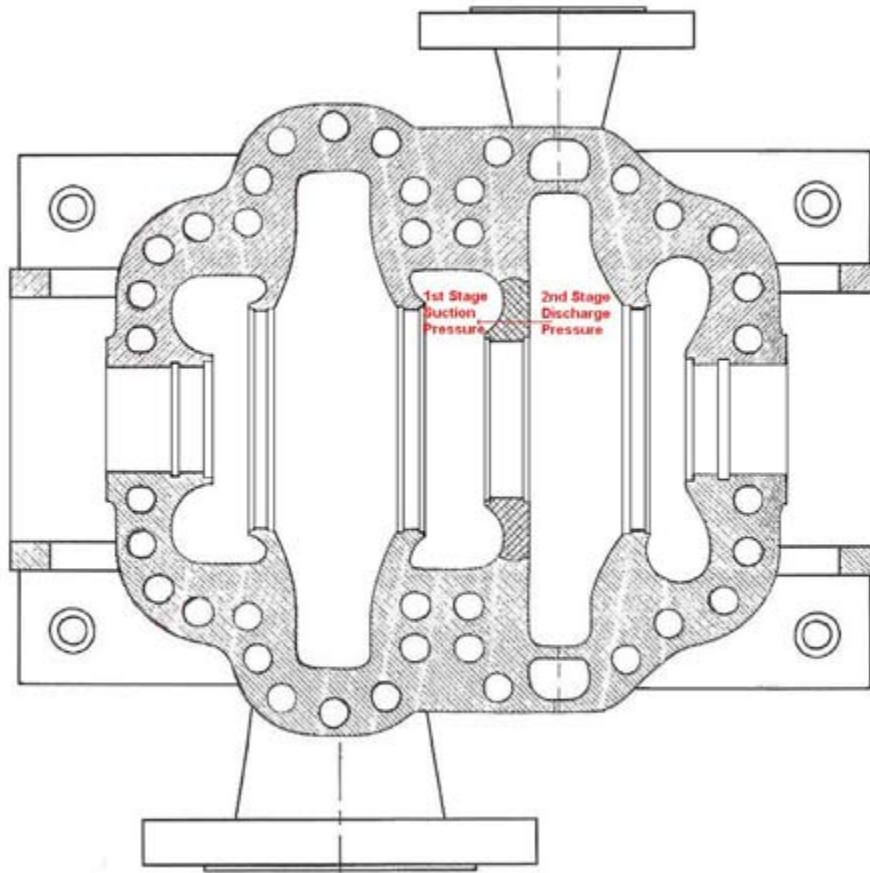
As part of the service center's dimensional inspection, the pump casing split line faces were inspected for flatness. It was observed that the casing split line faces adjacent to the second stage impeller, toward the non-drive side, had low spots. When the casing halves were assembled without any shims at the split line face, gaps measuring from 0.010-in to 0.020-in were observed between the top half and the bottom half at the split lines in these areas. Since this would also form the fit for the balance drum bushing separating the high pressure side from the suction side, this could have provided a possible leakage path (see Figure 3).

As part of the rebuild, the pump case fits were also welded and re-machined to restore OEM sizes and flatness. The pump was reassembled with new wear components and new bearings and was then shipped to the station.
