# Engineered Modifications for an Ash Handling Water Pump

**Written by:** George Harris, Hydro Inc.

**Publisher:** Pumps & Systems / May, 2009

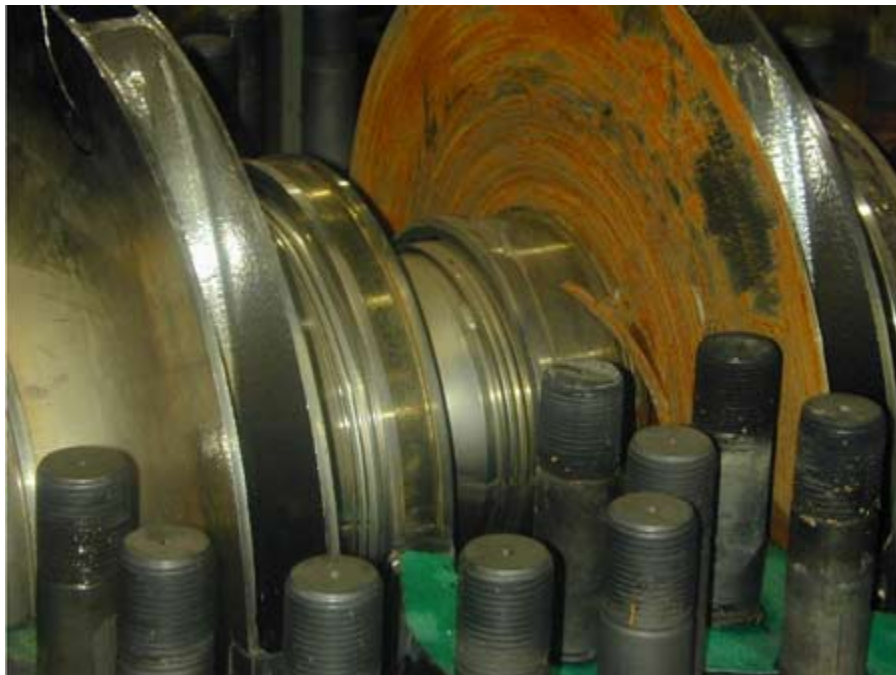
This pump was shipped to the service center where it was disassembled and inspected. It was observed that the bearings had failed and the rotor had moved axially toward the non-drive end, allowing the second stage impeller to contact the pump casing (see Figure 1).

Excessive wear was noted at all running clearances. Discussions with the plant subsequently revealed

that these pumps have an average MTBR of 18 months. Excess running clearances accompanied by rotor axial movement have resulted in similar failures on sister pumps.

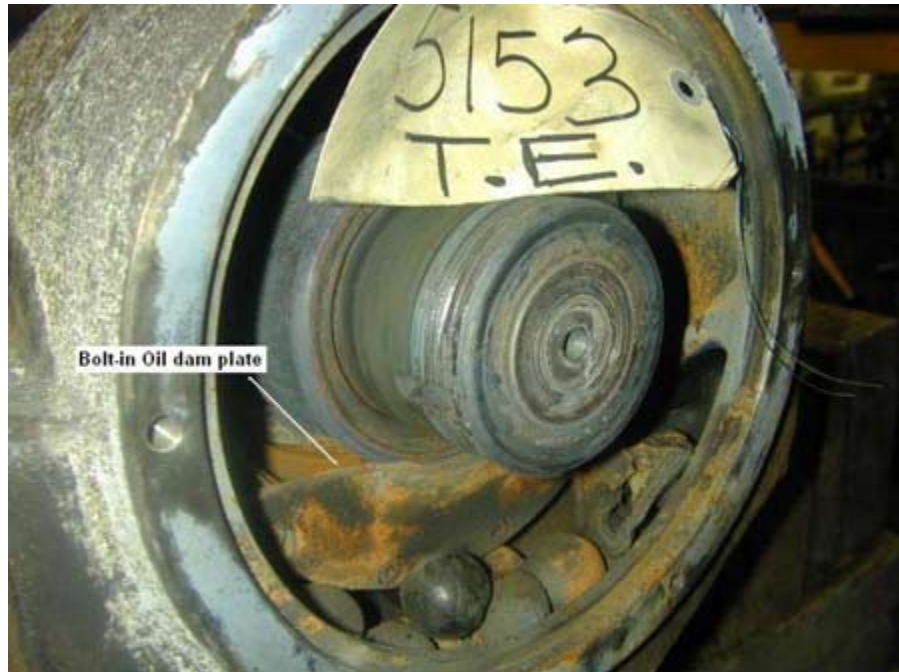
During disassembly, it was observed that there was not much evidence of any residual lubricant inside the bearing housing on the non-drive end side. There was rust build-up on the bearing debris (see Figure 2).

A 3/8-in diameter oil drain hole was added in the bearing bore at the 6:00 position, which eliminated bolt-in bearing housing oil dams. This would allow oil to be drained away from the bearings without any contaminants settling close to the bearings.

The bearing housing oil level was changed from 2.5-in below pump centerline to 3.5-in below pump centerline. The intent was to avoid excess churning of oil in the sump by the bearings in operation. To keep the bearings well lubricated, the pump repair shop increased the oil flinger ring diameters to allow the flingers to pick up sufficient oil from the new sump level.

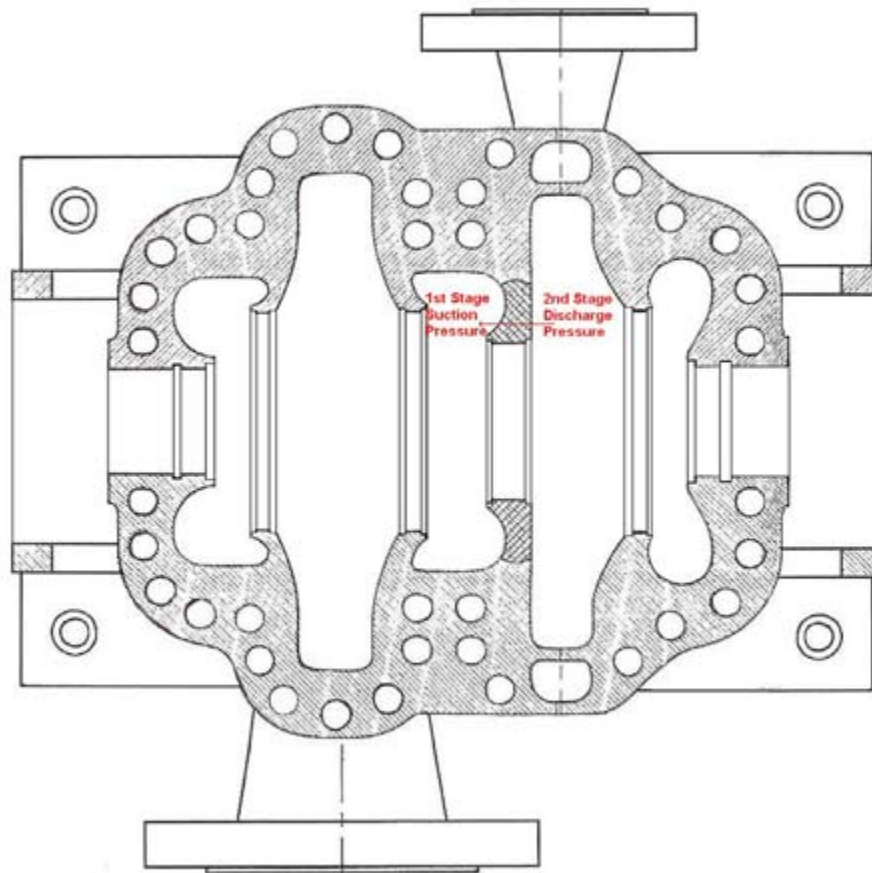
As part of the service center's dimensional inspection, the pump casing split line faces were inspected for flatness. It was observed that the casing split line faces adjacent to the second stage impeller, toward the non-drive side, had low spots. When the casing halves were assembled without any shims at the split line face, gaps measuring from 0.010-in to 0.020-in were observed between the top half and the bottom half at the split lines in these areas. Since this would also form the fit for the balance drum bushing separating the high pressure side from the suction side, this could have provided a possible leakage path (see Figure 3).

As part of the rebuild, the pump case fits were also welded and re-machined to restore OEM sizes and flatness. The pump was reassembled with new wear components and new bearings and was then shipped to the station.
