Engineered Modifications for an Ash Handling Water Pump

Written by: George Harris, Hydro Inc.

Publisher: Pumps & Systems / May, 2009

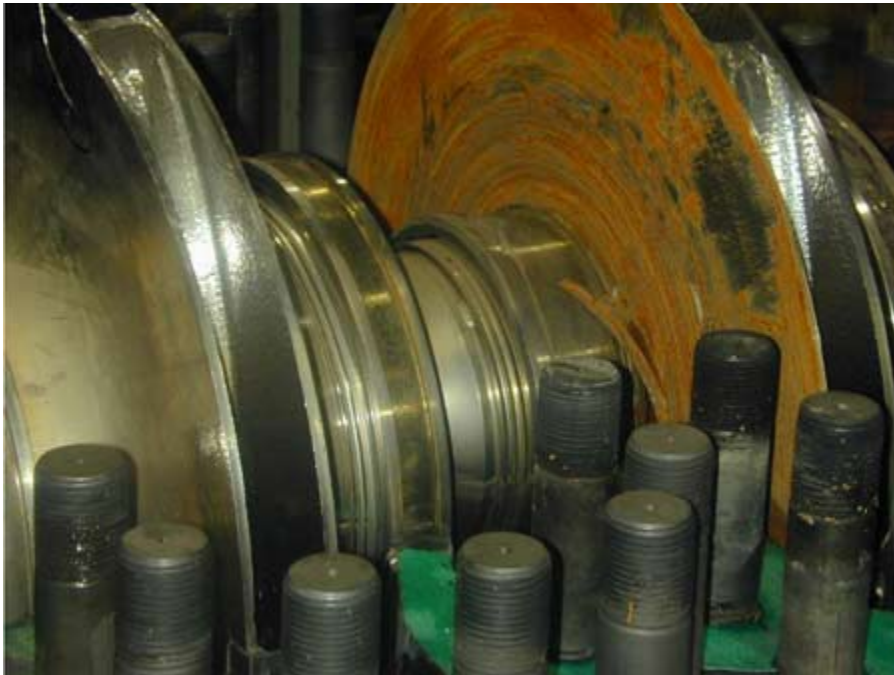
This pump was shipped to the service center where it was disassembled and inspected. It was observed that the bearings had failed and the rotor had moved axially toward the non-drive end, allowing the second stage impeller to contact the pump casing (see Figure 1).

Excessive wear was noted at all running clearances. Discussions with the plant subsequently revealed

that these pumps have an average MTBR of 18 months. Excess running clearances accompanied by rotor axial movement have resulted in similar failures on sister pumps.

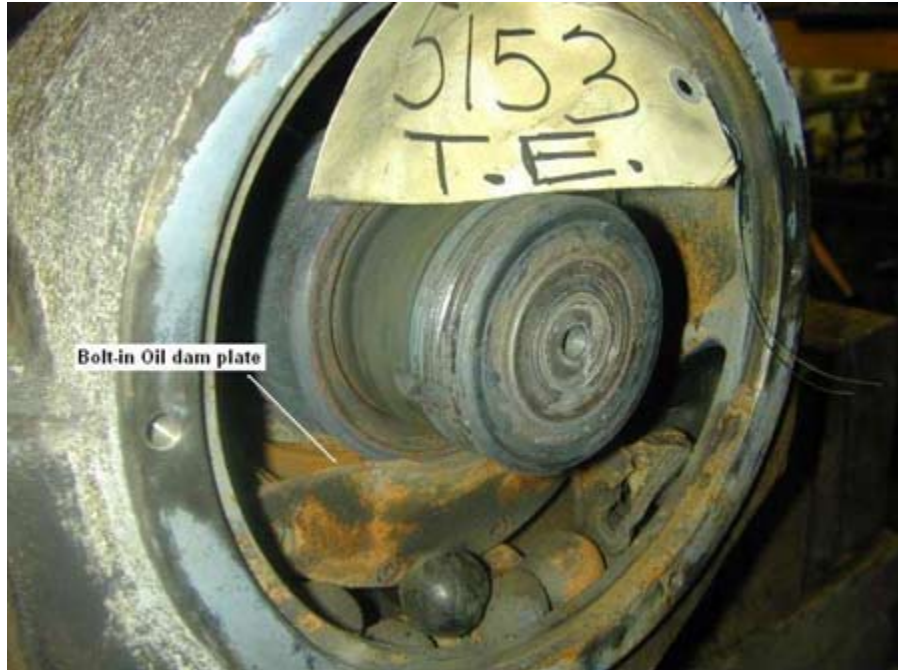
During disassembly, it was observed that there was not much evidence of any residual lubricant inside the bearing housing on the non-drive end side. There was rust build-up on the bearing debris (see Figure 2).

A 3/8-in diameter oil drain hole was added in the bearing bore at the 6:00 position, which eliminated

bolt-in bearing housing oil dams. This would allow oil to be drained away from the bearings without any contaminants settling close to the bearings.

The bearing housing oil level was changed from 2.5-in below pump centerline to 3.5-in below pump centerline. The intent was to avoid excess churning of oil in the sump by the bearings in operation. To keep the bearings well lubricated, the pump repair shop increased the oil flinger ring diameters to allow the flingers to pick up sufficient oil from the new sump level.

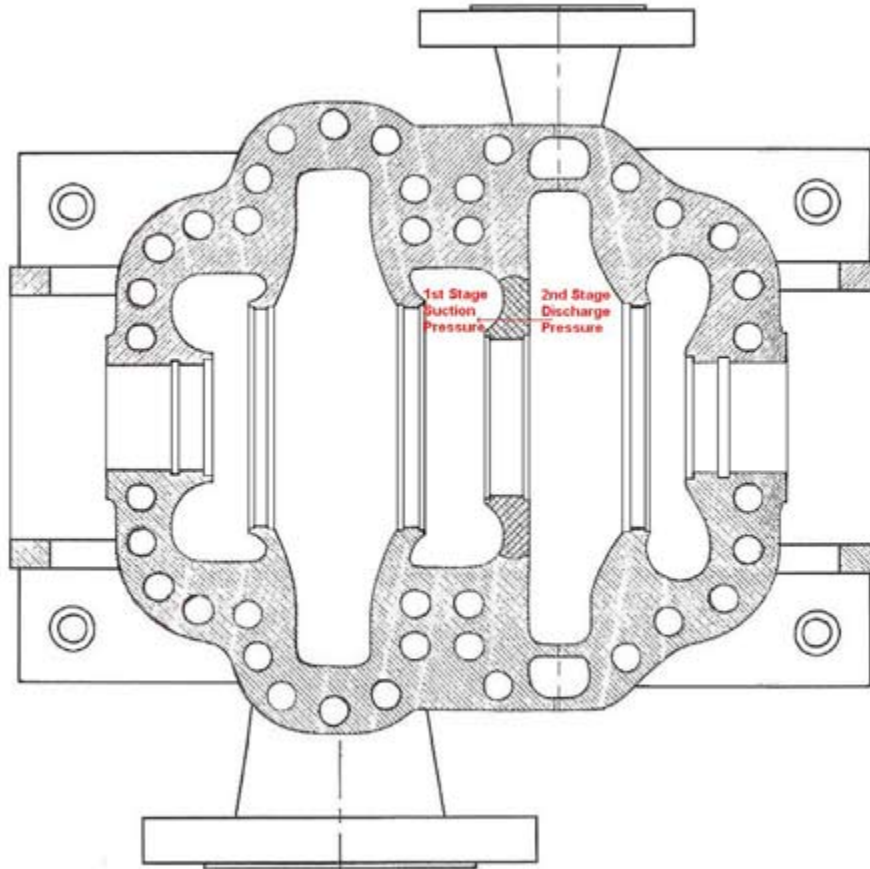
As part of the service center's dimensional inspection, the pump casing split line faces were inspected for flatness. It was observed that the casing split line faces adjacent to the second stage impeller, toward the non-drive side, had low spots. When the casing halves were assembled without any shims at the split line face, gaps measuring from 0.010-in to 0.020-in were observed between the top half and the bottom half at the split lines in these areas. Since this would also form the fit for the balance drum bushing separating the high pressure side from the suction side, this could have provided a possible leakage path (see Figure 3).

As part of the rebuild, the pump case fits were also welded and re-machined to restore OEM sizes and flatness. The pump was reassembled with new wear components and new bearings and was then shipped to the station.
