Engineered Modifications for an Ash Handling Water Pump

Written by: George Harris, Hydro Inc.

Publisher: Pumps & Systems / May, 2009

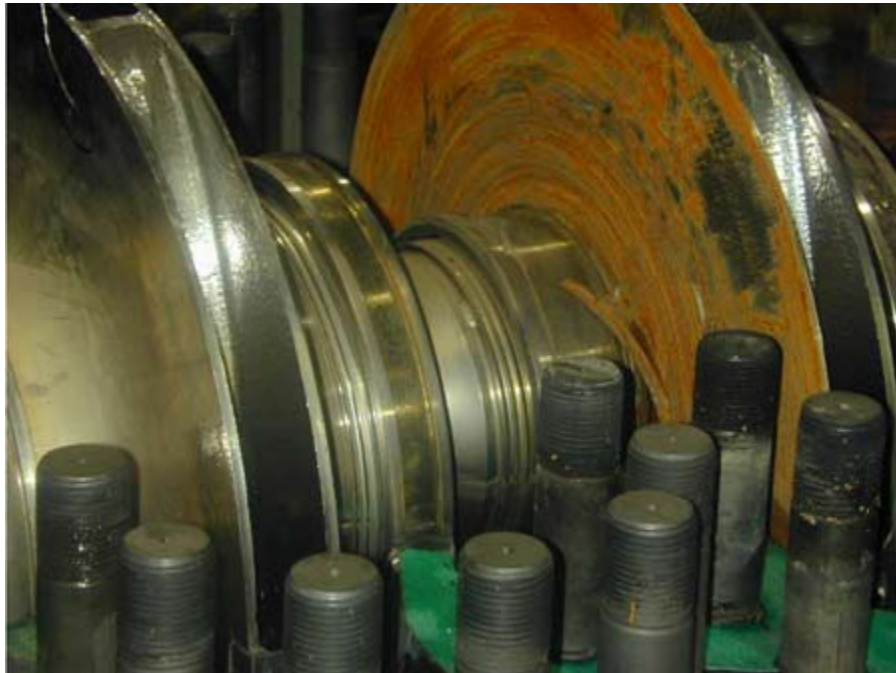
This pump was shipped to the service center where it was disassembled and inspected. It was observed that the bearings had failed and the rotor had moved axially toward the non-drive end, allowing the second stage impeller to contact the pump casing (see Figure 1).

Excessive wear was noted at all running clearances. Discussions with the plant subsequently revealed

that these pumps have an average MTBR of 18 months. Excess running clearances accompanied by rotor axial movement have resulted in similar failures on sister pumps.

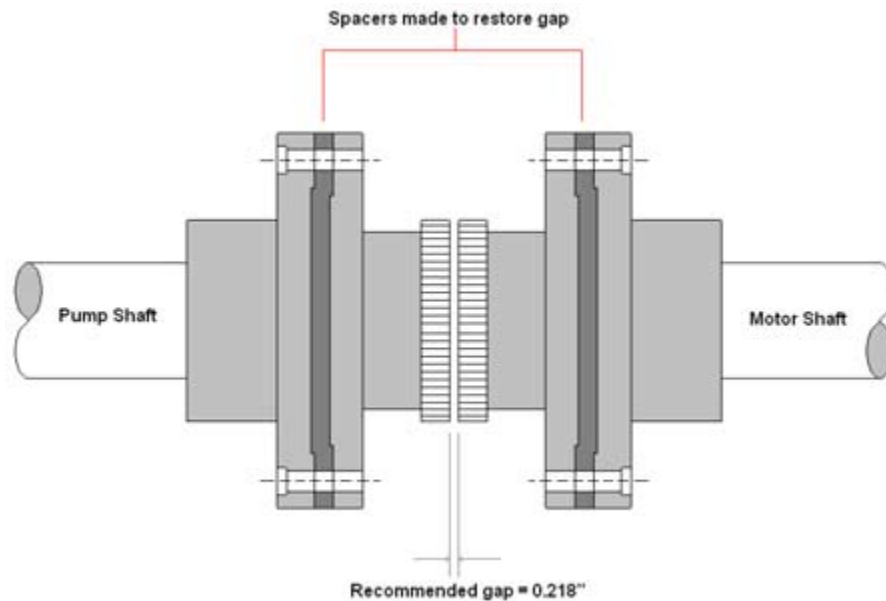
During installation, the service center personnel set the pump in position and connected its discharge and suction flanges to the plant piping before securing the pump feet. The purpose of this was to ensure that the pump was not under stress because of the piping. They then proceeded to align the motor to the pump. After confirming the direction of rotation, they performed a no-load run of the motor to locate its magnetic center. It was observed that the gap between the coupling hubs was 0.820-in (compared to an OEM recommended gap of 0.218-in). This may have been a preexisting condition. The only way to close this gap would have been to pull the motor rotor toward the pump and disturb its magnetic center.

To keep the motor running at its magnetic center, the service center manufactured two spacers (one for each coupling hub) to bridge this gap (see Figure 8) and completed the alignment using laser alignment equipment.
