Rebuilding Boiler Feed Pumps for the Wastewater Industry

Bob Bluse, Hydro East Inc., and Scott Morisi, Passaic Valley Sewerage Commissioners

Pumps & Systems

October, 2009

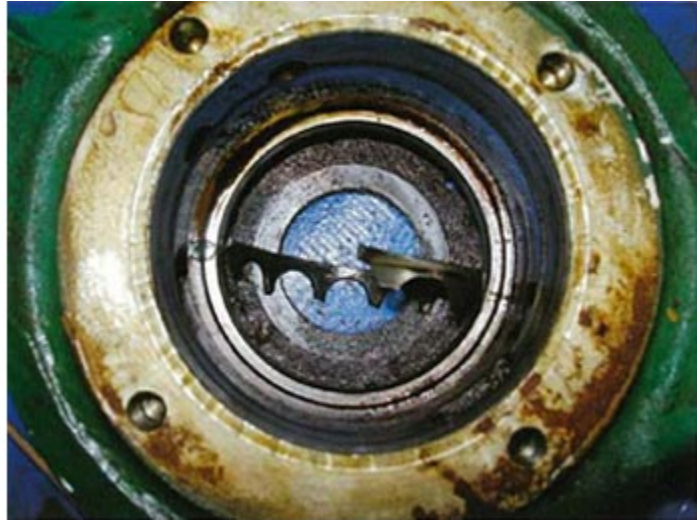
The pump turned freely when it was received. While dismantling the pump's thrust end, the service center found a portion of the bearing cage in the housing. The thrust bearings mounted on the shaft were intact; therefore, this piece of cage was from a previous failure. On one pump, the back to back thrust bearings were installed incorrectly, which resulted in a short run to failure. All bearings were installed correctly with the proper clearances and tolerances as recommended by the bearing manufacturer.

(Left) BFP Installation (Right) Bearing Cage from a previous repair

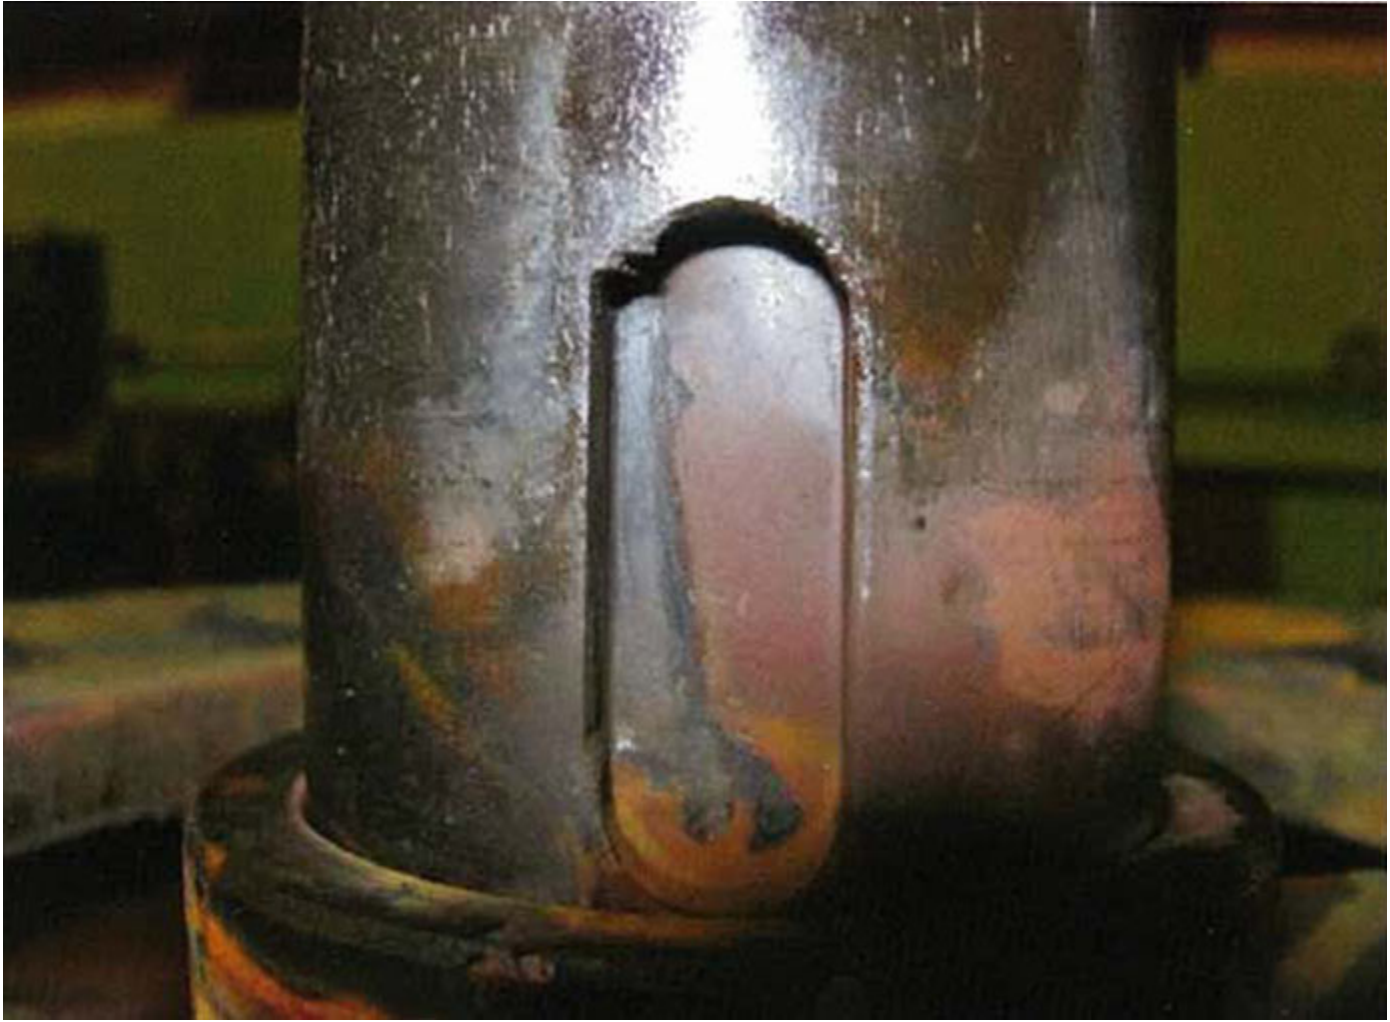
Dimensionally, the shaft was out of tolerance. Both bearing fits were undersized, and several of the impeller and sleeve fits were fretted. The first stage impeller keyway was deformed. The run out inspection found a 0.008 in TIR as a simple bow. The pump shaft was replaced and the tolerances between the impeller bores and pump shaft was tightened up to current repair practices.

Deformed keyway on pump shaft
