Rebuilding Boiler Feed Pumps for the Wastewater Industry

Bob Bluse, Hydro East Inc., and Scott Morisi, Passaic Valley Sewerage Commissioners

Pumps & Systems

October, 2009

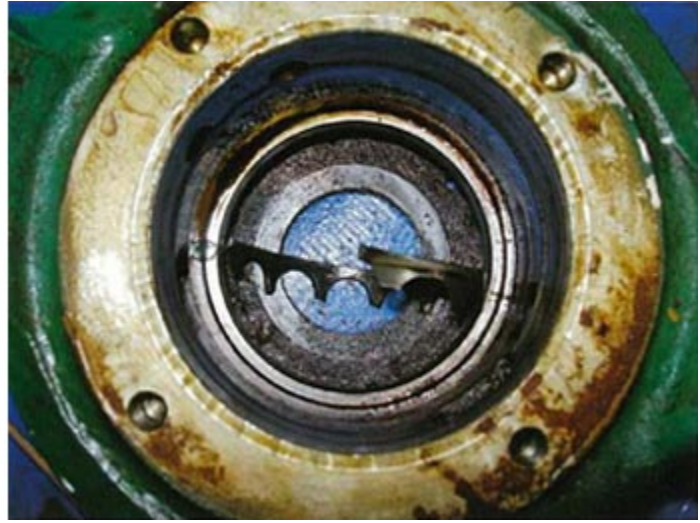
The pump turned freely when it was received. While dismantling the pump's thrust end, the service center found a portion of the bearing cage in the housing. The thrust bearings mounted on the shaft were intact; therefore, this piece of cage was from a previous failure. On one pump, the back to back thrust bearings were installed incorrectly, which resulted in a short run to failure. All bearings were installed correctly with the proper clearances and tolerances as recommended by the bearing manufacturer.

(Left) BFP Installation (Right) Bearing Cage from a previous repair
