Vibration Study and Root Cause Analysis

Ian Watson, Jim Steiger and Dr. T. Ravisundar, HydroAire Inc.

Pumps & Systems

December, 2009

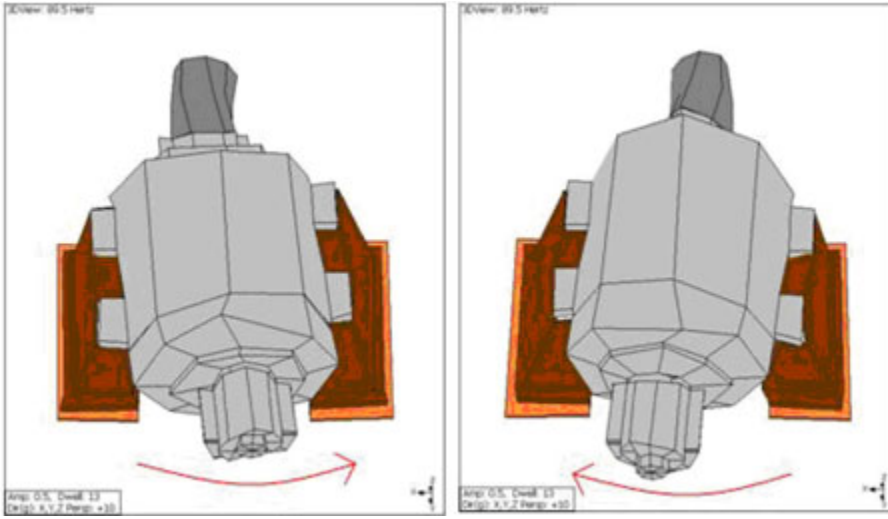
2. Analysis showed that the one times running speed vibration was a result of the entire pump twisting on its pedestals, and not a result of localized motion of the bearing housings (see Figure 1). The pedestals were deforming their cross-sectional shape to produce this twisting motion. The inboard bearing housing moved in-phase with the barrel at this frequency. Applying a fix to the coupling guard or inboard bearing housing could slightly reduce vibration levels, but did not address the vibration's root cause.

Figure 1. Data acquired during testing shows the pump twisting on its pedestals.

1. Structurally stiffen the pump pedestals in the direction of deformation as identified in the modal and ODS analysis. This could be done either by filling the hollow pedestals with concrete or by welding stiffening ribs in the appropriate locations. The idea was to prevent the rectangular cross-sections of the pedestal (as viewed from the top) from deforming into parallelograms.

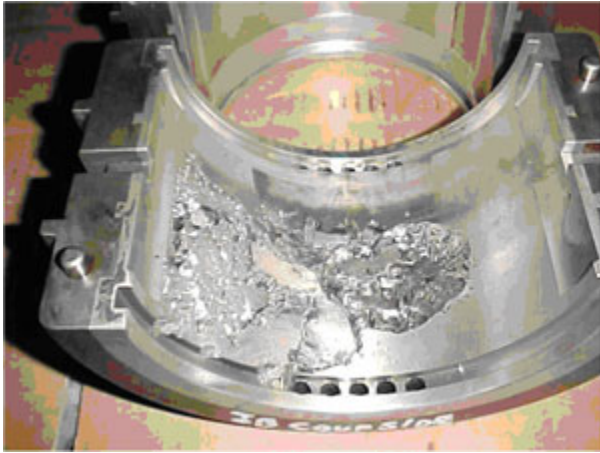
Figure 2. The inboard bearing was found to be nearly destroyed due to excessive vibration.

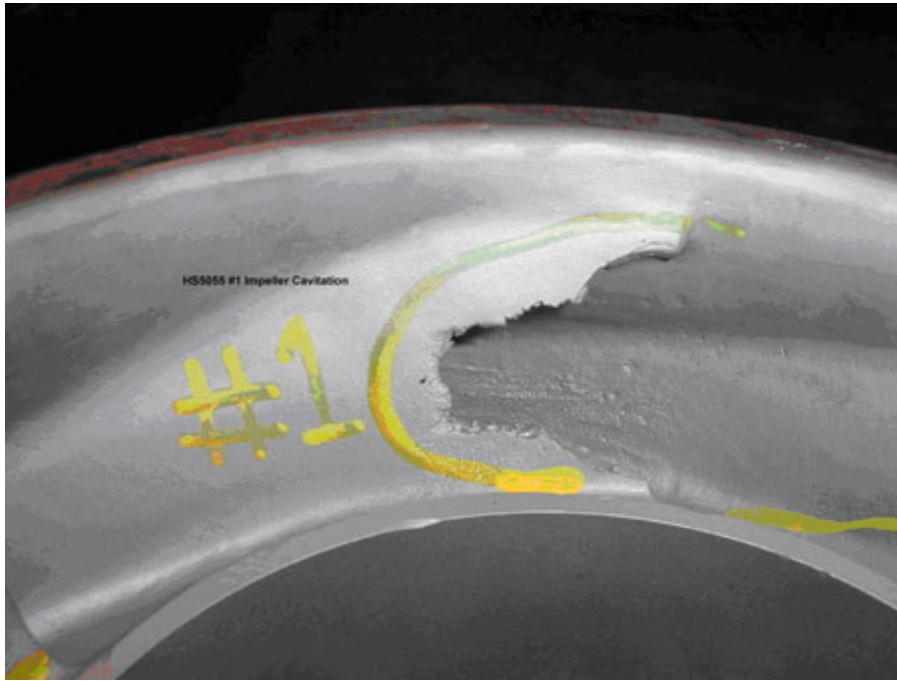
3. A close look at the eroded suction impeller indicated the signature of suction cavitation erosion. Since this damage was present in every pump, insufficient NSPHA/NPSHR ratios were suspected. This varied from 1.0 to 2.6 depending on operating speed and flow. The lowest ratio occurs at the highest capacity near the BEP. (For high energy pumps, according to Hydraulic Institute, this ratio should be at least 2.0 to minimize erosion damage due to cavitation).

Figure 3. Results of cavitation on the 1st stage impeller.

The low NPSH ratio results in an impeller life of 2.7 years and explains why the suction impellers have been repaired or replaced every two years. According to the plant, little could be done on NPSHA, so changing suction impeller design was the recommended option. Design parameters were agreed upon and the goal was set to increase the operating life of suction impellers to 40,000 hours, or 4.5 years. By varying the suction inlet and vane inlet geometries, several suction impeller designs were studied and

1. Correct the sealing gaps to the acceptable limit.
2. Replace five-vane impellers with a new seven-vane design.
3. Replace existing suction impeller with a new one designed for better suction behavior and aimed to increase its operational life.

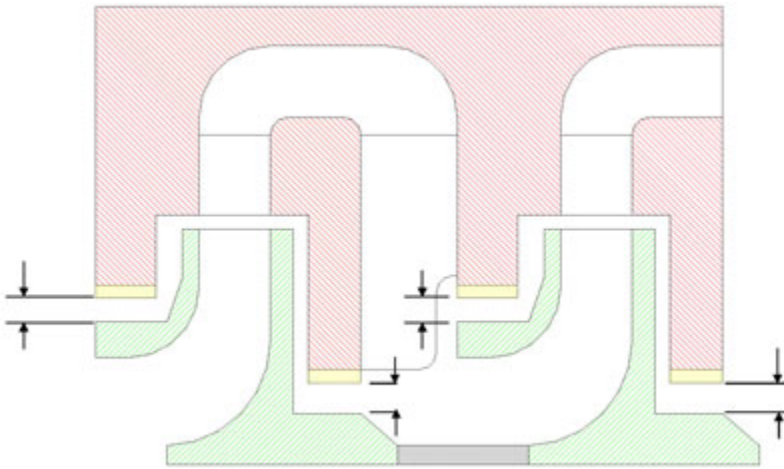
1. The impeller and balancing drum sealing gaps during operation were increased due to vibration. The effect of increased sealing gap meant increasing leakage flow, thereby reducing pump efficiency by an estimated 3.2 percent and reducing damping effect of sealing gaps and decreasing natural frequency of the rotor, which may lead to reducing the margin of critical speed.

Figure 4. Though the radial alignment was good, excessive clearances which existed needed to be reduced. Large clearances result in low efficiency and high operating costs.
