When Maintenance of a Condensate Pump Becomes an Emergency

In this case study, routine maintenance of a condensate pump at a nuclear power plant becomes an emergency situation.

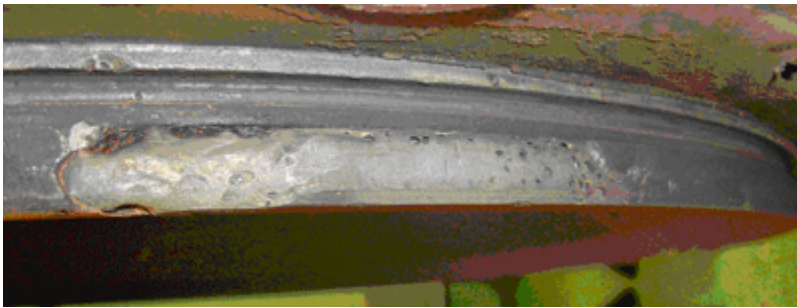
Best practice is to maintain stringent alignment and concentricity between interfacing parts. This ensures correct concentricity and perpendicularity between shaft and bearings and rotor to casing. The service center discovered that the top bowl male fit had been previously repaired by pad welding (see Figure 1), which is an improper practice due to the presence of a sealing O-ring. When a pad weld is performed on a pump that uses the O-ring design, fits and tolerances no longer meet acceptance criteria. It appears that the previous repair provider coated the faces with silicone or another sealant in an attempt to re-establish the proper fits or control leakage (see Figure 2).

Figure 1. Pad welded male fit for the top bowl.

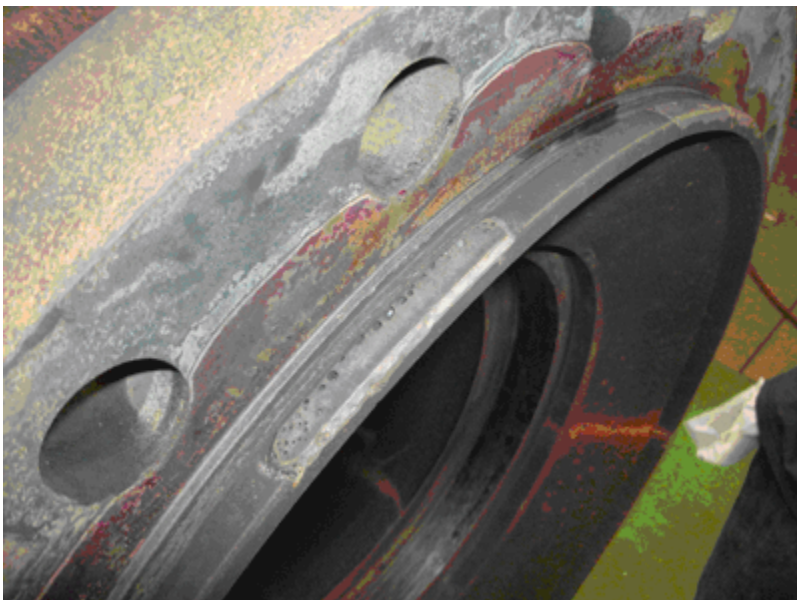
Figure 2. Silicone coating appears to have been

used in a previous repair after the male fits were pad welded in an attempt to seal the proper fit between the top bowl and the discharge head.

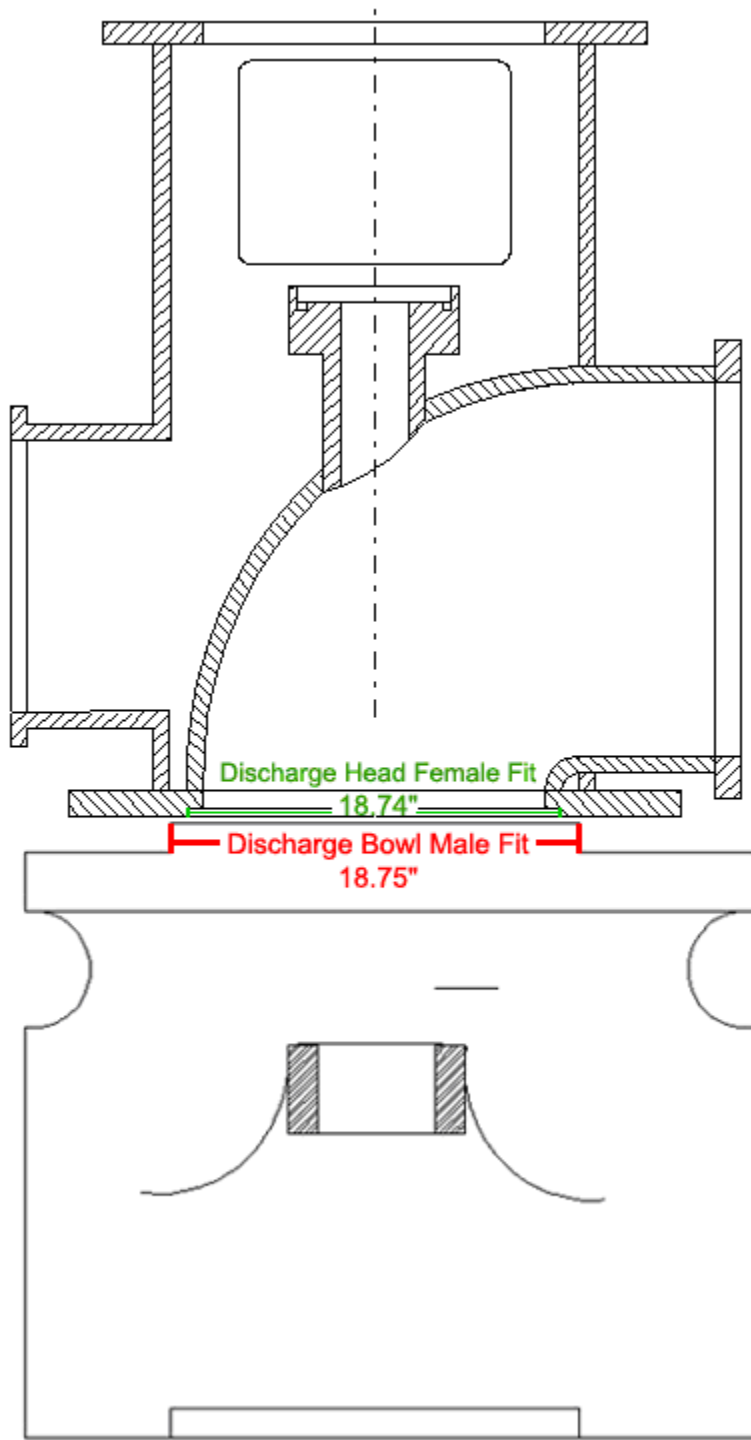
The top of the discharge bowl did not fit properly in the bottom of the discharge head (see Figure 3). Excessive force used to make these components fit bent the shaft and created a condition ripe for fatigue failure. The forced bending of the shaft caused the impeller ring to contact the case (bowl) ring during operation (see Figures 5 and 6). The motor had to produce more torque to drive the assembly due to frictional resistance from the heavy rub (see Figure 7). Furthermore, the suction bell was not properly seated in the alignment ring (see Figure 8).

The misalignment and excessive bending load on the entire rotating element assembly caused the shaft to break at the snap ring groove, which resulted in catastrophic pump failure.

Figure 3. The male fit of the top discharge bowl was over size at 18.754 in. and the female fit of the discharge head was 18.7445 in., causing an interference fit (Exaggerated diagram, not to scale).

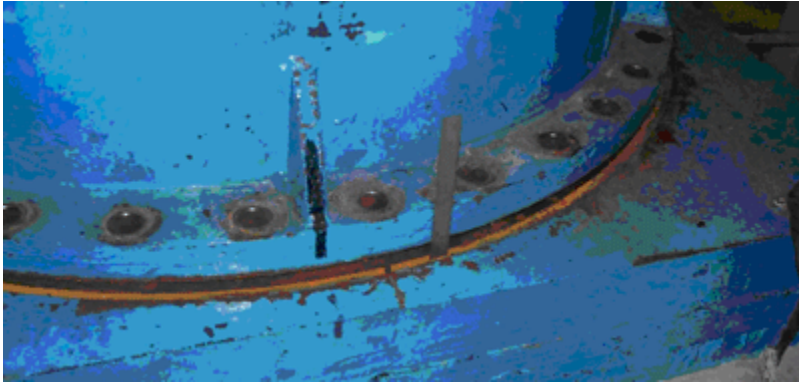
Figure 4. The bolts between the can flange and the discharge head appear to have been tightened with additional force as one section of the flange rose up about $\frac{3}{4}$ in. on one side after the discharge flange was unbolted from the base-plate.

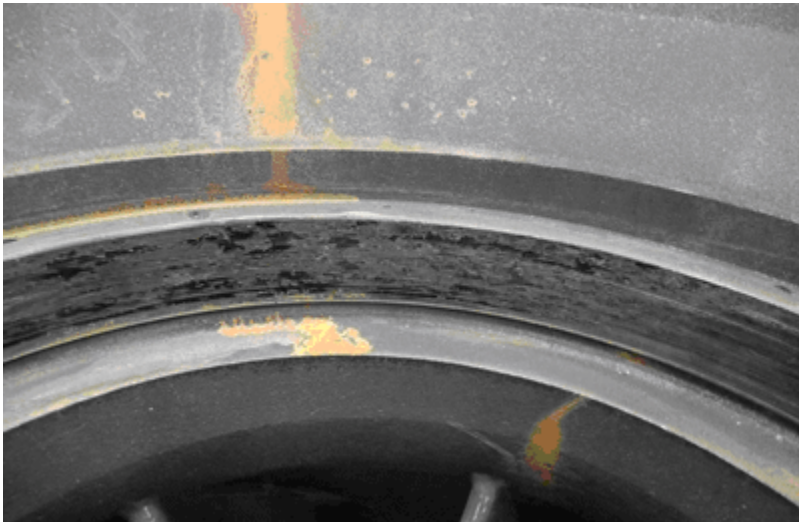
Figure 6. Heavy grooving from running stage impeller eye ring.

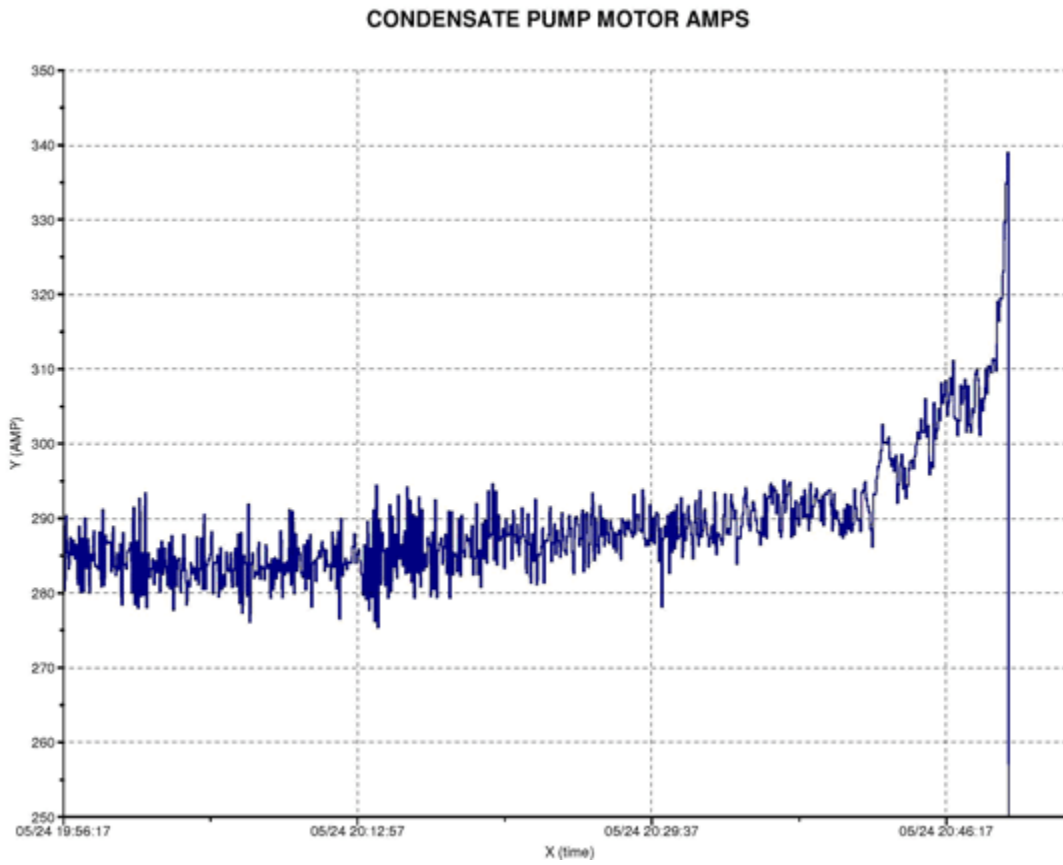
Figure 7. The high amps reading at pump failure show motor torque.

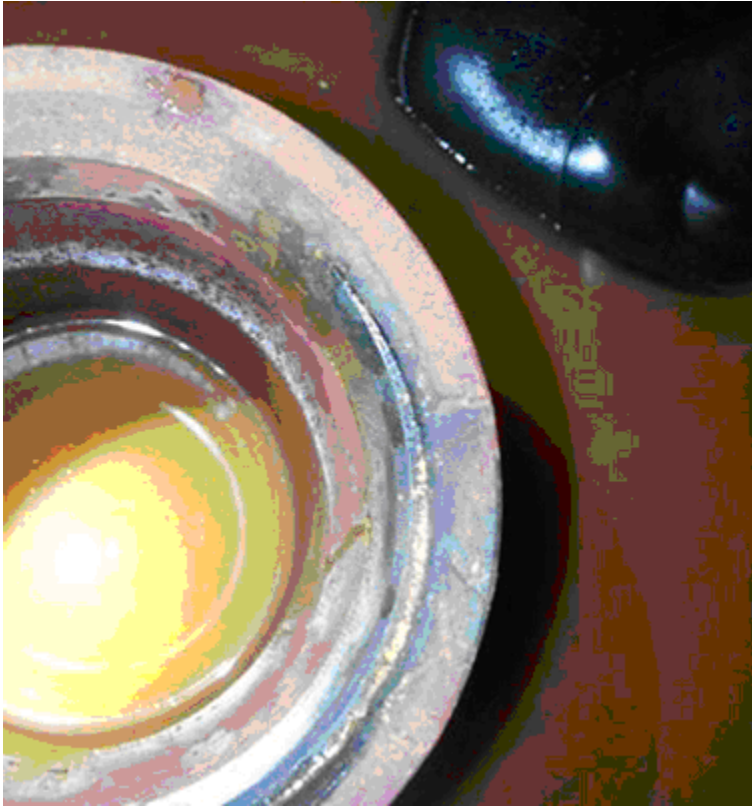
Figure 8. The alignment ring at the bottom has a damaged edge, which is evidence that the suction bell was not properly seated in the alignment ring.
