Impeller Failure Solution at a Vietnamese Power Plant

Written by: Kwa Soo Teck, Phu My 3 Power Station (Vietnam), & Chandra Verma, Hydro Australia

Publisher: Pumps & Systems / September, 2011

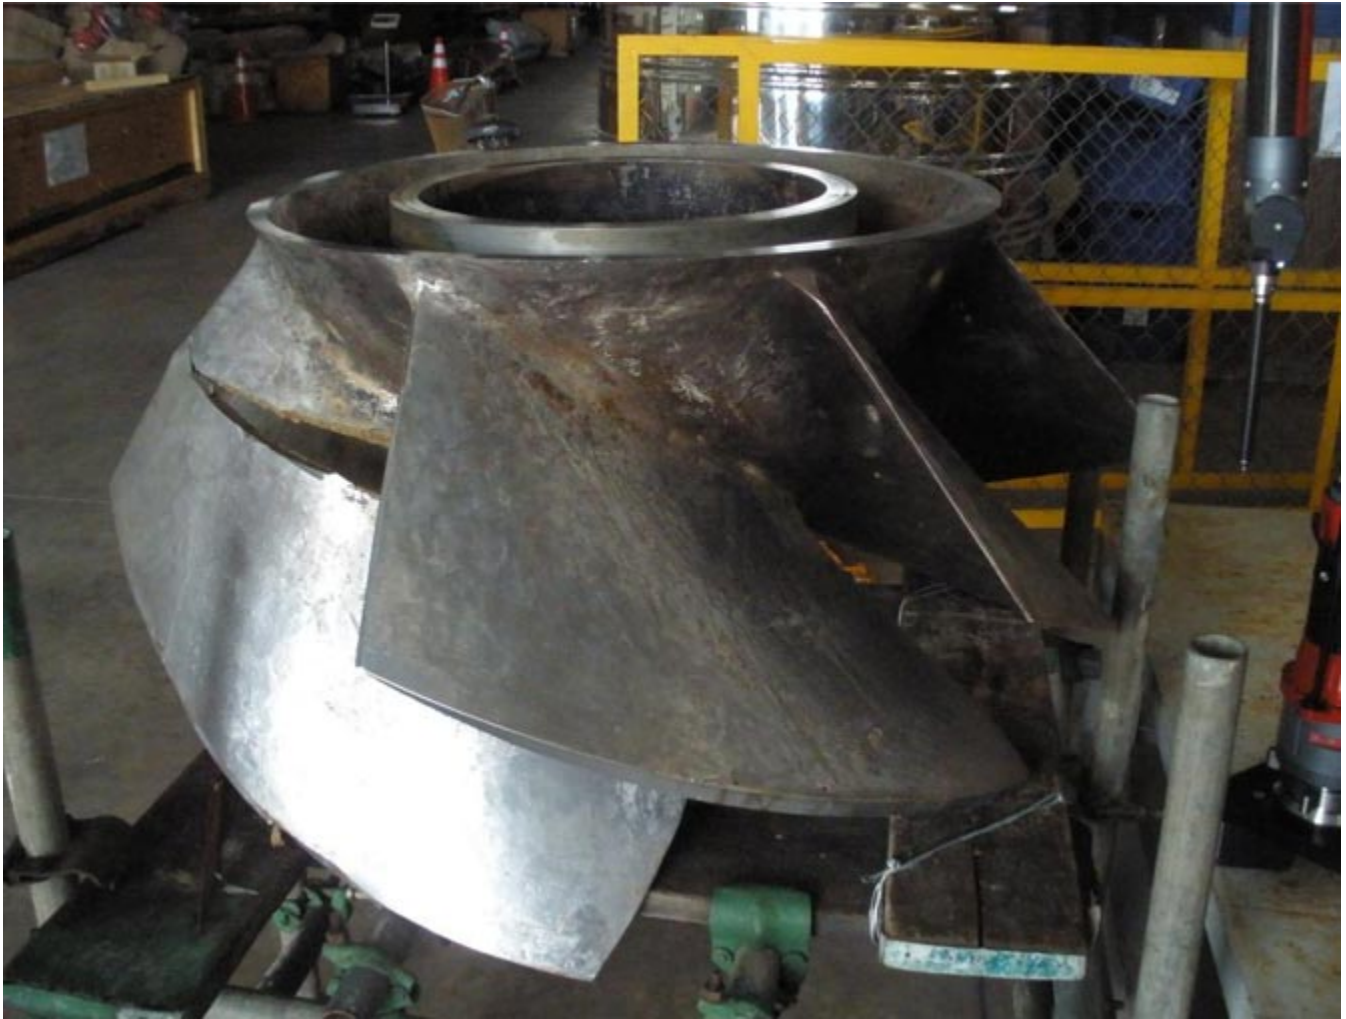
On viewing the damaged impellers, which weigh 850 kilograms, it was obvious the quality was poor. The first step in the process was to send over an engineer with a Romer Arm, a 3D coordinate measuring instrument, to reverse engineer the impeller. This data could be used to analyse the existing impeller design.

On returning home to Australia with all the information, the engineer proceeded to produce a 3D model in Solidworks. A detailed study was then carried out in conjunction with the foundry to analyze the root cause of the present defect. It was discovered through foundry simulation modeling that the crack in the impeller was due to shrinkage in the blade root due to insufficient feeding. The solution offered was to modify the impeller hub and cone thickness internally to improve the feeding without affecting the original hydraulic profile. The improved design was subjected to a simulation package to confirm the casting soundness.
