Impeller Failure Solution at a Vietnamese Power Plant

Written by: Kwa Soo Teck, Phu My 3 Power Station (Vietnam), & Chandra Verma, Hydro Australia

Publisher: Pumps & Systems / September, 2011

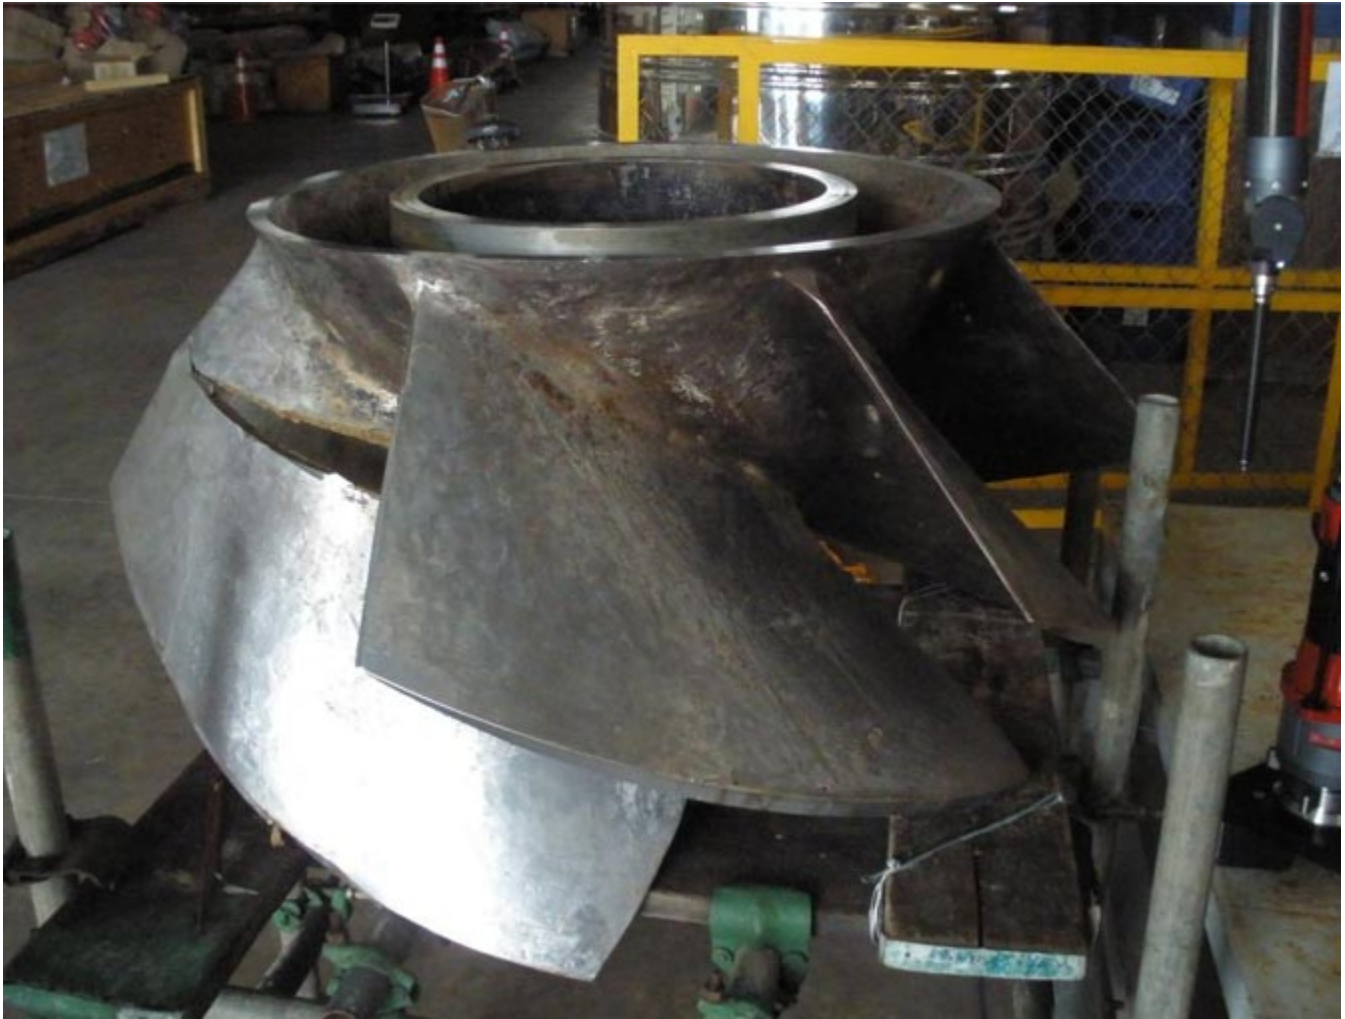
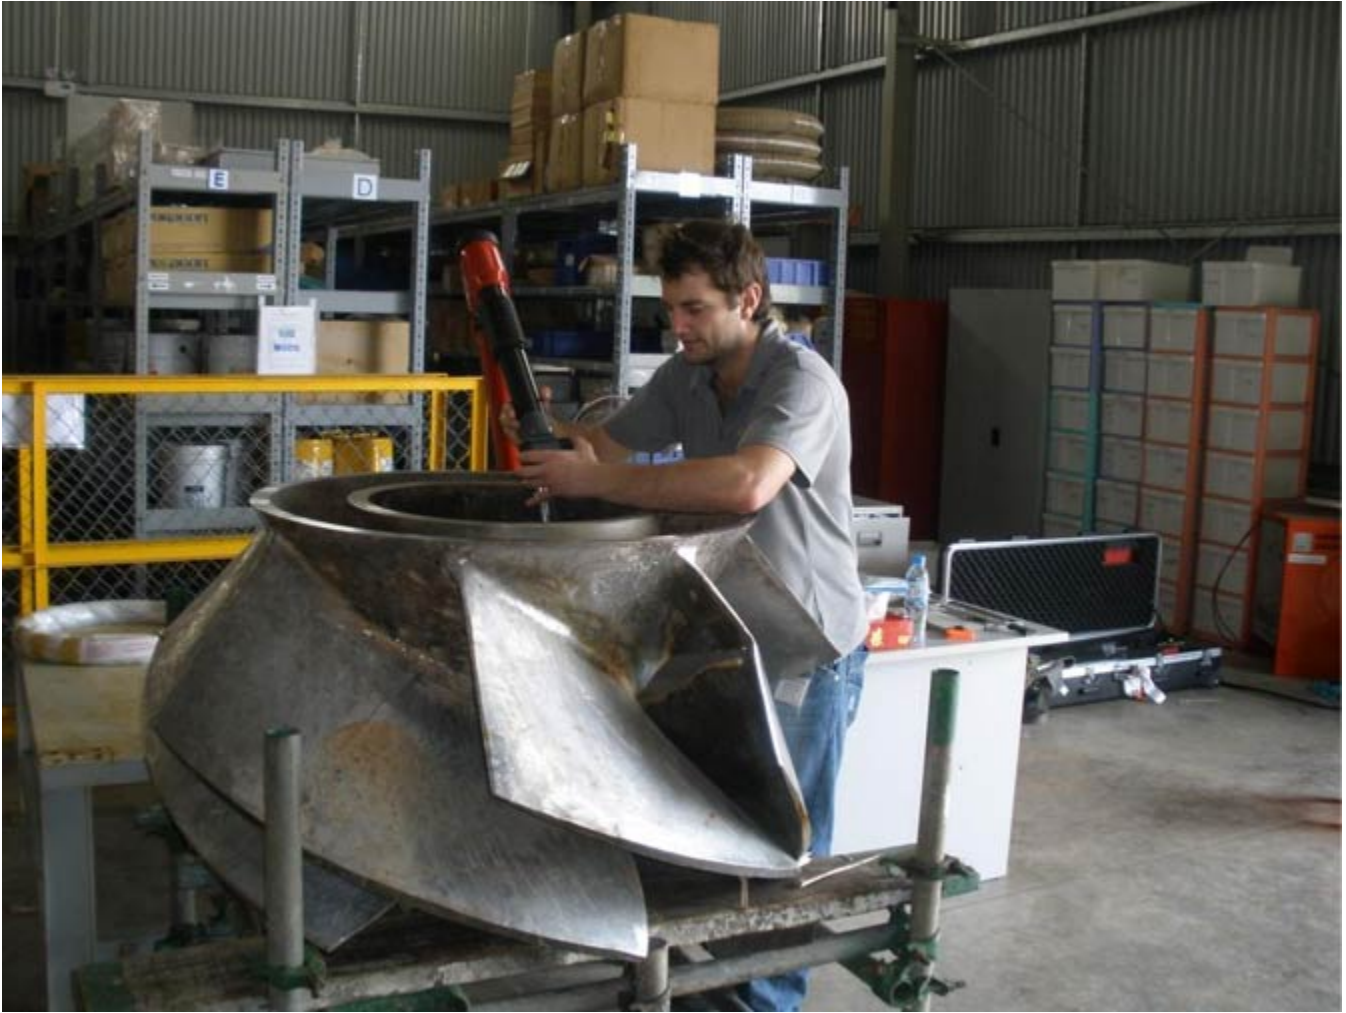
On viewing the damaged impellers, which weigh 850 kilograms, it was obvious the quality was poor. The first step in the process was to send over an engineer with a Romer Arm, a 3D coordinate measuring instrument, to reverse engineer the impeller. This data could be used to analyse the existing impeller design.

On returning home to Australia with all the information, the engineer proceeded to produce a 3D model in Solidworks. A detailed study was then carried out in conjunction with the foundry to analyze the root cause of the present defect. It was discovered through foundry simulation modeling that the crack in the impeller was due to shrinkage in the blade root due to insufficient feeding. The solution offered was to modify the impeller hub and cone thickness internally to improve the feeding without affecting the original hydraulic profile. The improved design was subjected to a simulation package to confirm the casting soundness.
