Repair is an Opportunity to Improve Pump Performance

Written by: Bob Bluse, Hydro East Inc.

Publisher: Pumps & Systems / February, 2012

This article highlights the opportunity seized by a coal-fired power station to upgrade a Westinghouse Vertical Pump during the repair process.

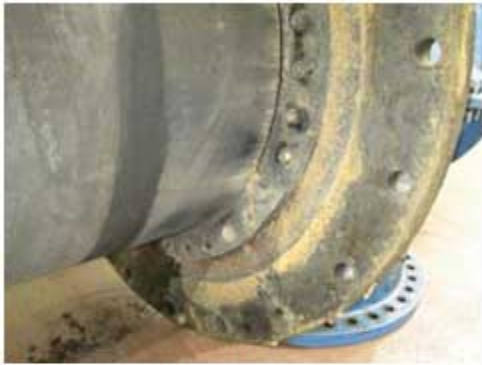
The general condition of the Bravo pump when received at the repair facility was much worse than anticipated with the top column flange broken about half way around. The entire pump had been hanging from this broken joint leaving a gap of $\frac{1}{4}$ " to $\frac{1}{2}$ " at the opening. The keyed coupling (internal to the pump) used to join its two shafts was broken in several pieces, the shaft journals were severely worn to one side and the impeller vanes & suction bell liner surface were also severely worn as expected, considering the significant pump damage.

Column pipe upper flange as-received

- The column pipe repair included replacing the entire upper flange, adding reinforcing gussets to the flanges on both ends, excavating defective flange & pipe seams and full-welding to restore integrity and improve overall strength.

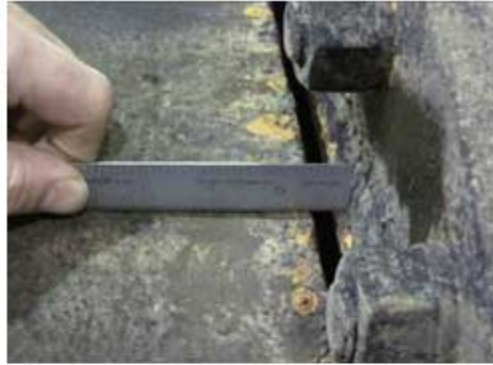
Close-up of the broken pipe

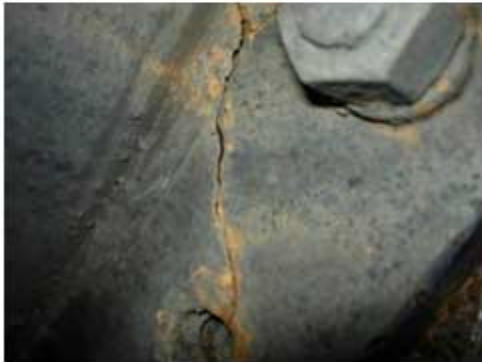
Close-up of the broken pipe flange

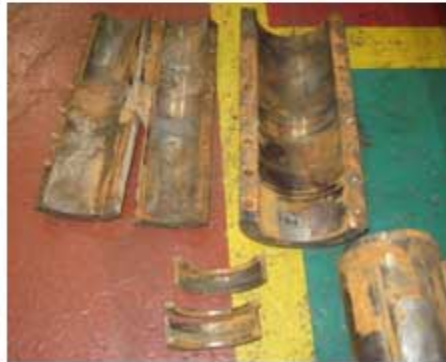
Destroyed shaft coupling and hardware

- The repair plan required the replacement of both shafts, which presented another opportunity. The service center upgraded the shafts by manufacturing them in a stronger, more durable material for the pump's application. The service center also manufactured a new coupling assembly to include an upgraded coupling design in addition to new shaft coupling hardware. The upgrades to the shafts included maintaining full size shaft diameter through the coupling assembly (the existing shafts were turned-down) and machining proper radii into all corners and keyways. The shaft coupling upgraded design consisted of a larger coupling outside diameter, heavier thrust rings (instead of the existing thin-walled clam-shell type), improved bolting and two keys 180 deg. apart on opposite ends for balance & strength.

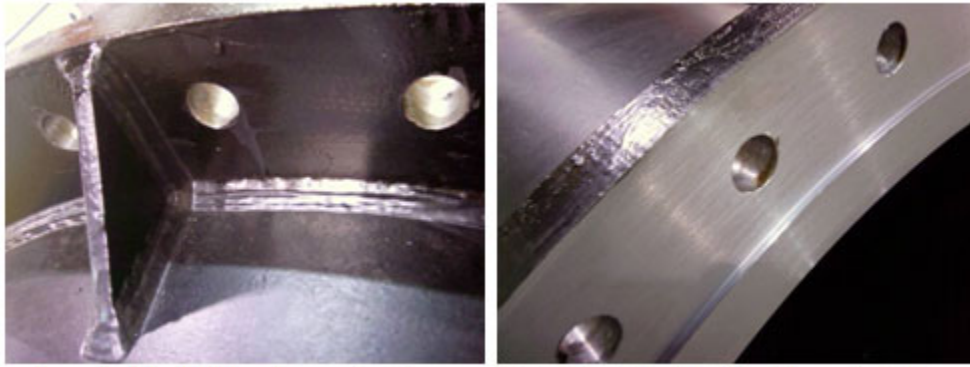
Gusset added to the column pipe flanges Typical register fits added throughout the pump

- Register fits were machined into each component as part of the repair process with minimum clearance to assure proper alignment.
- The impeller vanes were reestablished to the proper length and also to consistent vane lengths. This was done instead of merely de-burring the worn edges to restore pump performance and also to eliminate hydraulic imbalance. It required an extensive amount of welding to the sealing surface of the vanes and precision machining of the impeller and suction bell for proper fit; this tolerance has a significant effect on the pump efficiency. NDE of the impeller during inspection revealed minor cracks, which were also repaired.

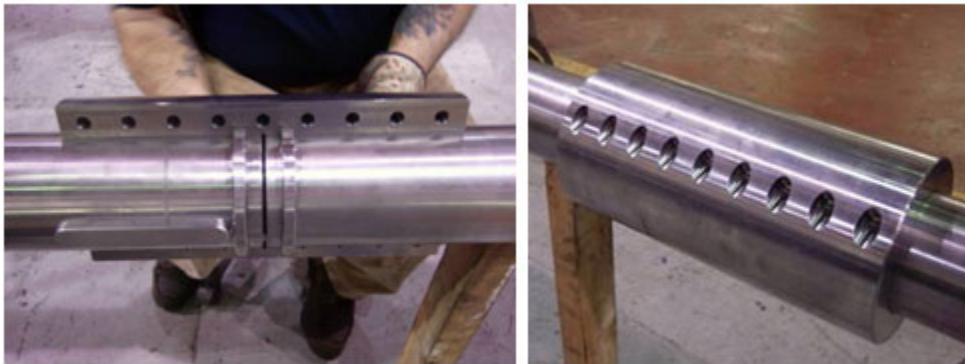
New shafts and shaft coupling components during and after assembly
