Repair is an Opportunity to Improve Pump Performance

Written by: Bob Bluse, Hydro East Inc.

Publisher: Pumps & Systems / February, 2012

This article highlights the opportunity seized by a coal-fired power station to upgrade a Westinghouse Vertical Pump during the repair process.

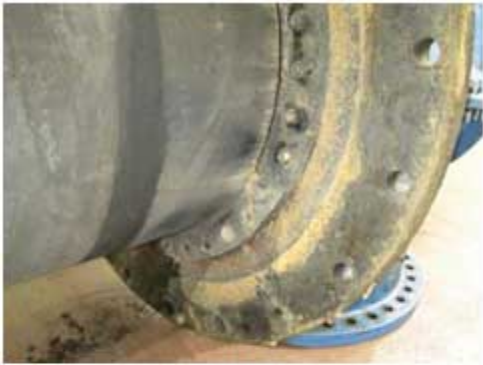
The general condition of the Bravo pump when received at the repair facility was much worse than anticipated with the top column flange broken about half way around. The entire pump had been hanging from this broken joint leaving a gap of $\frac{1}{4}$ " to $\frac{1}{2}$ " at the opening. The keyed coupling (internal to the pump) used to join its two shafts was broken in several pieces, the shaft journals were severely worn to one side and the impeller vanes & suction bell liner surface were also severely worn as expected, considering the significant pump damage.

Column pipe upper flange as-received

- The column pipe repair included replacing the entire upper flange, adding reinforcing gussets to the flanges on both ends, excavating defective flange & pipe seams and full-welding to restore integrity and improve overall strength.

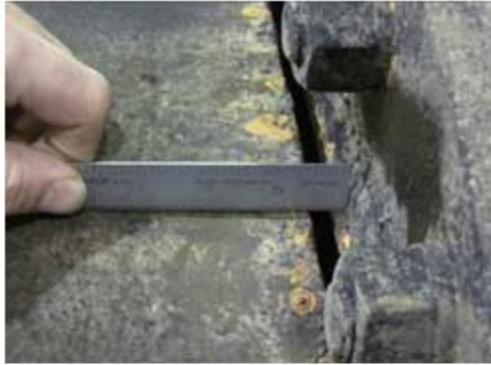
Close-up of the broken pipe

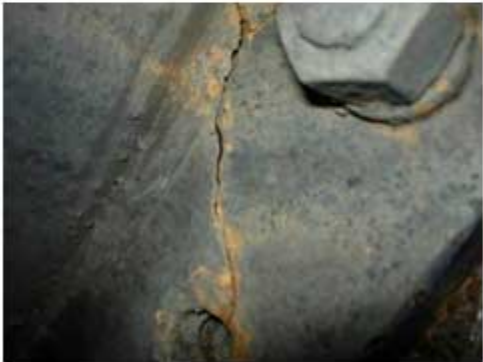
Close-up of the broken pipe flange

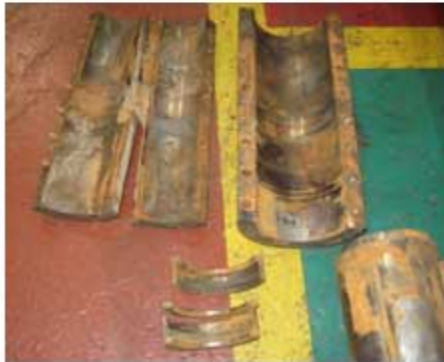
Destroyed shaft coupling and hardware

- The repair plan required the replacement of both shafts, which presented another opportunity. The service center upgraded the shafts by manufacturing them in a stronger, more durable material for the pump's application. The service center also manufactured a new coupling assembly to include an upgraded coupling design in addition to new shaft coupling hardware. The upgrades to the shafts included maintaining full size shaft diameter through the coupling assembly (the existing shafts were turned-down) and machining proper radii into all corners and keyways. The shaft coupling upgraded design consisted of a larger coupling outside diameter, heavier thrust rings (instead of the existing thin-walled clam-shell type), improved bolting and two keys 180 deg. apart on opposite ends for balance & strength.
