Benefit from Experienced Field Service Professionals

Written by: John Neely, General Manager, HydroAire Field Service

Publisher: Pumps & Systems / May, 2012

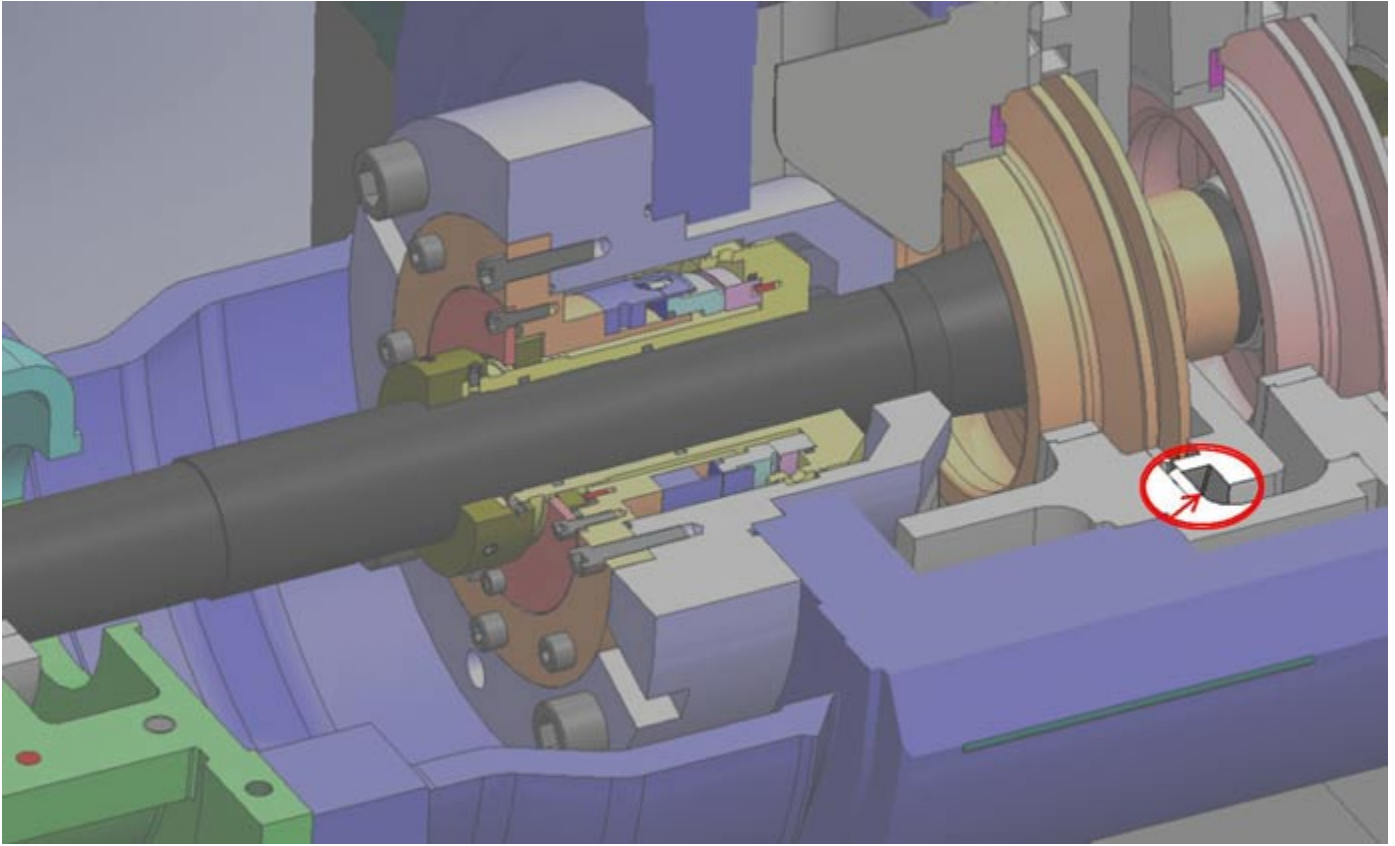
A nuclear power plant required field service support for their high energy multi-stage diffuser barrel pump when a feeler gage became lodged inside the pump element. The station had been experiencing a problem with a lube oil pump and the decision was made to flush the lube oil lines. During this process, the plant's maintenance team recognized that the charge pump's inboard pump bearing housing dowels had been bent and the rotor was not properly centered on the inboard end. As Murphy's Law dictates, "anything that can go wrong, will go wrong". While the rotor was being centered, a feeler gauge that had been left in the element broke off and became stuck in the inboard end at the first-stage wear ring between the inboard impeller shroud and cover wall.

The rotor had shuttled and rotated a considerable amount during the original attempt to remove the broken remnant. The station contacted a reliable pump aftermarket service provider who had a highly-skilled field service team with the knowledge and experience to provide support. The station wanted to get this pump back online quickly and asked the field service team to work around the clock to retrieve the broken material and complete the pump assembly. The field service team collaborated with the station's maintenance team to resolve the issues and get the pump back into service.

A bore scope was used to confirm the piece could not be easily extracted without removing the element. The Technical Field Advisor submitted to the station an Element Removal and Installation Procedure which defined the steps for retrieving the broken feeler gage and properly installing the element back into the barrel. Upon approval of the procedure, day and night shifts were scheduled to resolve the issues.

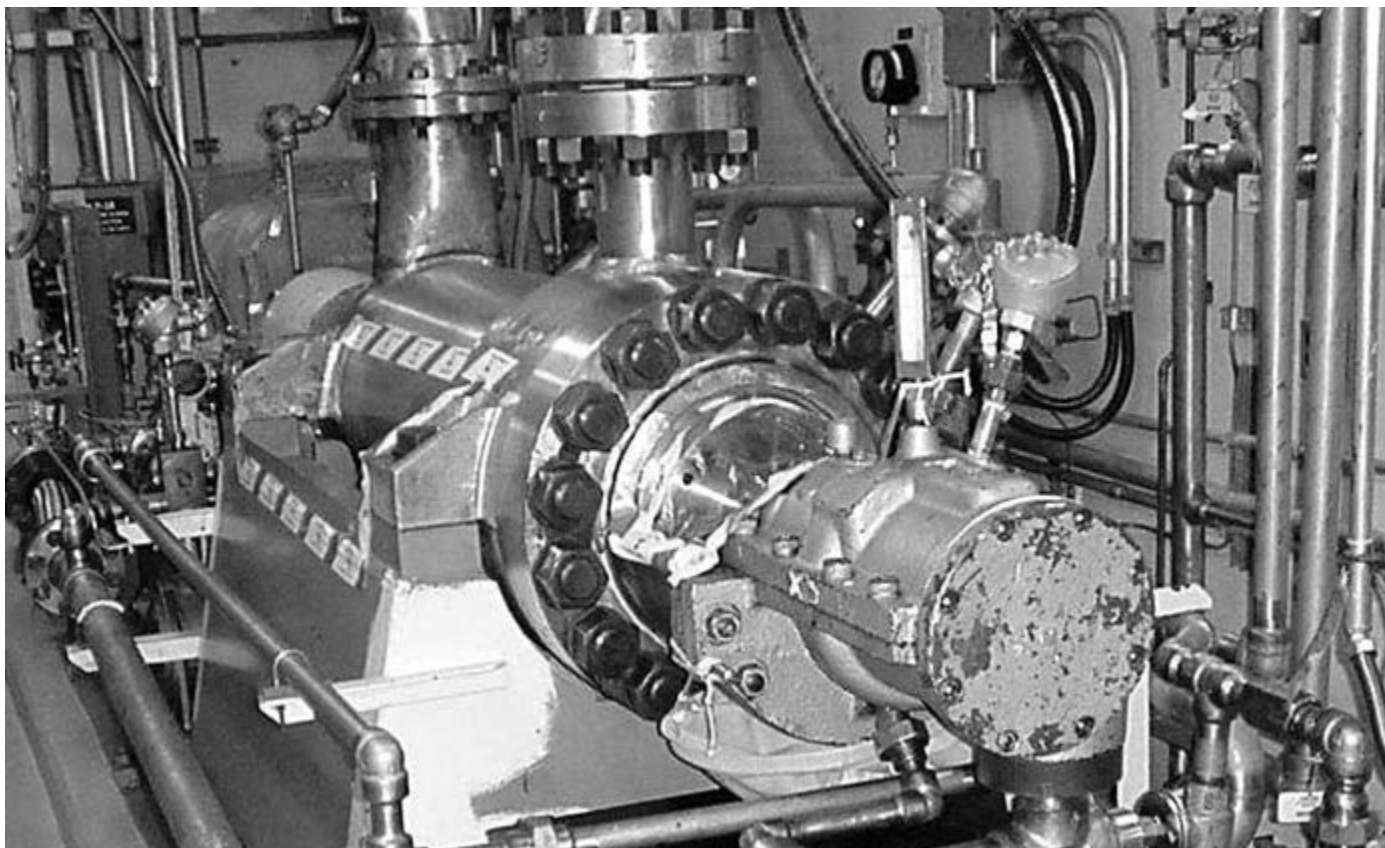
the suction spacer. The suction spacer was a clearance fit to the intermediate cover, so heating was not required. The suction spacer was removed and the remnant was located in the diffuser vane. The remnant had made it past the impeller shroud to the diffuser vane as a result of shuttling and turning the rotor during initial removal attempts. Once dislodged, the maintenance teams agreed the geometry of the broken piece matched the end of the original feeler gage and everyone was confident there were no additional pieces left inside the element.

After masking for foreign material exclusion (FME), the first-stage impeller wear surface was polished in areas exhibiting localized galling which had been a result of normal wear and tear. The suction spacer, rail key, and rail key cap screws were reinstalled and the element was rotated so as to position the rail key back to the six o'clock position. Following FME inspection of the barrel, the Field Service team utilized the even pressure and positioning advantage of the discharge head to set the element into its register fit. Once the element was installed back into the barrel, the lube oil flush could be completed. The Field Service Technical Advisor assisted the station with the lube oil flush procedure.
