# Benefit from Experienced Field Service Professionals

**Written by:** John Neely, General Manager, HydroAire Field Service

**Publisher:** Pumps & Systems / May, 2012

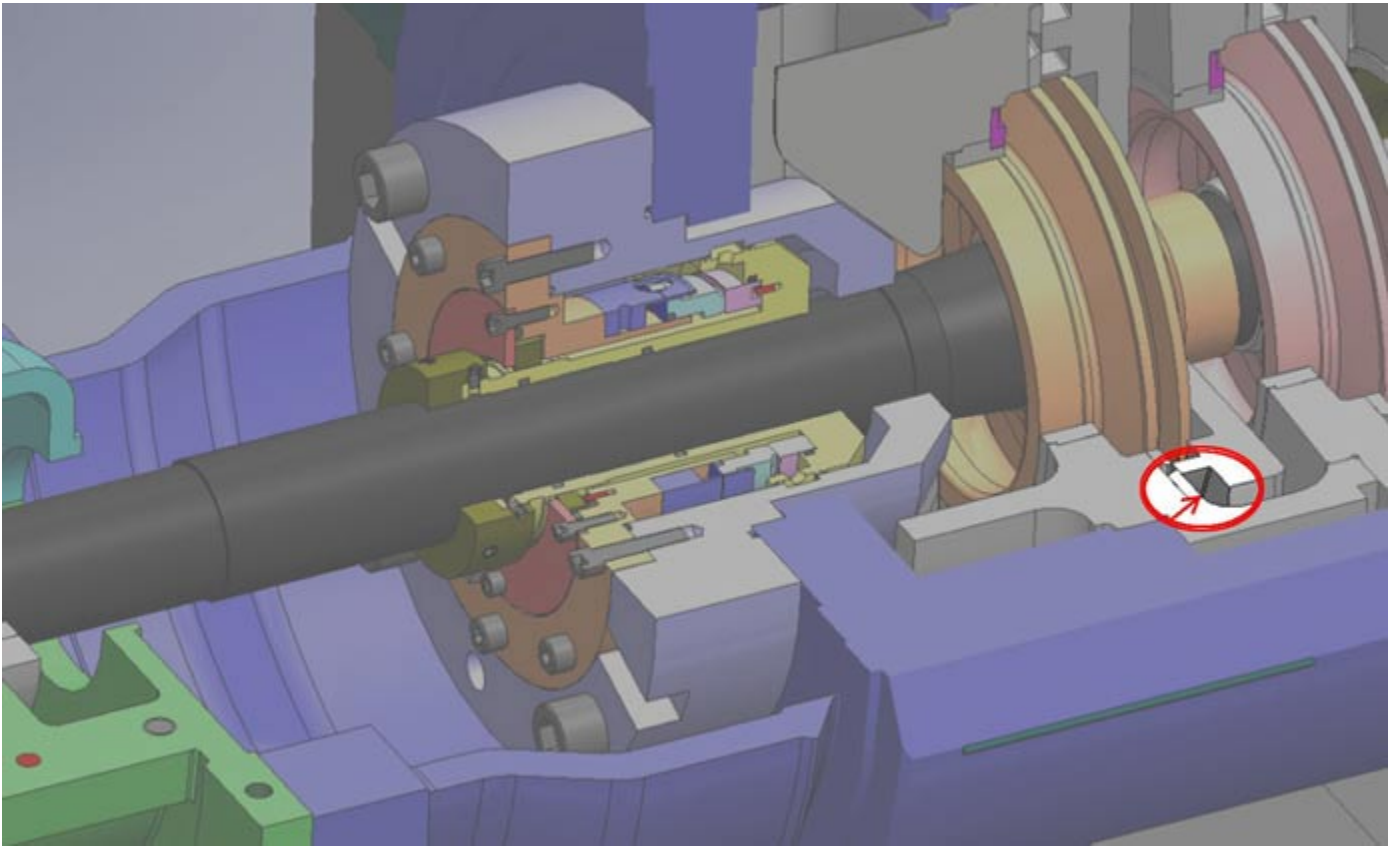
A nuclear power plant required field service support for their high energy multi-stage diffuser barrel pump when a feeler gage became lodged inside the pump element. The station had been experiencing a problem with a lube oil pump and the decision was made to flush the lube oil lines. During this process, the plant's maintenance team recognized that the charge pump's inboard pump bearing housing dowels had been bent and the rotor was not properly centered on the inboard end. As Murphy's Law dictates, "anything that can go wrong, will go wrong". While the rotor was being centered, a feeler gauge that had been left in the element broke off and became stuck in the inboard end at the first-stage wear ring between the inboard impeller shroud and cover wall.
