# Close Inspection Solves High Thrust Bearing Temperature Problem

**Careful analysis identified the issue with this multistage, oil transfer pump.**

**Written by:** Gary Dyson (Hydro, Inc.)

**Publisher:** Pumps & Systems / August 2014

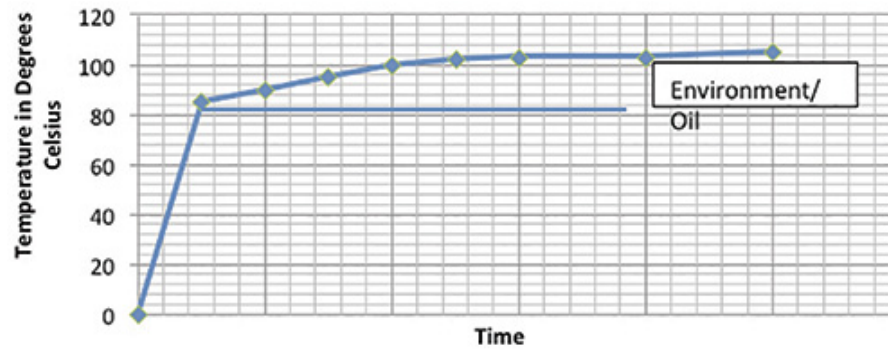
The behavior of thrust bearing pads during startup is seldom investigated. The temperature rise of the pads can be attributed to two distinct causes—thrust developed during startup and environmental and oil conditions (see Figure 1).

The significant finding from this data was the temperature rise associated with thrust. The pump could not achieve the temperatures measured prior to maintenance in its current condition. The total thrust bearing temperature includes the oil temperature and environmental conditions. Based on comparisons with previous site data, both the thrust and oil cooling had altered. Analysis of the temperature data at the motor bearings, which were experiencing oil temperature increases of 10 to 15 C, further supported the conclusion.
