# Close Inspection Solves High Thrust Bearing Temperature Problem

**Careful analysis identified the issue with this multistage, oil transfer pump.**

**Written by:** Gary Dyson (Hydro, Inc.)

**Publisher:** Pumps & Systems / August 2014

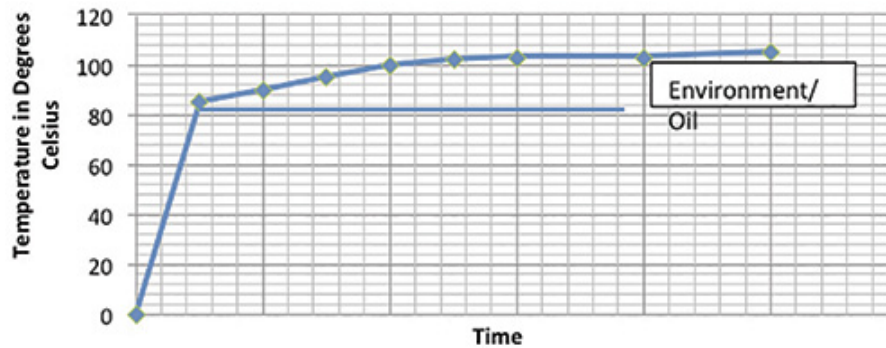
The behavior of thrust bearing pads during startup is seldom investigated. The temperature rise of the pads can be attributed to two distinct causes—thrust developed during startup and environmental and oil conditions (see Figure 1).

The significant finding from this data was the temperature rise associated with thrust. The pump could not achieve the temperatures measured prior to maintenance in its current condition. The total thrust bearing temperature includes the oil temperature and environmental conditions.

Based on comparisons with previous site data, both the thrust and oil cooling had altered. Analysis of the temperature data at the motor bearings, which were experiencing oil temperature increases of 10 to 15 C, further supported the conclusion.

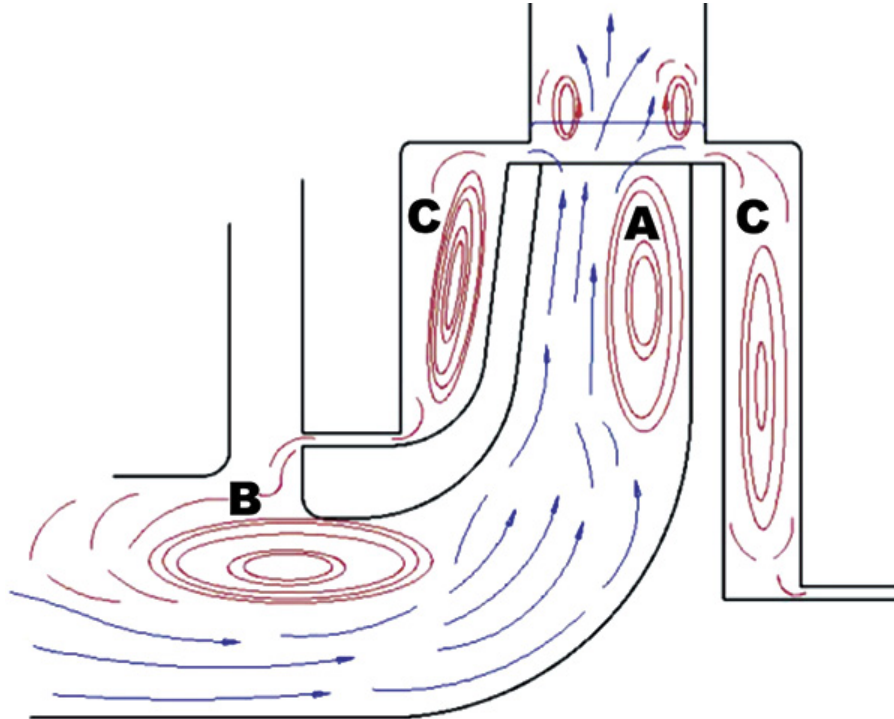
Traditionally, this flow regime interaction has been illustrated as in Figure 2 in the meridional plane. Although this image is helpful in understanding the flow physics, the true picture is far more complex.

The meridional view clearly depicts these two unstable flow interactions with the vortex that exists within the gap between the channel ring and impeller shroud (see Point C in Figure 2).

This vortex accounts for the developed thrust within this pocket. Any disruption to this vortex leads to a more unpredictable thrust regime.

The centralization effect of the rotor within this channel influences both the development and speed of this vortex. The space available for the vortex is either increased or decreased so boundary layer effects begin to dominate.

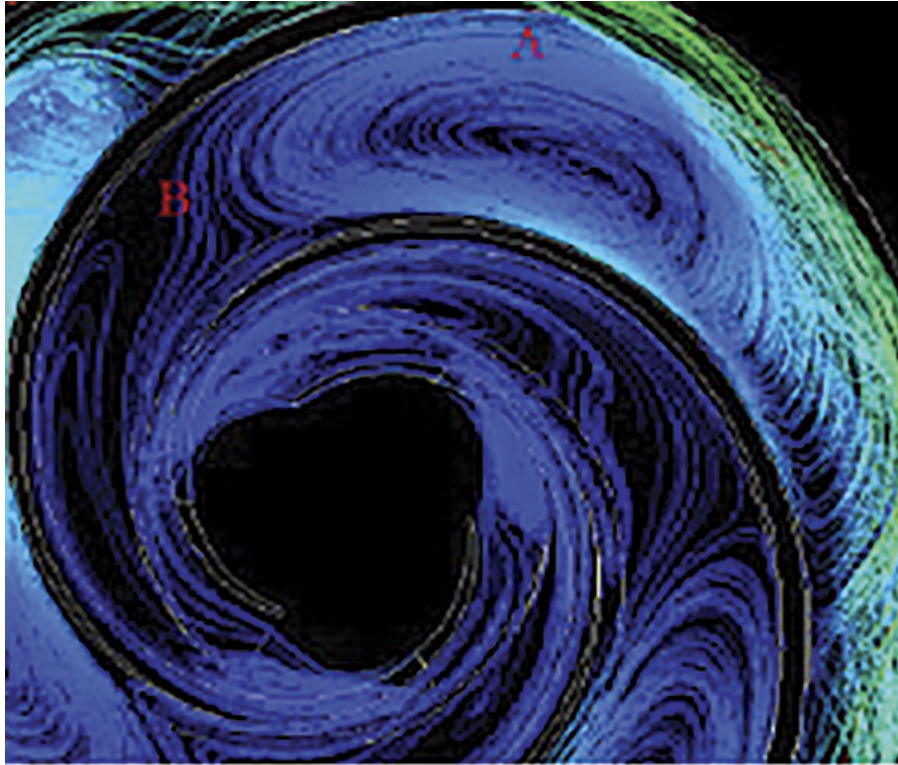
Figure 3 illustrates the complex nature of the flow that develops within the impeller when the pump operates at extreme part load. Point A illustrates the development of a discharge vortex that commences on the hub at the impeller discharge.

Point B illustrates the boundary of this interaction with the inlet backflow recirculation within the impeller eye. This inlet backflow recirculation is also illustrated in detail in Figure 4.

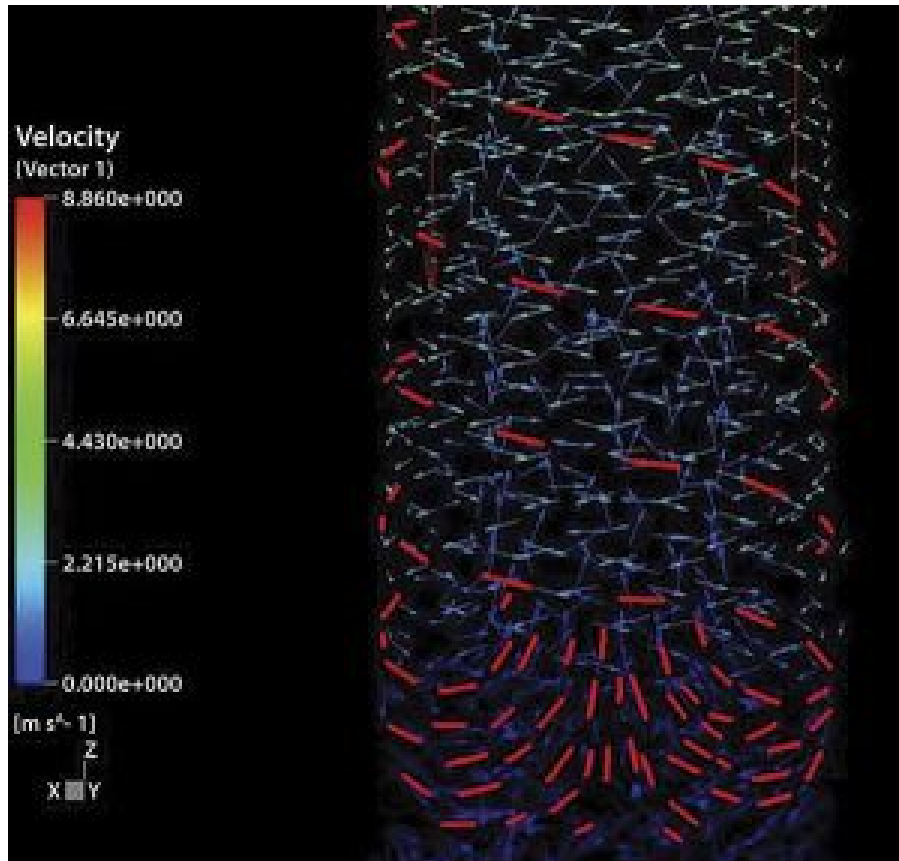
At partial capacity, the flow exits the impeller eye at the hub inlet angle and spirals down the suction channel impinging on splitters of the previous stage.

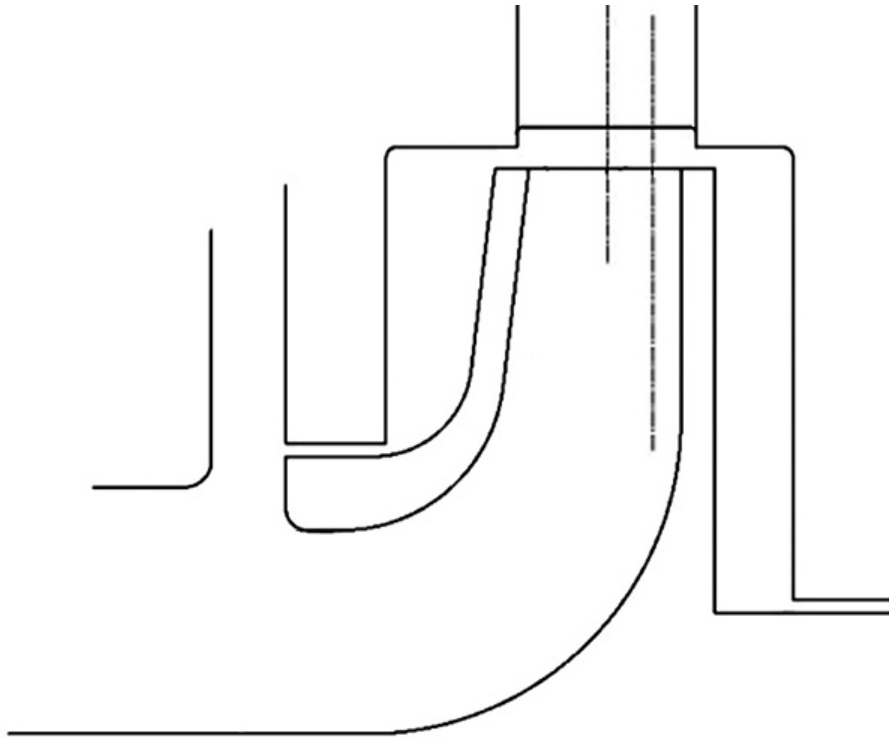
- Oil temperature correction: A thermostatic valve was disabled during pump removal. On commissioning, this valve was left in an inoperable position, which kept the oil from passing through the cooler. The engineering services company identified the problem and returned the valve to the appropriate setting.
- Rotor centralization: The rotor centralization had been adjusted to off-center by the original equipment manufacturer to limit the thrust on the outer pads (see Figure 5). The engineering

services company restored the rotor to the correct position relative to the diffuser, which put the thrust bearing temperature within an acceptable range.
