# How Root-Cause Analysis Solved a Vertical Turbine Pump Failure

**A comprehensive approach to reverse engineering helped to establish the differences between the stainless steel and original bronze impellers.**

**Written by:** Hydro, Inc.

**Publisher:** Pumps & Systems / March 2016

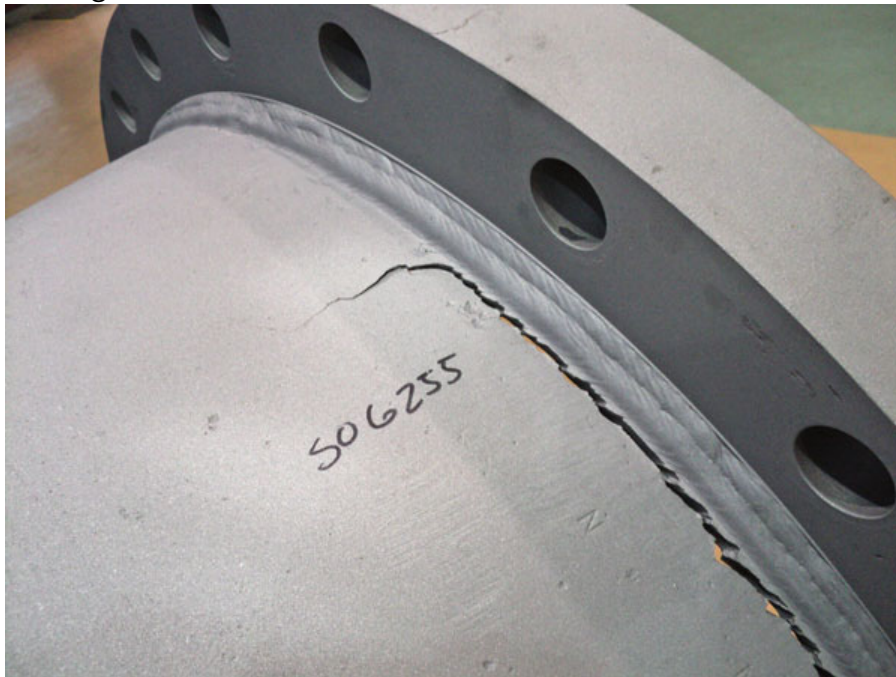
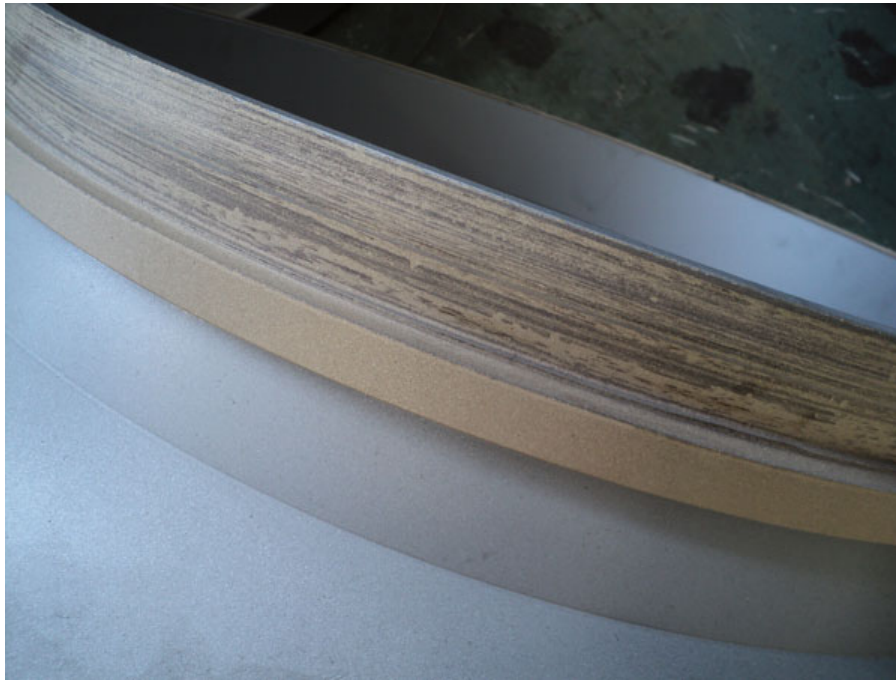
The equipment in question consisted of three-stage vertical turbine pumps running either in standalone or in [parallel](#) operation as required. The failure manifested itself through high vibration and caused severe scoring of the pump shaft and wear ring landings, leading to fatigue failure of the weld on the discharge head flange (see Images 1 and 2). The commissioned pump was refurbished and rebuilt by another company's service center with spare impellers supplied by an original equipment manufacturer. No changes to the geometry had reportedly been made, although the impeller material had been upgraded from bronze to stainless steel.

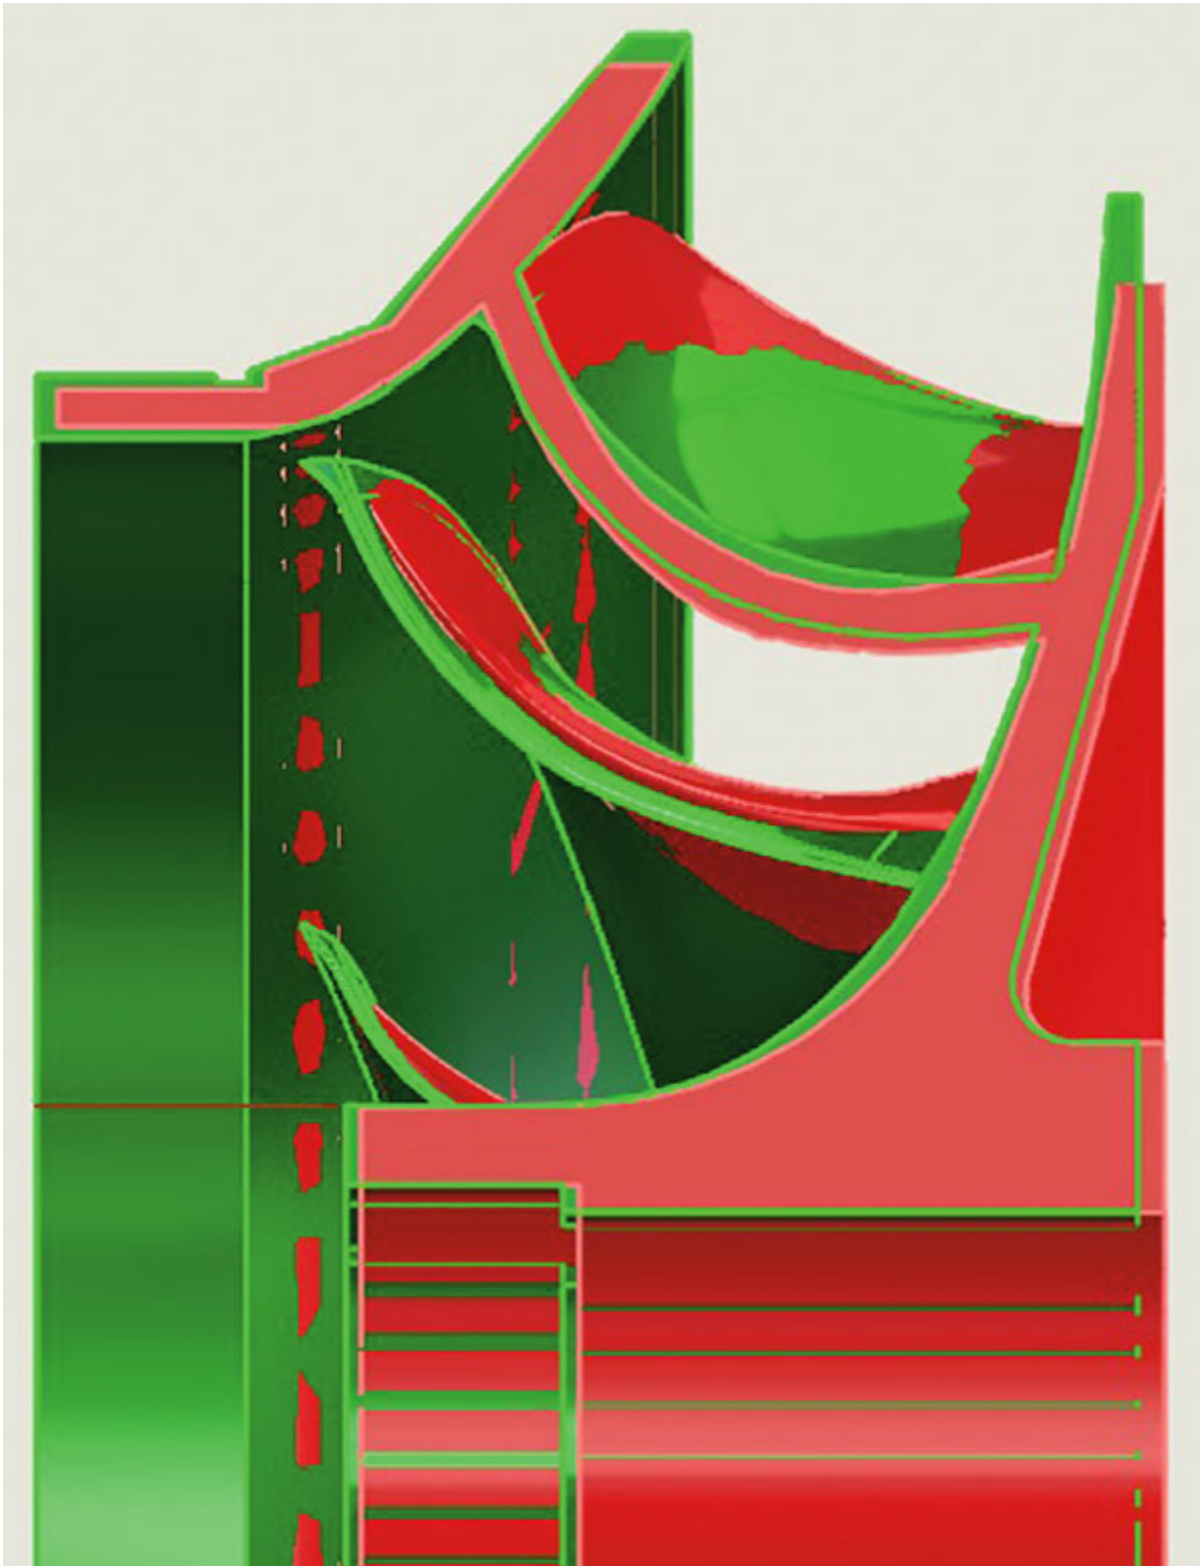
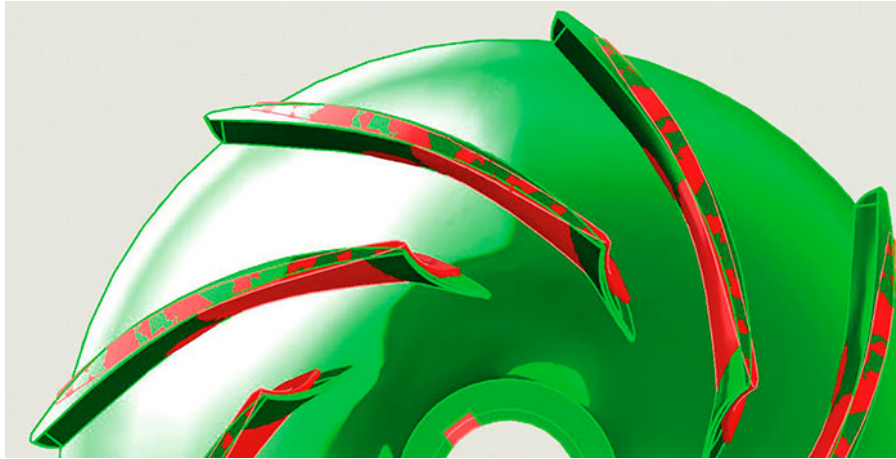
Using a comprehensive approach to impeller reverse engineering, experts established the differences between the stainless steel and the original bronze impellers. Significant differences in the vane shape and at the vane exit and inlet (at the impeller eye) raised concerns about the impeller geometry (see Figures 2 and 3).

The discharge vanes at the impeller outlet were considerably different, causing the discrepancy in head and curve shape.

The inlet angles and geometry of the impeller inlets also showed significant deviations from the original design—meaning consequences for the machine's net positive suction head required ([NPSHR](#)).

Based on the geometry differences at the impeller inlet, it was noted that the required minimum submergence level for the pump with the stainless steel impellers might be relatively higher than the required minimum for the bronze impellers.

With this input, the plant reviewed the submergence data and confirmed the actual submergence level was at the minimum at the time of the pump failure. The minimum level for bronze impellers might not be sufficient for the stainless steel impellers, which could have compounded the problems of unstable operation and high vibrations.
