# How Root-Cause Analysis Solved a Vertical Turbine Pump Failure

**A comprehensive approach to reverse engineering helped to establish the differences between the stainless steel and original bronze impellers.**

**Written by:** Hydro, Inc.

**Publisher:** Pumps & Systems / March 2016

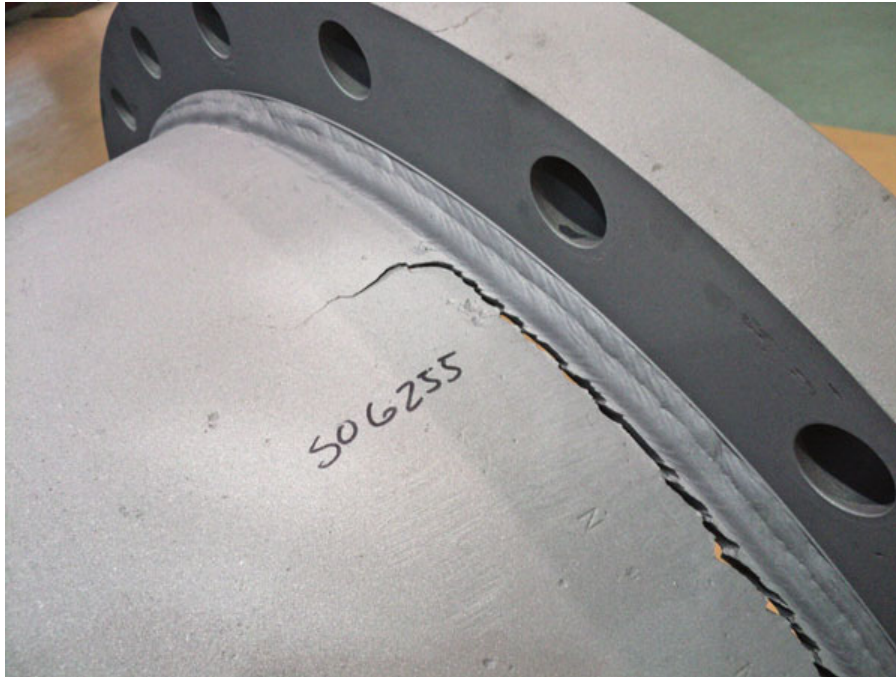
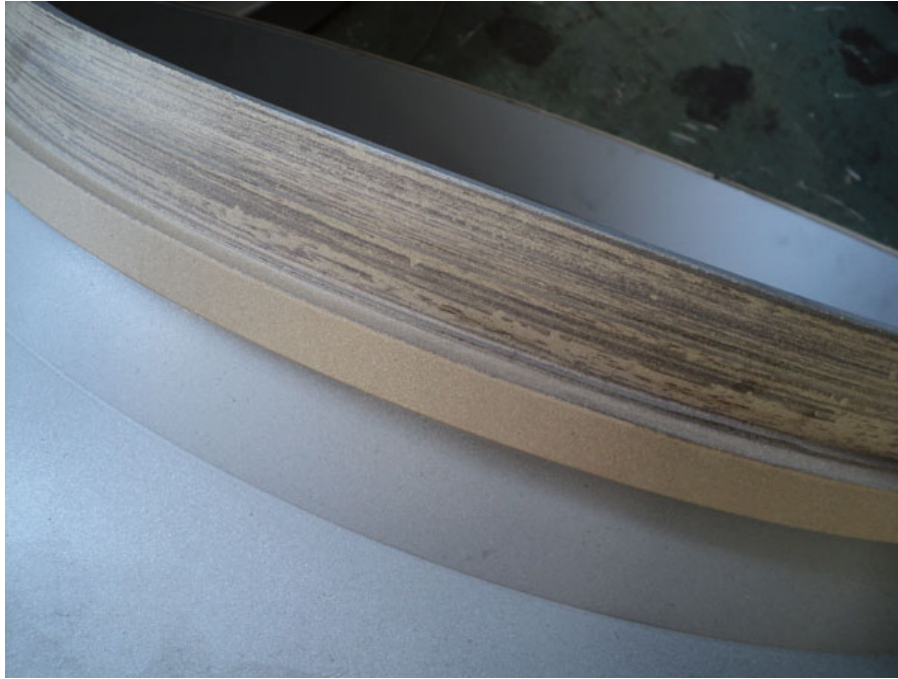
The equipment in question consisted of three-stage vertical turbine pumps running either in standalone or in [parallel](#) operation as required. The failure manifested itself through high vibration and caused severe scoring of the pump shaft and wear ring landings, leading to fatigue failure of the weld on the discharge head flange (see Images 1 and 2). The commissioned pump was refurbished and rebuilt by another company's service center with spare impellers supplied by an original equipment manufacturer. No changes to the geometry had reportedly been made, although the impeller material had been upgraded from bronze to stainless steel.

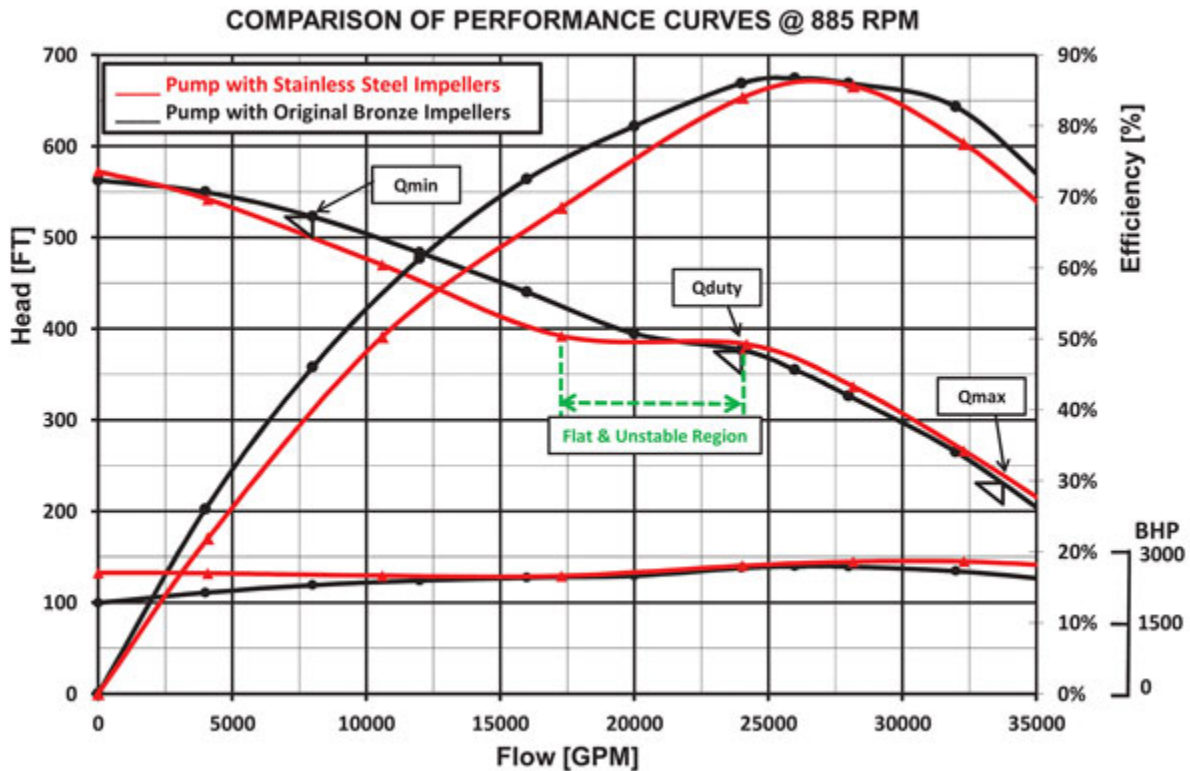
A thorough investigation of the machine's performance was conducted, and a detailed comparison between the stainless steel and bronze impellers showed considerable differences in the shape of the head and flow (H-Q) curve (see Figure 1).

From the analysis of the pump curves, engineers saw that the shape of the pump curve differed significantly from the original, suggesting a discrepancy in geometry. The newly supplied stainless steel impellers represented a relatively higher specific speed.

Also, the head curve of the stainless steel impellers showed a flat area at the duty point. This allowed the pump to "hunt" across this area and created severe vibration that contributed to the pump's failure. As a result, the head curve of the stainless steel impellers was less stable than the original bronze design at the vicinity of the duty flow.

The pump with the stainless steel impeller also consumed more brake horsepower at the required maximum flow ( $Q_{max}$ ). With this observation, engineers determined the unstable operation at the duty flow could have been the cause of the pump failure. This shows the importance of analyzing the impeller geometry and providing pump tests to ensure proper pump operations. The next step involved studying the difference in geometries of the bronze and stainless steel impellers.

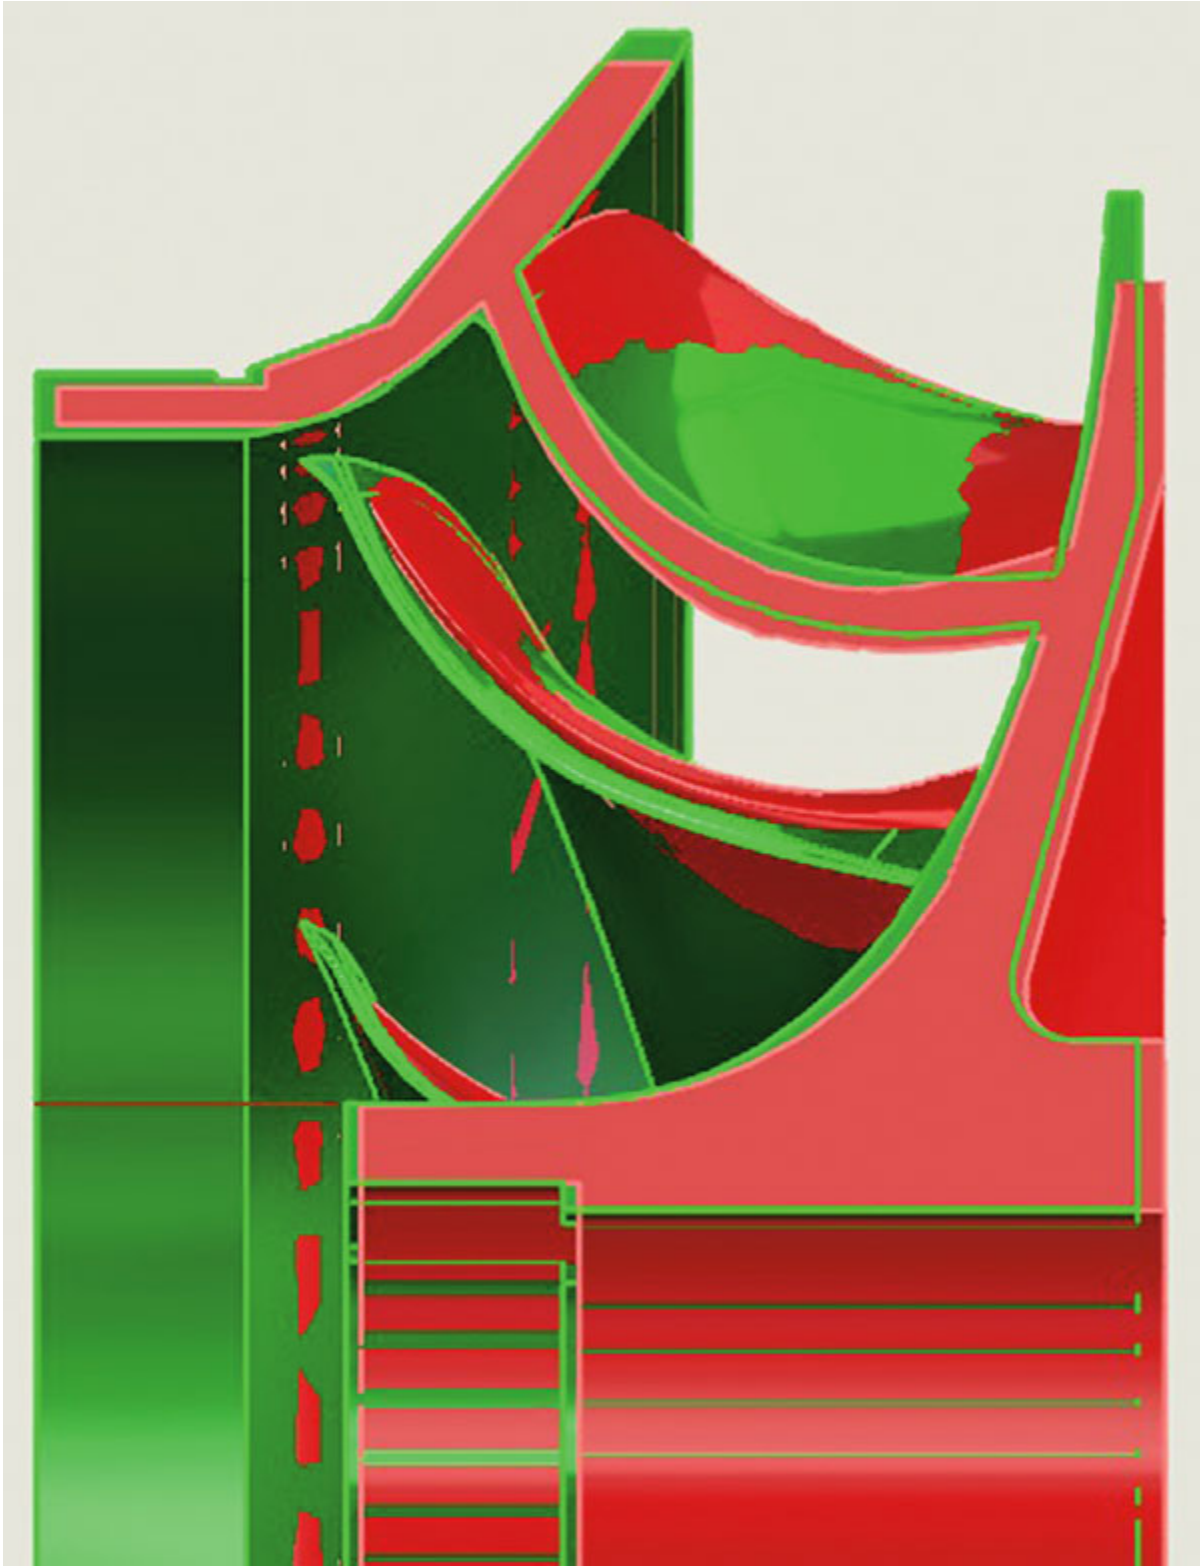
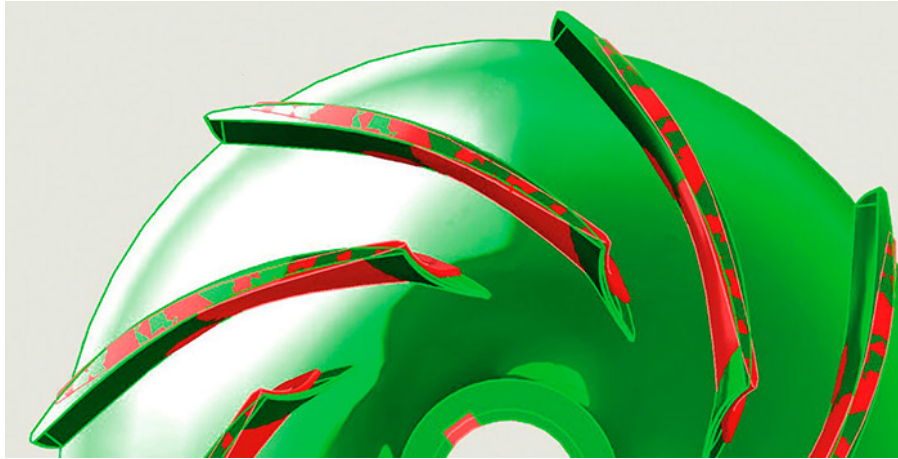
Using a comprehensive approach to impeller reverse engineering, experts established the differences between the stainless steel and the original bronze impellers. Significant differences in the vane shape and at the vane exit and inlet (at the impeller eye) raised concerns about the impeller geometry (see Figures 2 and 3).

The discharge vanes at the impeller outlet were considerably different, causing the discrepancy in head and curve shape.

The inlet angles and geometry of the impeller inlets also showed significant deviations from the original design—meaning consequences for the machine's net positive suction head required ([NPSHR](#)).

Based on the geometry differences at the impeller inlet, it was noted that the required minimum submergence level for the pump with the stainless steel impellers might be relatively higher than the required minimum for the bronze impellers.

With this input, the plant reviewed the submergence data and confirmed the actual submergence level was at the minimum at the time of the pump failure. The minimum level for bronze impellers might not be sufficient for the stainless steel impellers, which could have compounded the problems of unstable operation and high vibrations.
