Shortcuts Can Lead to Disastrous Outcomes

Design flaws cause catastrophic failure in a geothermal power station hotwell in New Zealand.

Written by: Chandra Verma (Hydro, Inc.)

Publisher: Pumps & Systems / August 2016

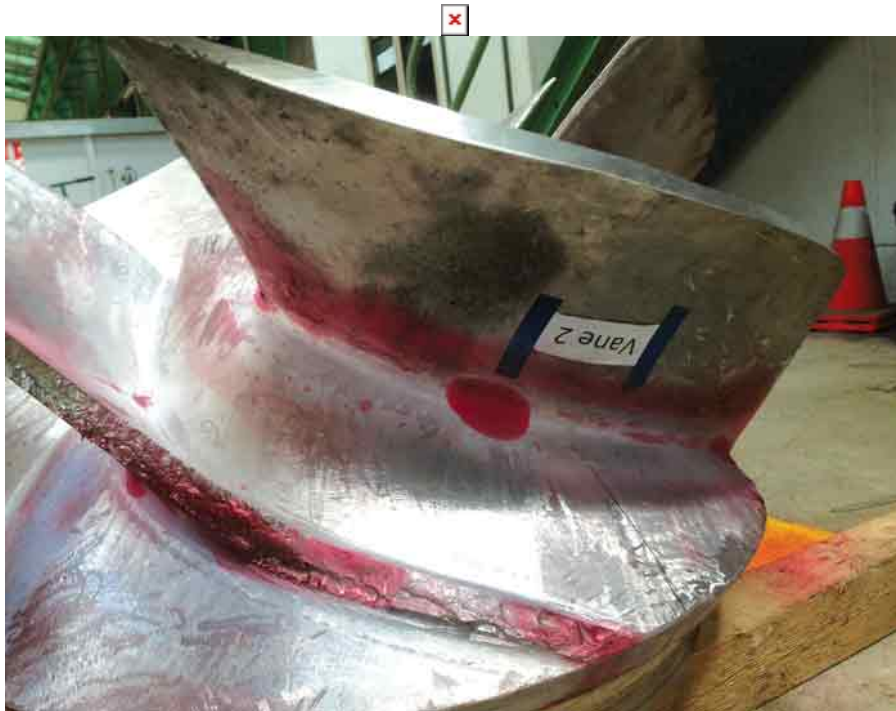
Poor casting quality led to other problems. The extent of such severe cavitation damage within seven weeks—a depth of 10 millimeters (mm) at places (see Image 1)—and the blade vane break (see Image 2) indicated an inferior product. The casting problems were reconfirmed by the surface-fracture analysis of the blade root. Numerous surface blow holes indicated gas porosity during casting.

With respect to poor-quality castings, a defect at the blade/hub root in open-vane impellers is common because of sudden changes in thickness coupled with insufficient metal feed during casting. Although not an excuse, some of the reasons for poor casting quality can be attributed to a lack of experience by new foundries. For example, sometimes an old pattern made for one material (usually cast iron) is reused for more difficult castings (e.g. stainless steel) without adequate modification to the thickness, radius and method.

The flow straighteners were removed and hydraulic cones were introduced to the bottom of each pump canister. These created a more uniform flow through the bell mouth throat with minimum loss. Concerning the manufacturing defects, the broken vane and severe cavitation were remedied by sourcing new impeller castings, produced under conditions with better quality control. The machining errors were also corrected.
