Quality Nuclear Performance Testing in Urgent Conditions

A 5-day emergency testing turnaround for a nuclear pump proved no problem for this world-class testing facility.

Published by: Nuclear Plant Journal

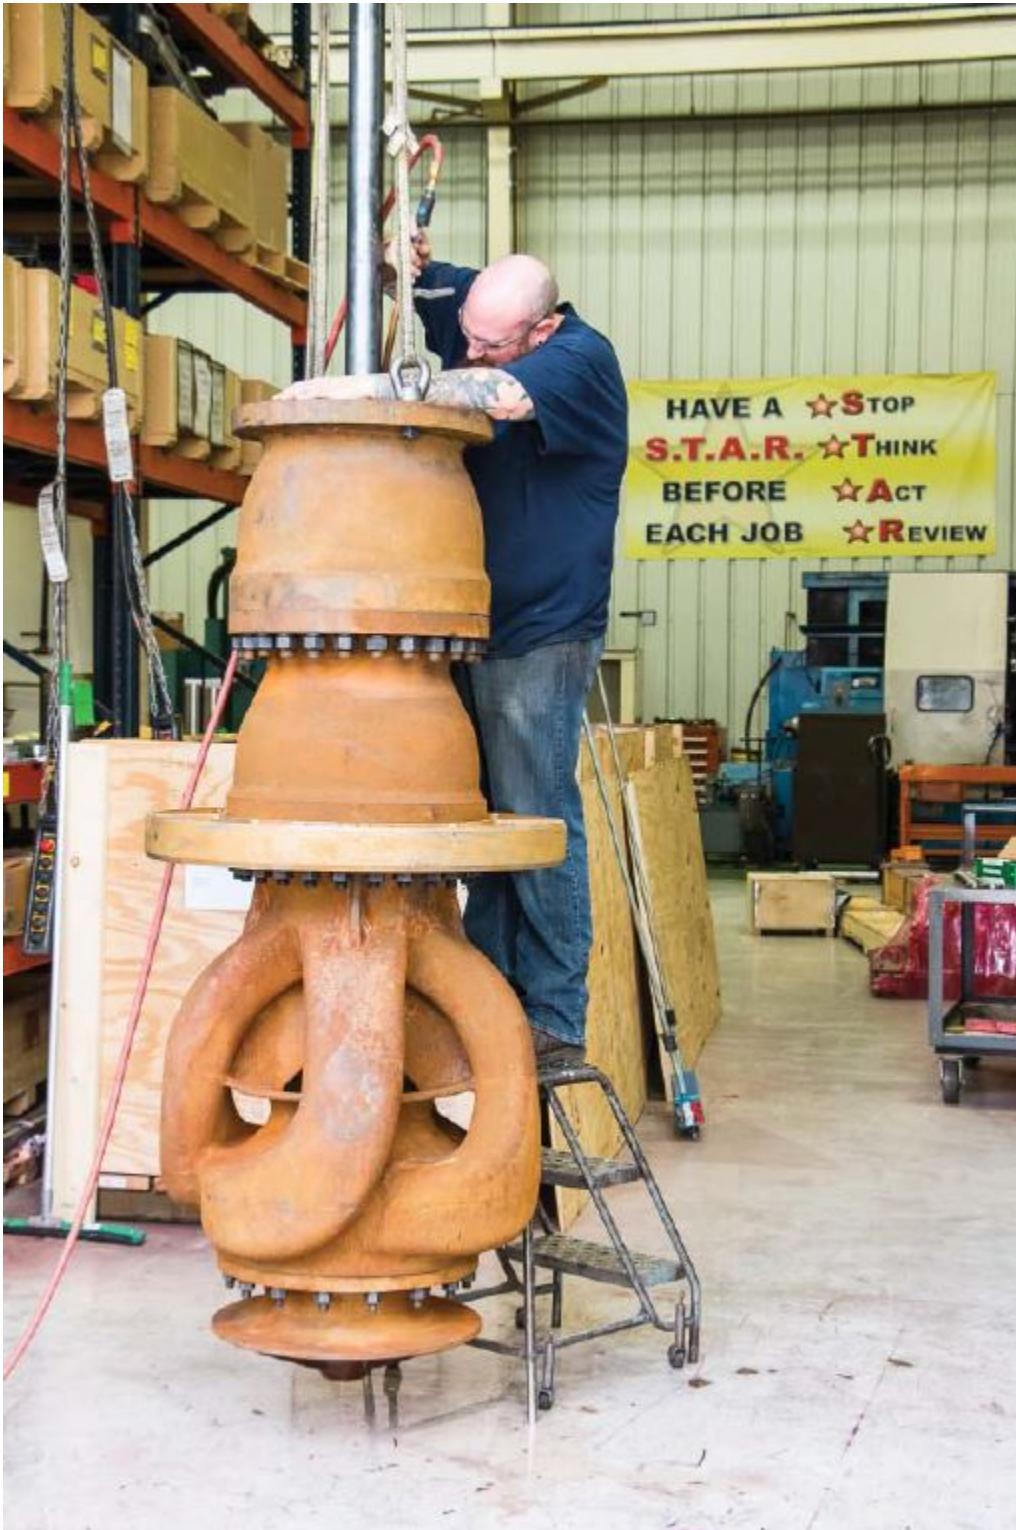
Inspecting the pump.

Once testing was completed, results were submitted to the plant for final approval. The pump and the supporting documentation were both shipped to the plant within the required time frame. Testing confirmed that the pump met the regulator's standards and no pump repair or rebuild was required.
