## Pump Renovation Restores Balance

**Vibration issues with a two-stage pump forced a major steel manufacturer to remove the pump from service. Due to incorrect weights welded on an impeller, a steel manufacturer called upon Hydro to repair and balance a two-stage pump.**

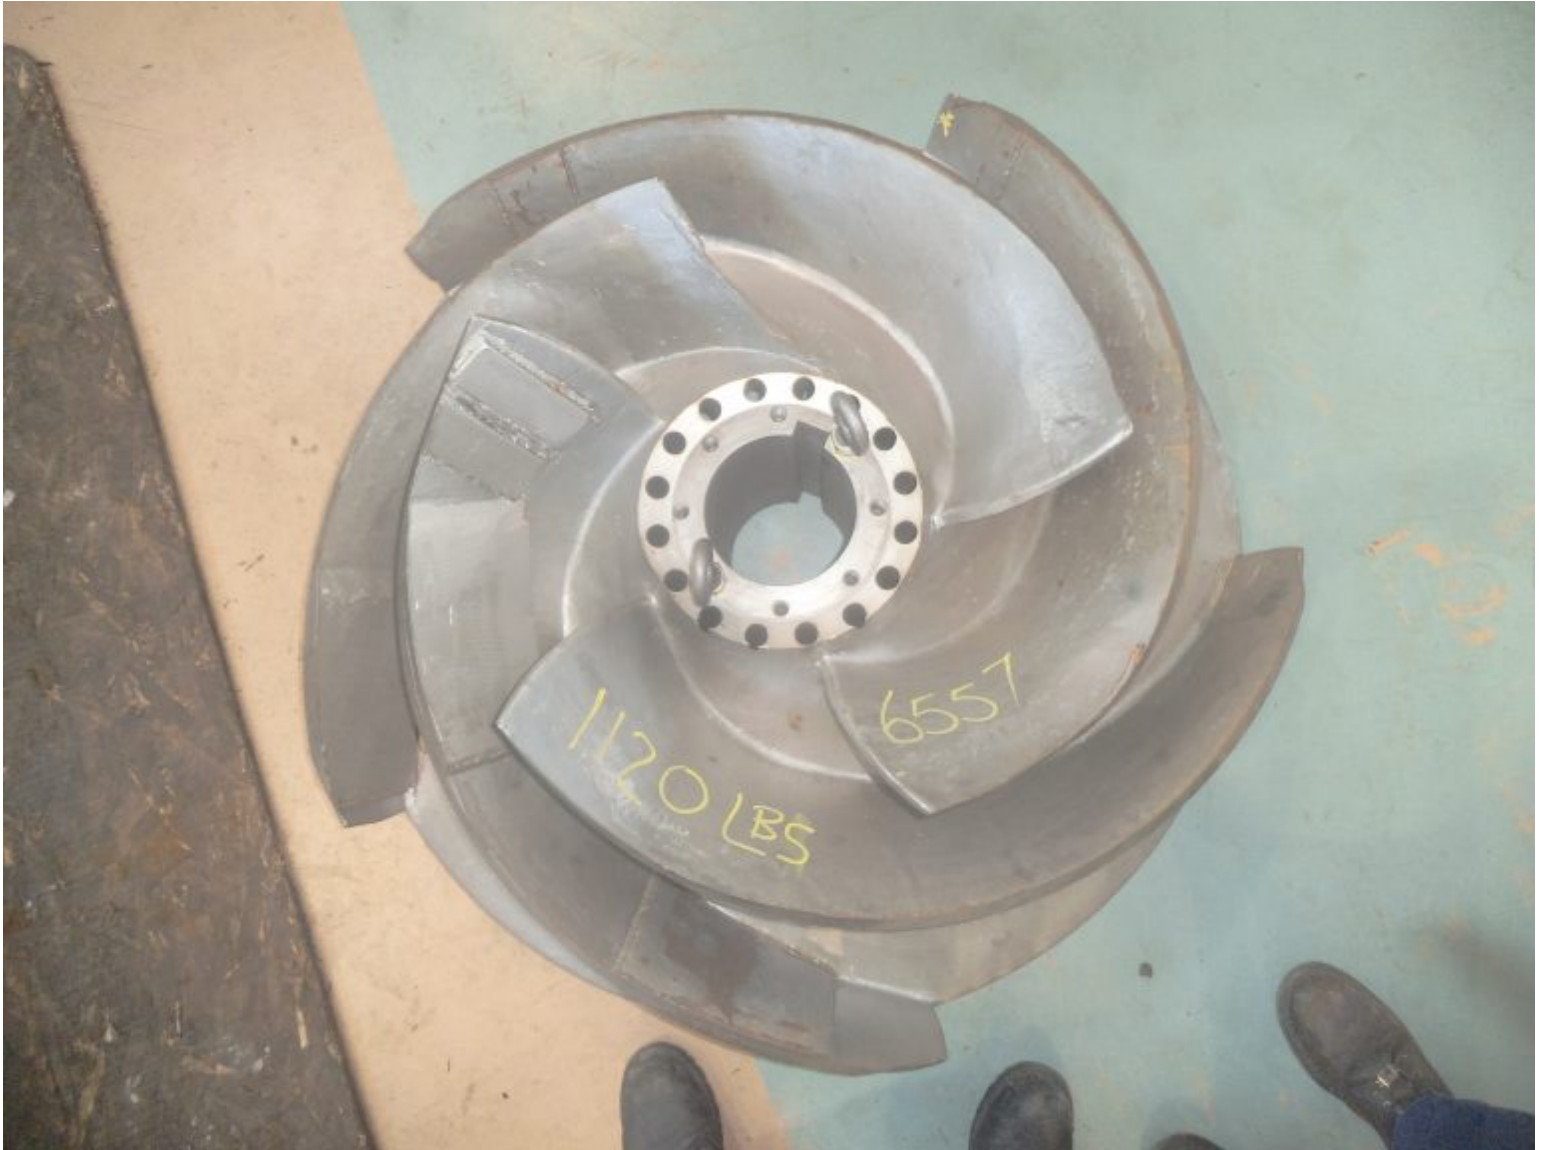
The initial testing and analysis determined that the impeller had large weights welded onto it. The steel company was concerned for many reasons, especially because the staff knew that using weights was not the correct way to balance an impeller. This caused the steel manufacturer to question the manner in which the pump had previously been repaired.

Vibration was the root cause of the component damage and rotor imbalance was the cause of the vibration. HydroAire's assessment upon disassembly was that lake water, mud, and silt continuously built up over time. Centrifugal force then captured this debris and trapped the mud and silt. The company realized that the situation would only worsen over time. The impeller balance holes, designed to equalize pressure, having been clogged with debris, disrupted the hydraulic balance of the pump. This is a phenomenon HydroAire has seen before, especially where pumps are drawing water from lakes or rivers with heavy mud and silt beds. Kansas City Power & Light experienced similar problems with their CW pumps so HydroAire designed baffles and plates to stop the build-up of debris and protect against hydraulic imbalance.

Based on experience repairing pumps that have vibration issues, HydroAire recommended removing the current impeller weights and using a different type of material. Since the bores had been oversized, HydroAire honed the bores and sized a new impeller shaft on the impeller lands. They then intermediately case flanged the bushing land accordingly. The service company further recommended welding and reclaiming the wear on the vane edges and machining the existing wear rings. The holes were re-tapped and the face dressed. Each impeller was balanced to ISO 1941 6.3 specification. The impeller retaining collar was sandblasted and machined in order to reclaim. The steel manufacturer was onsite to review HydroAire's proposal and to further inspect the pump. The weights on the impellers were kept intact because they were deemed 'acceptable'. However, they were positioned appropriately and tested further. Upon installation and startup in February 2017, the vibration results were found to be optimum.

The customer needed the pump repaired and returned urgently. HydroAir manufactured the damaged components including one new shaft coupling sleeve, two coupling locknuts and six split rings. The company also cleaned the components and indicated critical faces and diameters to ensure proper runout. At the customer's insistence, HydroAire removed the weights from the SO 7123 impellers, advising they would likely have to be re-applied to use the same impellers to achieve balance. That was exactly the outcome as the rotor was significantly out of balance by nearly 20 pounds. The weights were re-applied and the rotor balance was achieved. HydroAire returned the completed unit for installation and start-up and the unit now runs well without vibration.
