Pump Renovation Restores Balance

Vibration issues with a two-stage pump forced a major steel manufacturer to remove the pump from service. Due to incorrect weights welded on an impeller, a steel manufacturer called upon Hydro to repair and balance a two-stage pump.

Written by: Ken Babusiak (Hydro, Inc.)

Published by: World Pumps

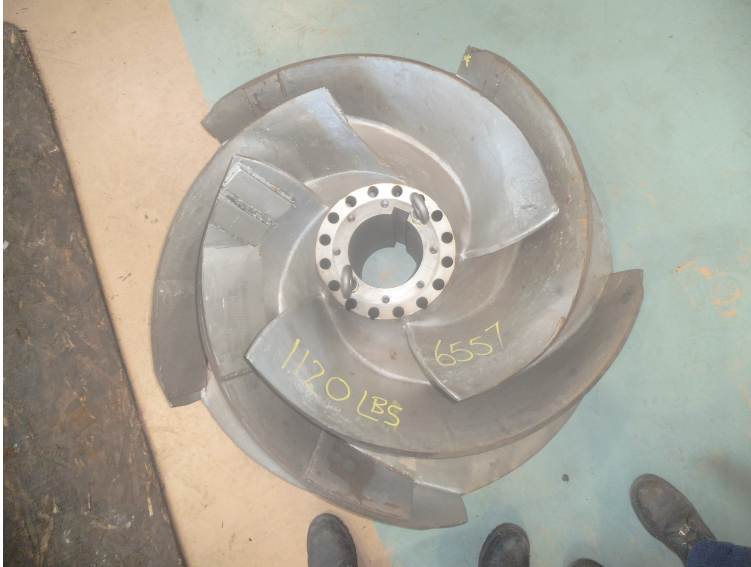
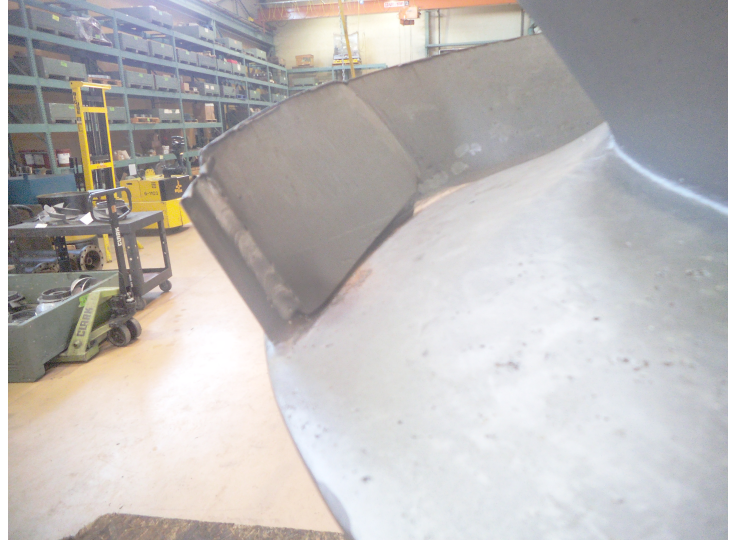
The initial testing and analysis determined that the impeller had large weights welded onto it. The steel company was concerned for many reasons, especially because the staff knew that using weights was not the correct way to balance an impeller. This caused the steel manufacturer to question the manner in which the pump had previously been repaired.

Based on experience repairing pumps that have vibration issues, HydroAire recommended removing the current impeller weights and using a different type of material. Since the bores had been oversized, HydroAire honed the bores and sized a new impeller shaft on the impeller lands. They then intermediately case flanged the bushing land accordingly. The service company further recommended

welding and reclaiming the wear on the vane edges and machining the existing wear rings. The holes were re-tapped and the face dressed. Each impeller was balanced to ISO 1941 6.3 specification. The impeller retaining collar was sandblasted and machined in order to reclaim. The steel manufacturer was onsite to review HydroAire's proposal and to further inspect the pump. The weights on the impellers were kept intact because they were deemed 'acceptable'. However, they were positioned appropriately and tested further. Upon installation and startup in February 2017, the vibration results were found to be optimum.

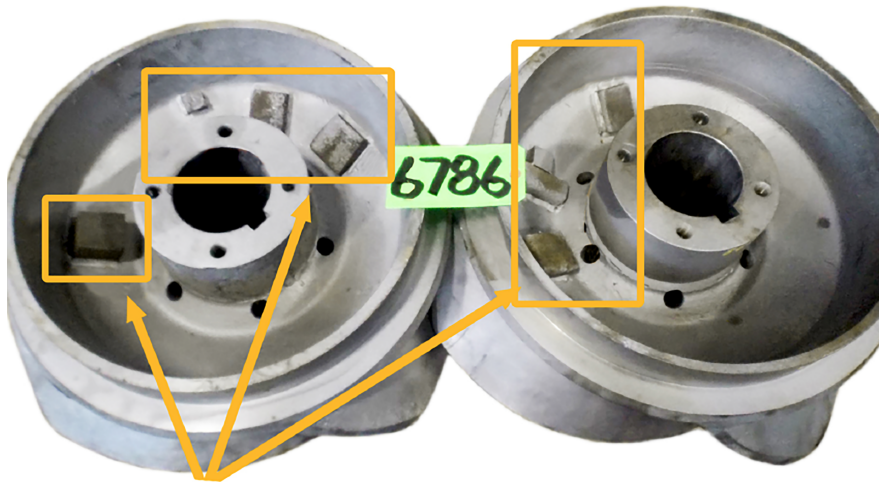
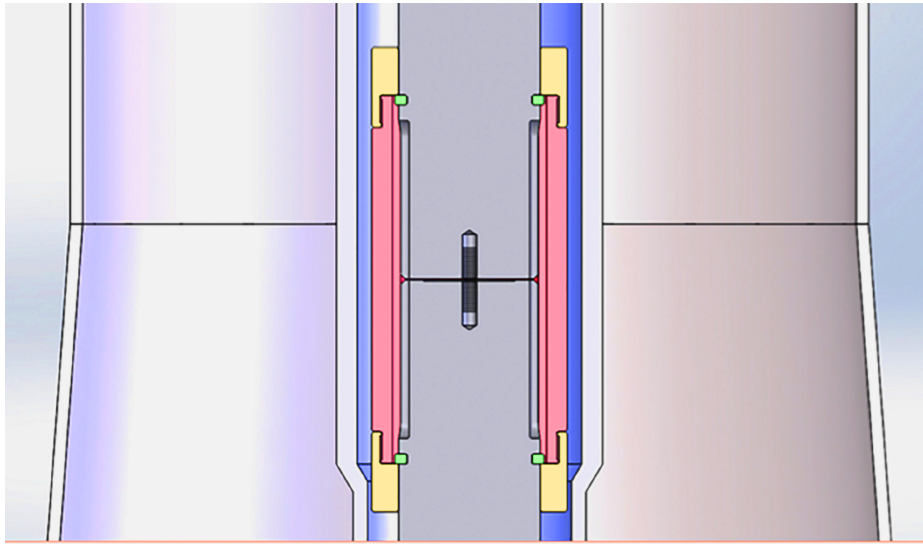
Vibration was the root cause of the component damage and rotor imbalance was the cause of the vibration. HydroAire's assessment upon disassembly was that lake water, mud, and silt continuously built up over time. Centrifugal force then captured this debris and trapped the mud and silt. The company realized that the situation would only worsen over time. The impeller balance holes, designed to equalize pressure, having been clogged with debris, disrupted the hydraulic balance of the pump. This is a phenomenon HydroAire has seen before, especially where pumps are drawing water from lakes or rivers with heavy mud and silt beds. Kansas City Power & Light experienced similar problems with their CW pumps so HydroAire designed baffles and plates to stop the build-up of debris and protect against hydraulic imbalance.

The customer needed the pump repaired and returned urgently. HydroAir manufactured the damaged components including one new shaft coupling sleeve, two coupling locknuts and six split rings. The company also cleaned the components and indicated critical faces and diameters to ensure proper runout. At the customer's insistence, HydroAire removed the weights from the SO 7123 impellers, advising they would likely have to be re-applied to use the same impellers to achieve balance. That was exactly the outcome as the rotor was significantly out of balance by nearly 20 pounds. The weights

were re-applied and the rotor balance was achieved. HydroAire returned the completed unit for installation and start-up and the unit now runs well without vibration.
