# Increasing MTBR Under Emergency Conditions

By Faisal Salman, HydroAire.

NuclearPlantJournal.com Nuclear Plant Journal, May/June 2019

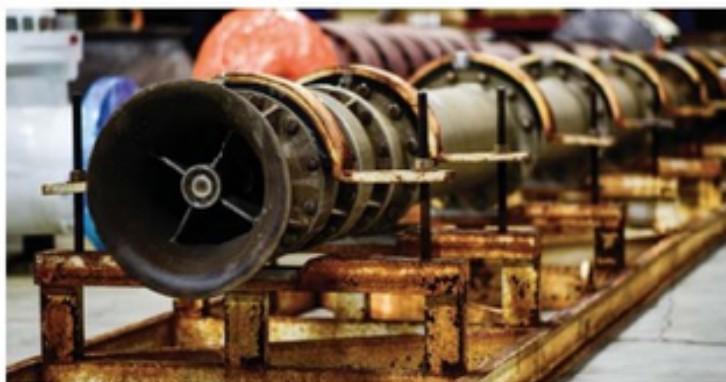
Routine wear had contributed to severe corrosion and erosion seen throughout the pump and its components. The edges of the impeller suction vanes were worn to a sharp, thin edge. The columns also experienced damage and were displaying thinned walls. Leakage from the pump's flange joints was also noted which can decrease pressure and flow, negatively affecting the throughput.

The operating pump was actively exhibiting performance issues and was reaching the end of its lifecycle, requiring their reserve unit be placed into service under expedited conditions.
