Engineering a Long-Term Solution

By way of example, this article will discuss a fertilizer plant in the Gulf of Mexico that had a boiler feedwater pump unit that was experiencing performance problems after a significant plant expansion project. Unfortunately, it was not the first time this particular unit had experienced a loss of capacity; the pump had been in operation only 18 months prior to the current issue.

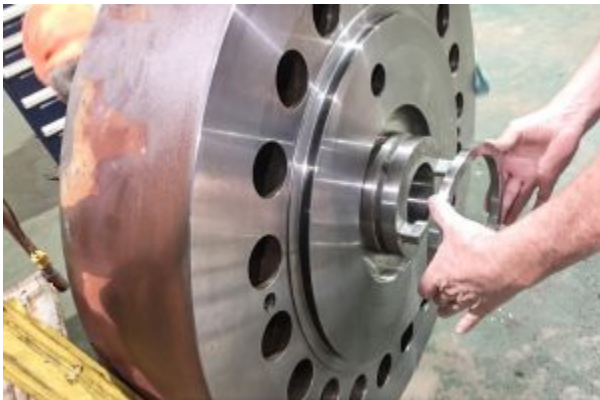
The dimensional analysis of the pump components revealed that the shim compensation pack was not thick enough to provide sufficient compression on the internal suction head gasket. The suction head gasket seals the face between the suction entry, at suction pressure, and the chamber surrounding the internal volute element, at discharge pressure. This high differential pressure makes it crucial to provide a sealing arrangement that prevents internal recirculation. Flow is driven from high pressure to low pressure areas and costly erosion damage occurs to the barrel.

The combination of the discharge head extension that protrudes into the casing, the shim compensator set, and the internal assembly determines the crush on the internal suction gasket. The insufficient thickness of the compensator shims resulted in an unloaded gasket, preventing the formation of an effective seal. The failure of this gasket allowed internal leakage from the high pressure discharge chamber back to suction.

To resolve the internal recirculation caused by insufficient gasket crush, the comprehensive work scope also included a rebuild of the volute assembly with an upgraded steel jacketed gasket and a redesign that removed the compensator shim set. This design included a volute locating ring and a full upgrade to the discharge cover and barrel casing to ensure proper gasket crush was achieved. The discharge cover was installed with a corrected location, and gasket loads were ensured by the precision locating ring (Figure 4).

The solution, whilst appearing to be relatively straightforward, required significant engineering knowledge of high-energy pumping equipment. Utilising a correctly sized precision locating ring addressed the pump reliability issues (Figure 5). After installing the ring and ensuring the precision of the component locations and the build quality, the pump ran at its desired operating point.
