Engineering a Long-Term Solution

By way of example, this article will discuss a fertilizer plant in the Gulf of Mexico that had a boiler feedwater pump unit that was experiencing performance problems after a significant plant expansion project. Unfortunately, it was not the first time this particular unit had experienced a loss of capacity; the pump had been in operation only 18 months prior to the current issue.

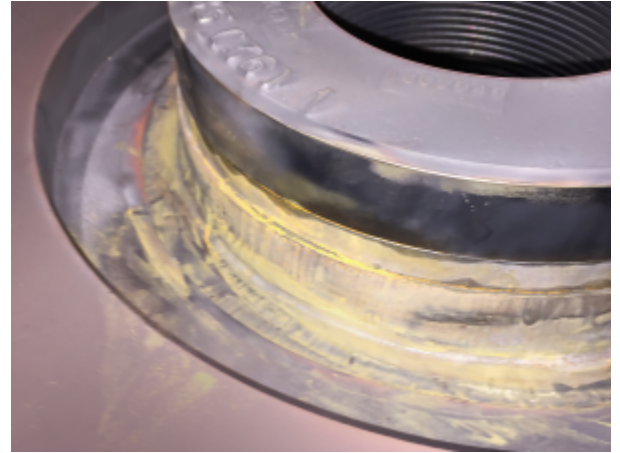
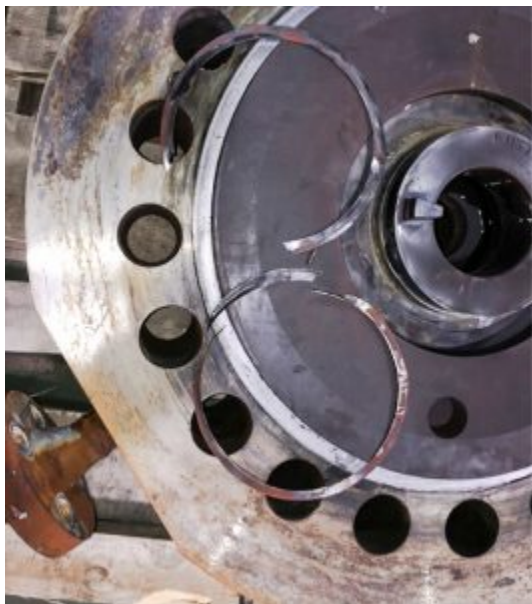
With this new information, the plant manager decided to proceed with the proposed forensic inspection plan. The service provider opted to have the pump sent to a service centre in Houston, Texas, US, for in-depth analysis and repair. The client agreed, and the entire unit, including the casing, was shipped for service (Figure 1).

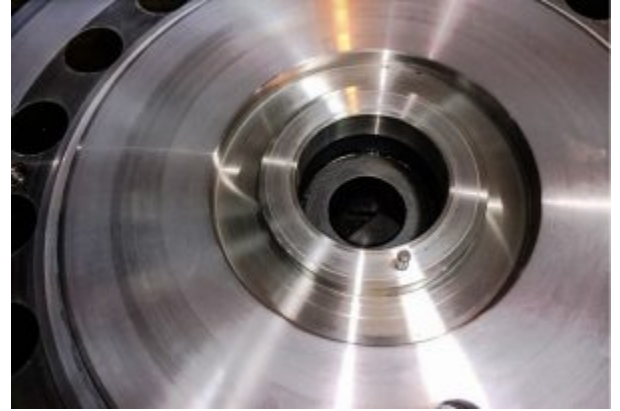
The in-depth inspection process uncovered a range of serious issues, including a damaged centring ring seat in the discharge cover (Figure 2). Most significantly, severe erosion of the suction pressure face was observed. It was determined that this erosion was due to insufficient gasket compression. The original design contained a shim compensation pack containing multiple shims (Figure 3). This shim pack was not sized correctly, leading to the failure of the internal suction head gasket.

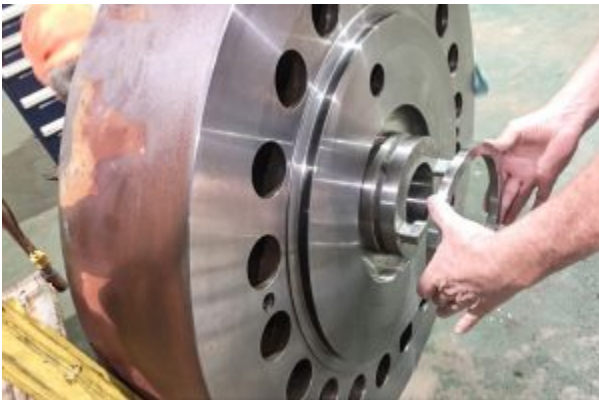
The dimensional analysis of the pump components revealed that the shim compensation pack was not thick enough to provide sufficient compression on the internal suction head gasket. The suction head gasket seals the face between the suction entry, at suction pressure, and the chamber surrounding the internal volute element, at discharge pressure. This high differential pressure makes it crucial to provide a sealing arrangement that prevents internal recirculation. Flow is driven from high pressure to low pressure areas and costly erosion damage occurs to the barrel.

The combination of the discharge head extension that protrudes into the casing, the shim compensator set, and the internal assembly determines the crush on the internal suction gasket. The insufficient thickness of the compensator shims resulted in an unloaded gasket, preventing the formation of an effective seal. The failure of this gasket allowed internal leakage from the high pressure discharge chamber back to suction.

To resolve the internal recirculation caused by insufficient gasket crush, the comprehensive work scope also included a rebuild of the volute assembly with an upgraded steel jacketed gasket and a redesign that removed the compensator shim set. This design included a volute locating ring and a full upgrade to the discharge cover and barrel casing to ensure proper gasket crush was achieved. The discharge cover was installed with a corrected location, and gasket loads were ensured by the precision locating ring (Figure 4).

The solution, whilst appearing to be relatively straightforward, required significant engineering knowledge of high-energy pumping equipment. Utilising a correctly sized precision locating ring addressed the pump reliability issues (Figure 5). After installing the ring and ensuring the precision of the component locations and the build quality, the pump ran at its desired operating point.
