Engineering a Long-Term Solution

By way of example, this article will discuss a fertilizer plant in the Gulf of Mexico that had a boiler feedwater pump unit that was experiencing performance problems after a significant plant expansion project. Unfortunately, it was not the first time this particular unit had experienced a loss of capacity; the pump had been in operation only 18 months prior to the current issue.

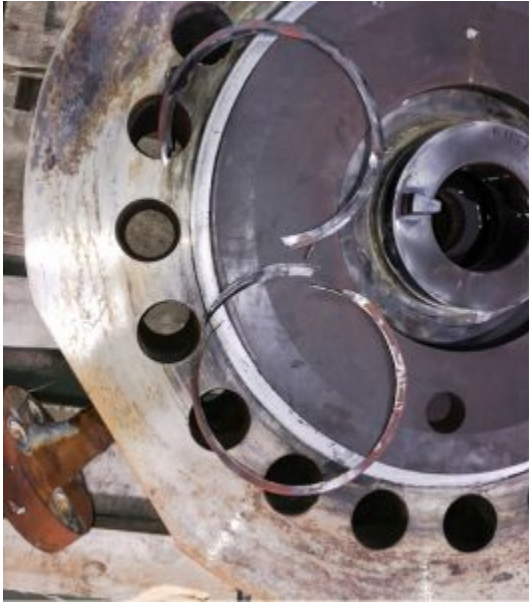
The in-depth inspection process uncovered a range of serious issues, including a damaged centring ring seat in the discharge cover (Figure 2). Most significantly, severe erosion of the suction pressure face was observed. It was determined that this erosion was due to insufficient gasket compression. The original design contained a shim compensation pack containing multiple shims (Figure 3). This shim pack was not sized correctly, leading to the failure of the internal suction head gasket.

The dimensional analysis of the pump components revealed that the shim compensation pack was not thick enough to provide sufficient compression on the internal suction head gasket. The suction head gasket seals the face between the suction entry, at suction pressure, and the chamber surrounding the internal volute element, at discharge pressure. This high differential pressure makes it crucial to provide a sealing arrangement that prevents internal recirculation. Flow is driven from high pressure to low pressure areas and costly erosion damage occurs to the barrel.

protrudes into the casing, the shim compensator set, and the internal assembly determines the crush on the internal suction gasket. The insufficient thickness of the compensator shims resulted in an unloaded gasket, preventing the formation of an effective seal. The failure of this gasket allowed internal leakage from the high pressure discharge chamber back to suction.

To resolve the internal recirculation caused by insufficient gasket crush, the comprehensive work scope also included a rebuild of the volute assembly with an upgraded steel jacketed gasket and a redesign that removed the compensator shim set. This design included a volute locating ring and a full upgrade to the discharge cover and barrel casing to ensure proper gasket crush was achieved. The discharge cover was installed with a corrected location, and gasket loads were ensured by the precision locating ring (Figure 4).

The solution, whilst appearing to be relatively straightforward, required significant engineering knowledge of high-energy pumping equipment. Utilising a correctly sized precision locating ring addressed the pump reliability issues (Figure 5). After installing the ring and ensuring the precision of the component locations and the build quality, the pump ran at its desired operating point.
